The wild side of Karori Park

Dog exercise and trail plan

For Consultation

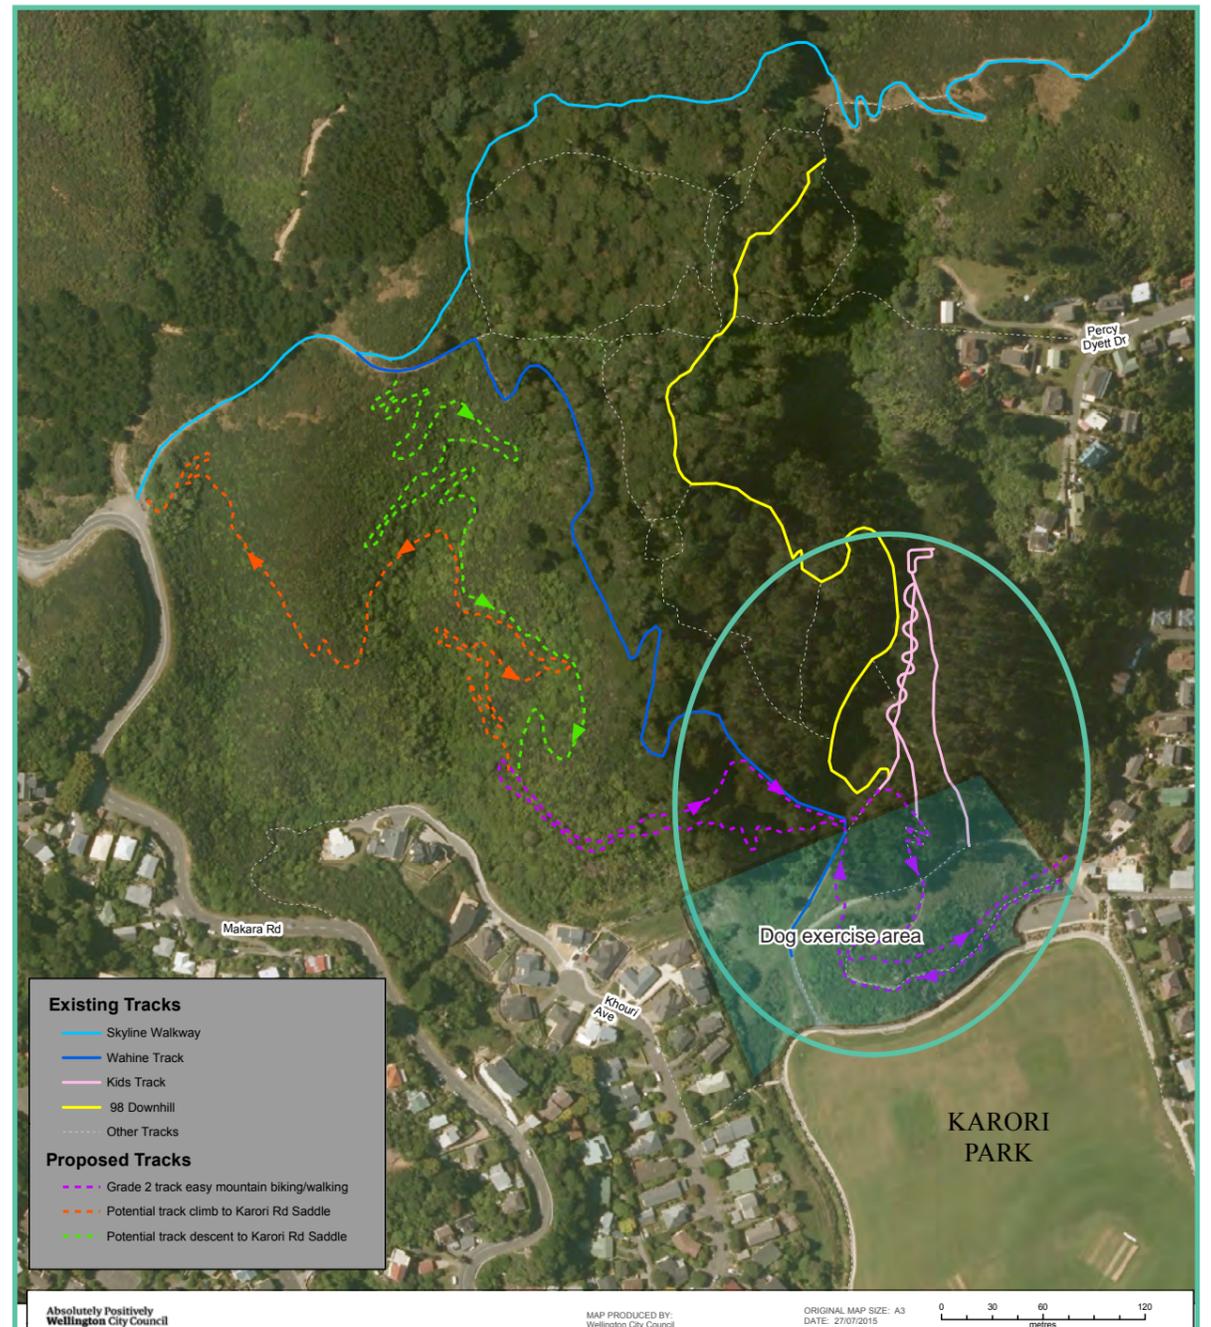
Figure 2: Aerial view of Karori Park with existing tracks and their use, and new easy shared track with connections to Karori Rd summit and the Skyline Walkway. This 'Dog Exercise Area and Trail Plan' proposes changes within the area ringed in green.

It is proposed to be a short but interesting loop trail with a gentle gradient. It would be wide enough for shared use by walkers and mountain bikers. To manage this shared use, mountain bikers would ride the trail in one direction only (see Figure 2 for existing and proposed tracks).

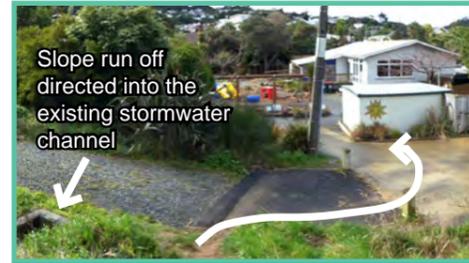
Run off into the kindergarten entrance

- The entrance to the proposed Grade 2 shared trail is not easily seen, especially for people new to the park
- The area is used by a wide range of people with some real and perceived conflicts between users at the kindergarten drop off, the beginning and end of the new Grade 2 trail and the beginning of the dog exercise area
- Soil washes into the kindergarten entry from the steep slope.

- Widening the existing children's bike trail
- Reducing the risk of collisions between mountain bikers and carpark users by the new trail exiting at an oblique angle to slow riders down before crossing the kindergarten entry and entering the carpark
- Planting the steep clay slope to reduce runoff
- Run off directed into an existing stormwater channel.

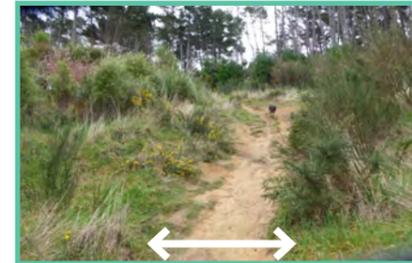
Steep, slippery slope where planting would improve runoff

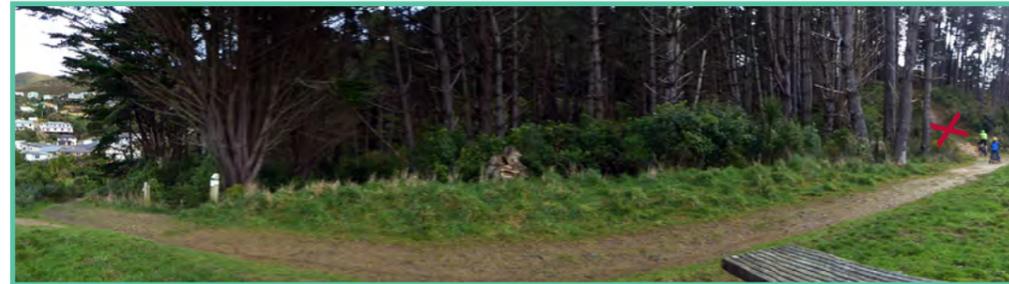
Area 2 with picnic tables and tracks. The unofficial track that confuses visitors is marked with the red cross. Planting the entrance would remove confusion

- Wayfinding is unclear with a number of tracks to choose from
- An unofficial but prominent track leads to a dead end at private property at the eastern edge of the park. First time visitors have been seen to choose this track mistakingly thinking it leads to the Skyline Walkway
- Views from picnic tables over the sportsfields are obscured by vegetation.

- Information at entrances in Sunshine Avenue carpark will inform visitors of track locations
- Planting to reduce run off and obscure entrances to unofficial tracks.
- A viewshaft from the lookout area can be retained by selective trimming of vegetation.

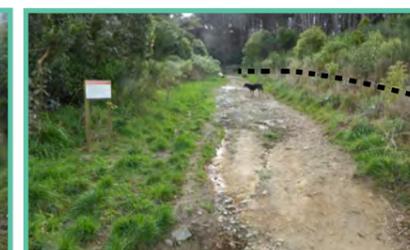
Track surface difficult to maintain due to water running down the fall line. Relocating the trail off the gully floor will improve experience of the trail

Relocate the trail slightly above the gully floor and plant the trail's current location to absorb runoff

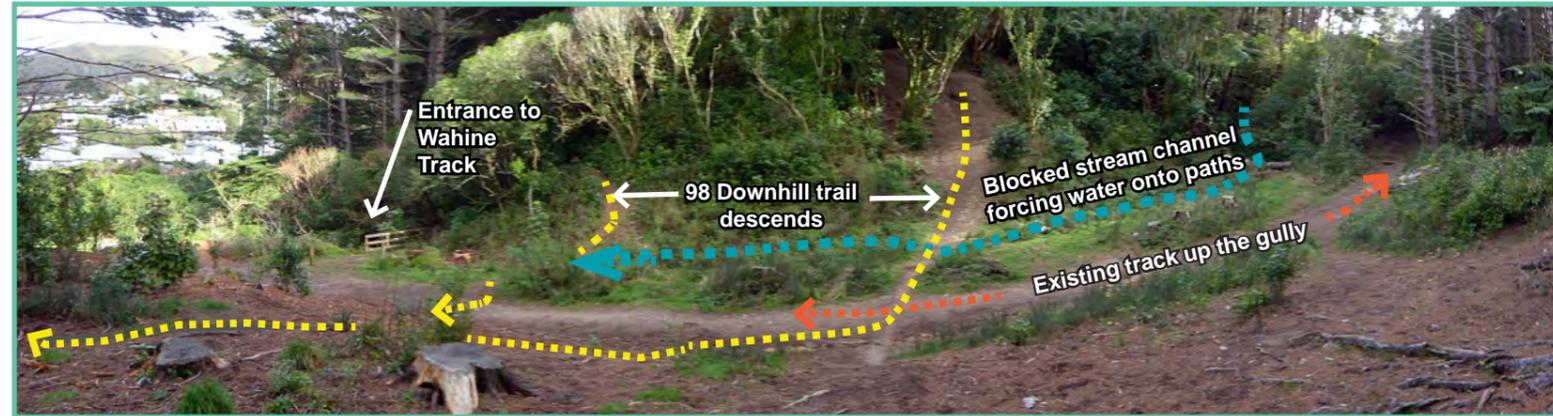
Area 4 Looking west

- The entry to the Wahine Track is low key and easily overlooked
- Potential conflict with the 98 Downhill mountain bike trail (yellow lines) entering the gully floor and crossing the main gully access track
- The stream channel (blue line) is overgrown and blocked by tracks, logs, vegetation, debris and 98 Downhill mountain bike trail exits. Poor drainage means the main track in the gully becomes muddy and rutted.

- Development of the new grade 2 loop trail includes upgrading the Wahine Track where it is part of that trail. Keeping only one exit from the 98 downhill trail and redesigning where it exits onto the gully floor to reduce conflict between different track users
- Clearing the stream channel and planting in native riparian species.

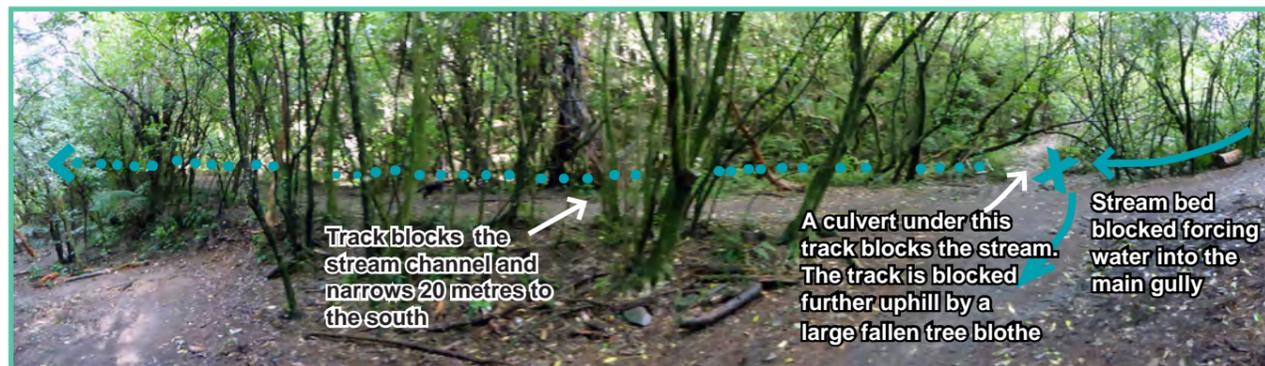
View looking east - stream channel needs reforming and two tracks removed to restore flow and catch runoff

- Two tracks block the stream bed creating the small wetland. Water from the streams, seepage from slopes above and springs is forced to run onto the central path or to seep underground. The wider track is misleading for walkers as it narrows to become part of the 98 downhill mountain bike trail. A large fallen tree blocks the second trail approximately 10 metres uphill
- The wetland and trough are difficult to see due to vegetation and a large fallen tree.

- Reforming the stream channel and removing tracks where they block the stream channel to improve drainage
- Clearing some vegetation and a large tree where it has fallen over the wetland to expose the stream and trough as an interesting reminder of earlier farming.

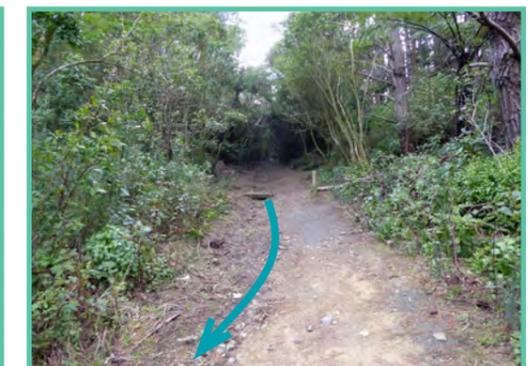
Water is forced down the central gully path

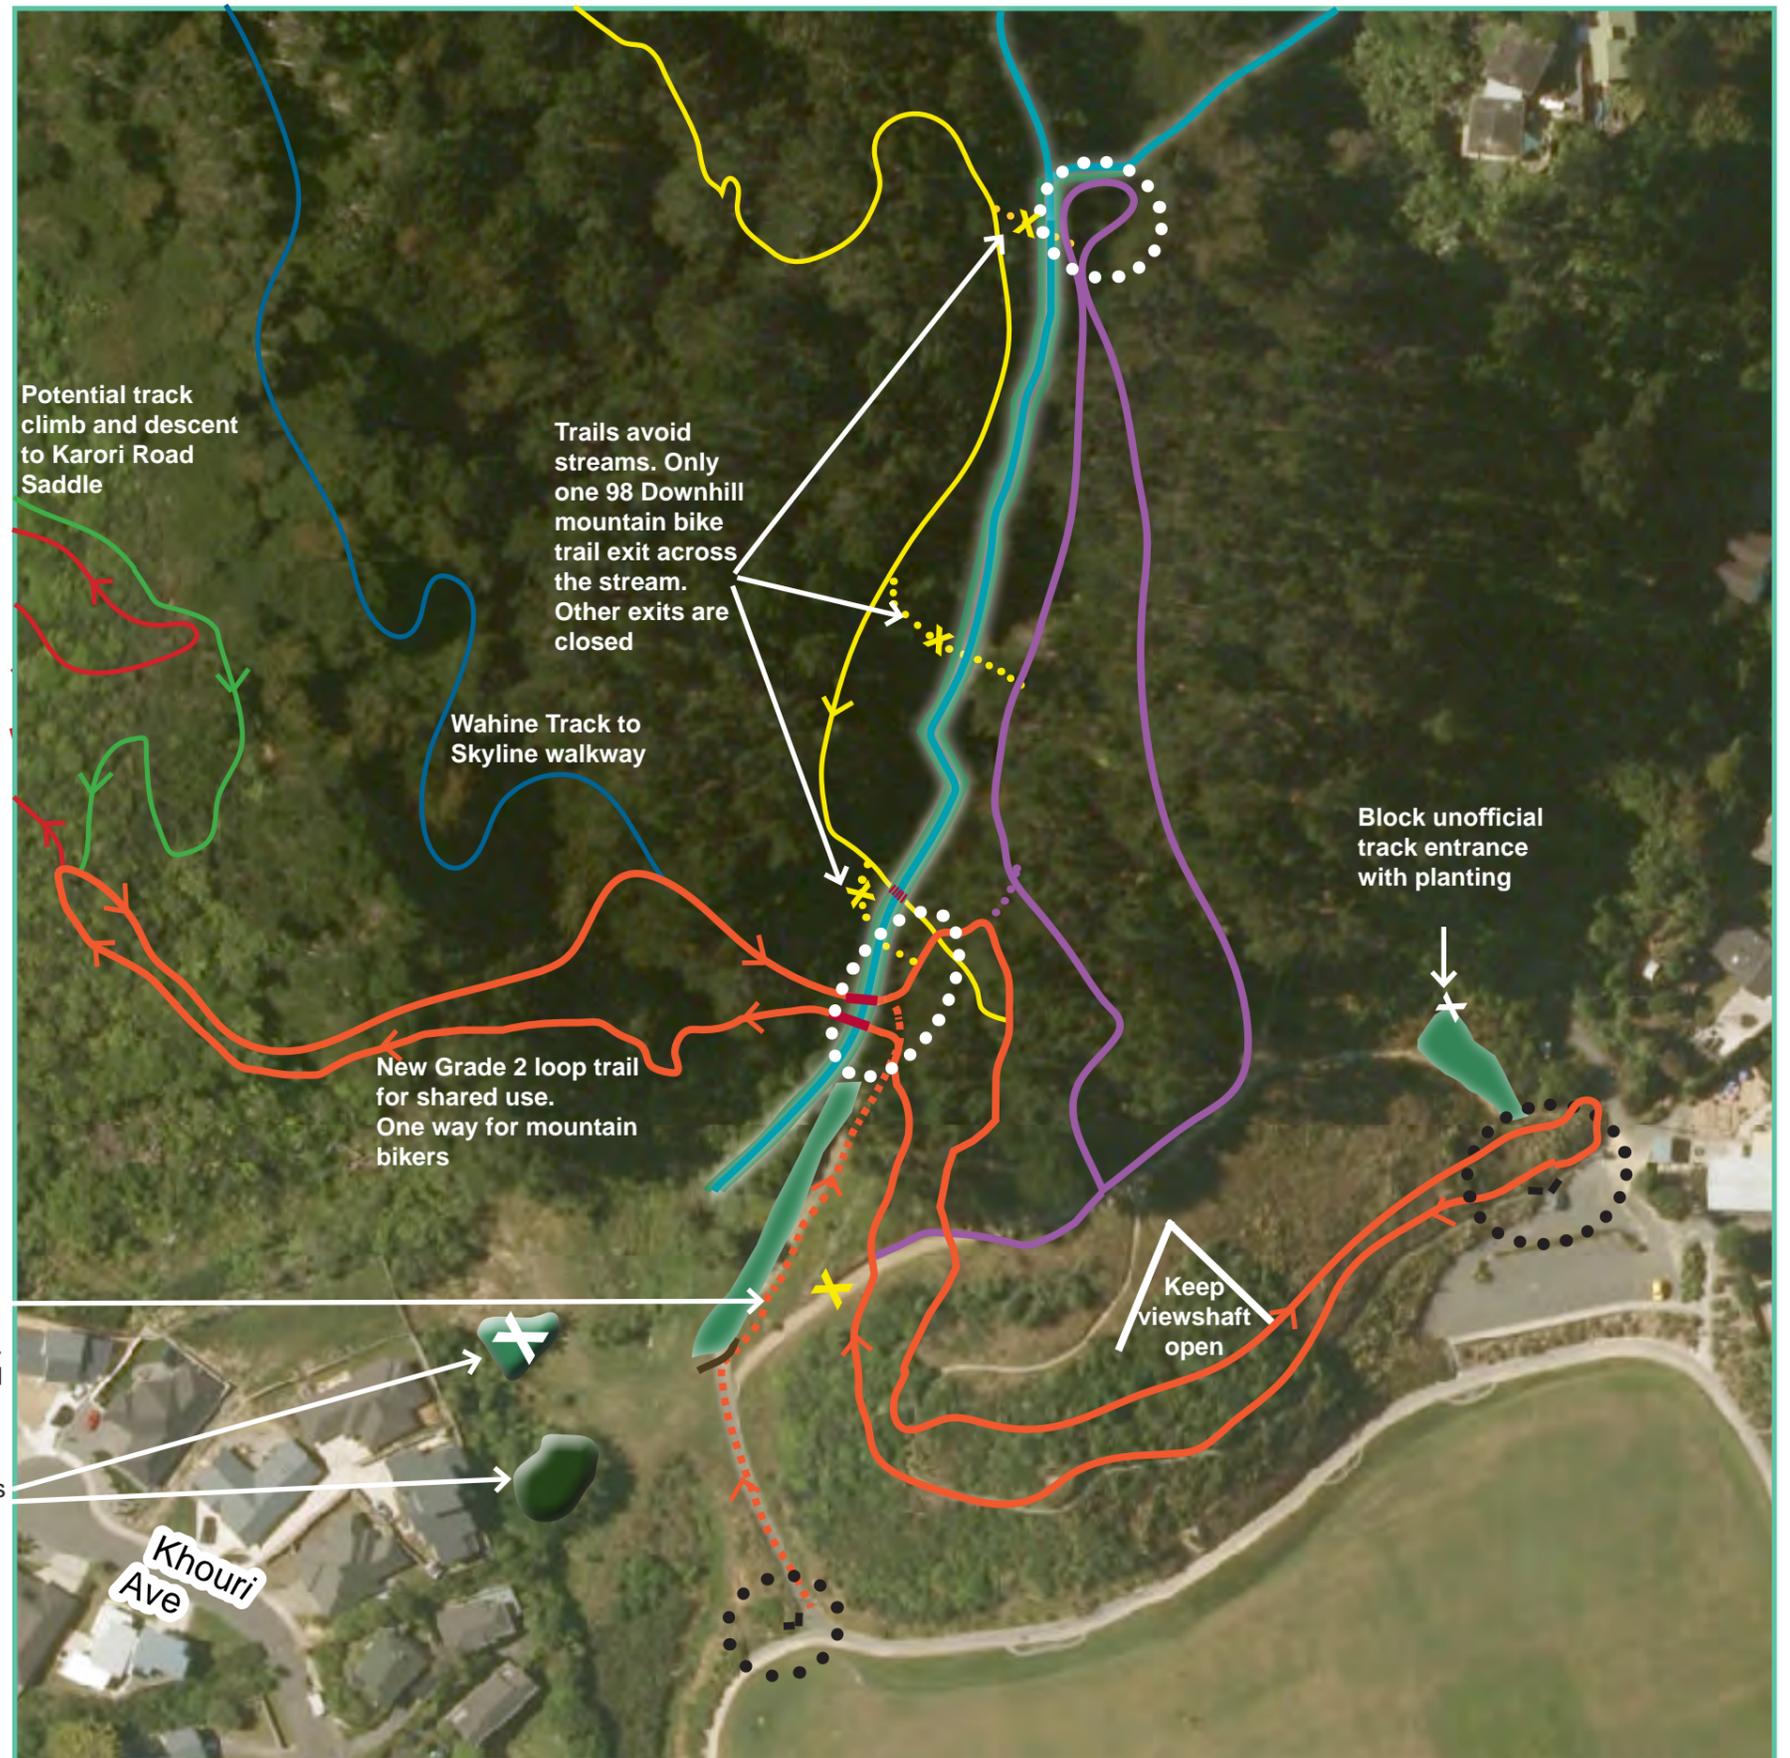
Figure 4 Overall concept for improvements

Realign track (existing track is on the fall line and water scours the track surface). Plant existing track. Timber post and rail barrier redirects users. Uphill mountain biking only

Remove vegetation that restricts sightlines to improve a sense of safety and create more open space for dog exercise

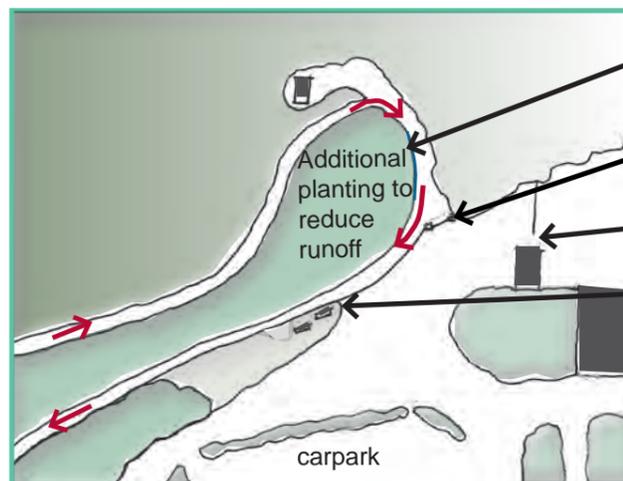
Plan view of sunshine Avenue carpark and the new Grade 2 shared trail

- Slot drain directed into existing stormwater drains to reduce run off into kindergarten entrance
- Existing bollards and chain at driveway to control access to pump station retained
- Kindergarten access
- Trail information at entrance to new Grade 2 shared trail

- Information panels on trails, trail use, links to the Skyline Walkway, activities and dog exercise area
- The shared trail exits above the kindergarten entry at an uphill angle to slow mountain bikers and run off is directed away from the kindergarten entry and into the existing stormwater channel

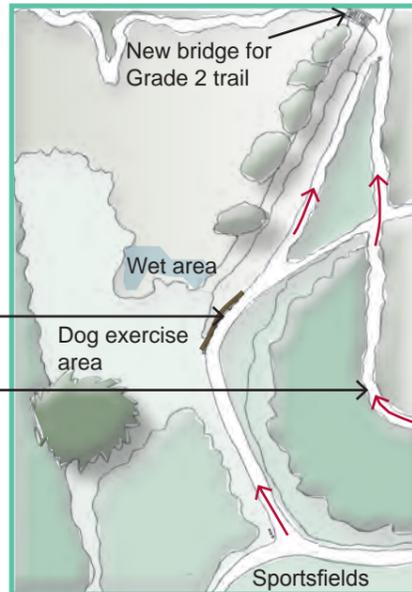
Shared track with posts and rails to direct users
Grade 2 trail from Sunshine carpark

- Shared track from the dog exercise area to the Wahine Track and new Grade 2 trail bridge is realigned to avoid the gully floor. Users are directed by a post and rail fence. This replaces the existing gully floor track which is difficult to maintain because water runs down it causing a very rough, uneven and scoured surface

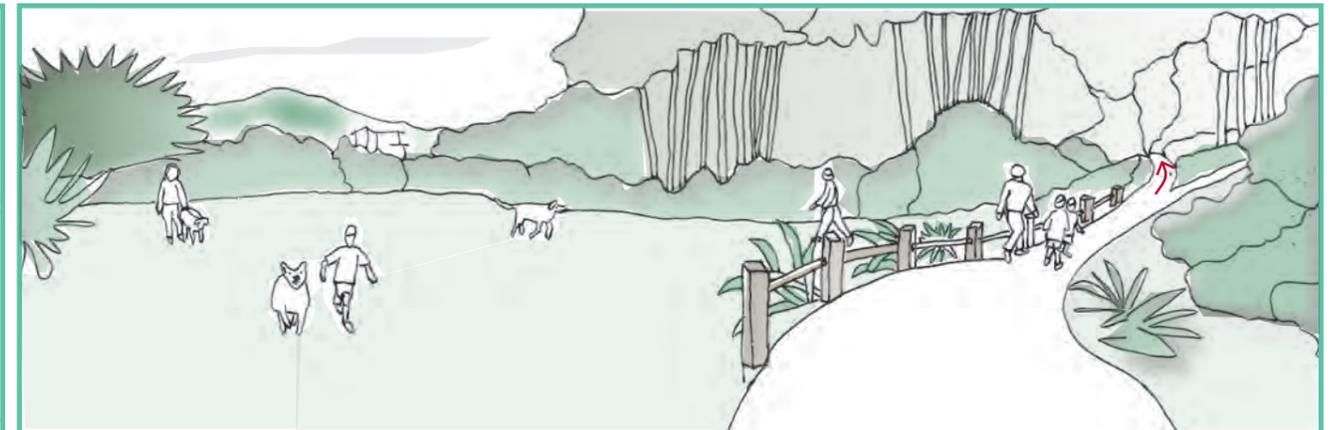
View of existing asphalt path from the sportsfield perimeter path, dog exercise area and realigned shared trail to the Wahine Track. Uphill biking only. Post and rail fence directs users to the realigned track

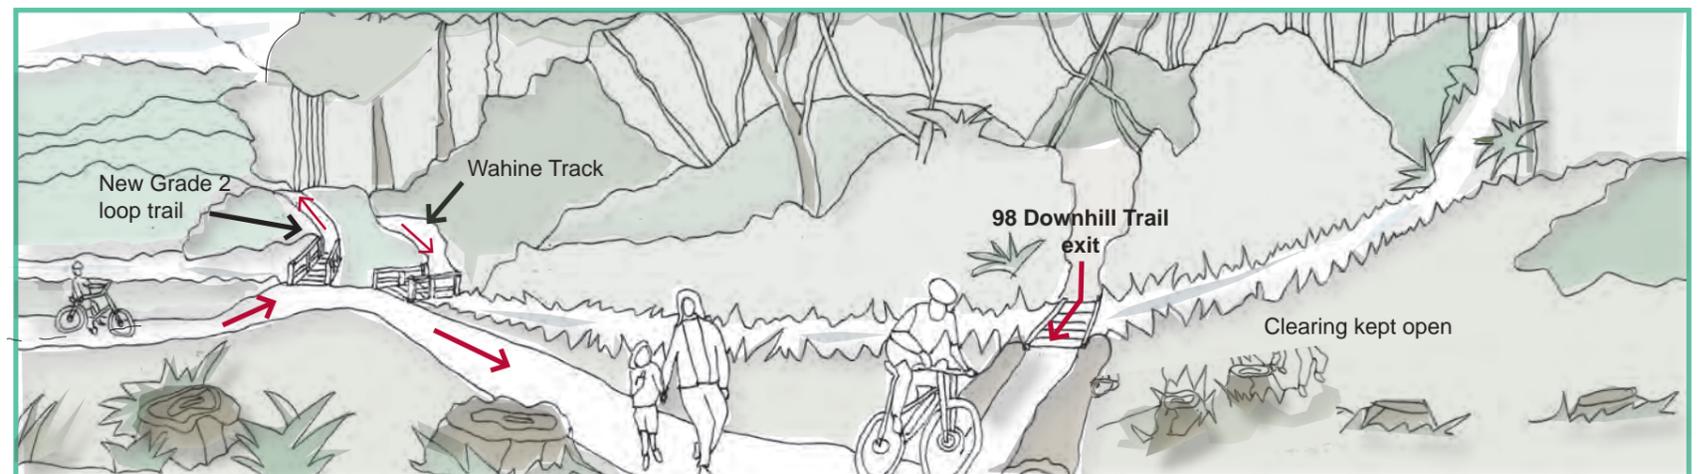
Area 4 Proposed - Looking west

- Only one mountain bike downhill trail exit retained. At the foot of the slope the downhill trail is controlled using strategically placing logs
- The stream channel is cleared of vegetation, logs and other debris and edges planted in riparian native species

- The forest clearings are tidied up and kept open with some logs and stumps for children's adventure/nature play
- The path up the gully (for walkers and dog walkers) is redirected and away from exiting downhill mountain bikers (see Area 4 Proposed - Looking east)

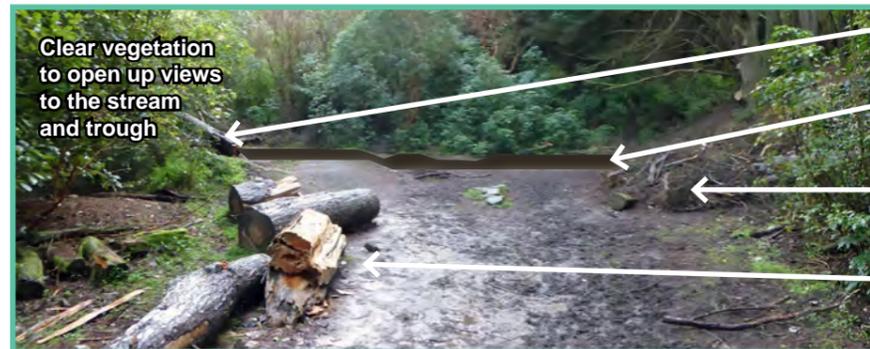
Area 5 Part of the dog exercise trail with small streams on two sides

- Clear vegetation to open up views to the stream and trough
- Remove part of tree fallen over the stream and the trough
- Reform bund to direct runoff away from the clearing
- Tidy up the area by removing debris
- Keep some logs for adventure play and informal seats but rearrange and remove damaged logs

- The small bund at the end of the clearing is reformed to direct the small stream and runoff from the slope above away from the clearing
- The tree fallen over the stream and some vegetation is removed to expose the stream and trough as an interesting reminder of earlier farming

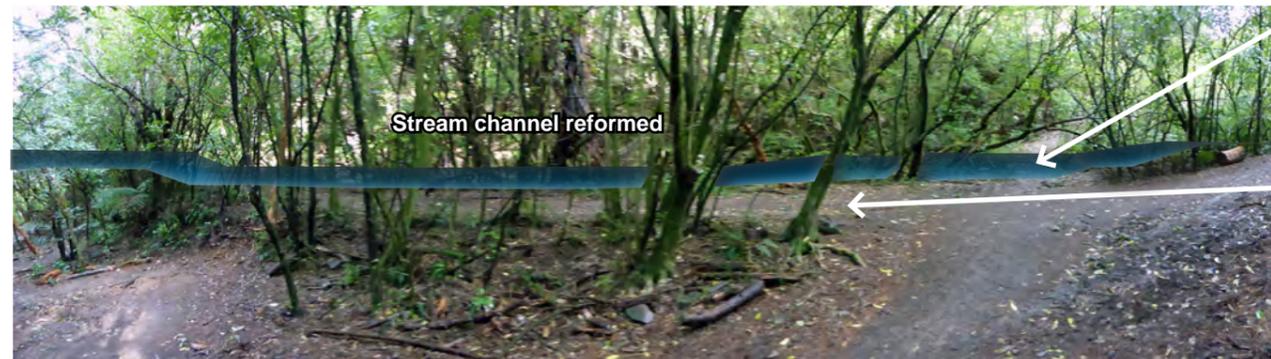
Area 5 View looking east - stream channel reformed and two tracks removed to restore flow and catch runoff

- Remove culvert and the track (which is blocked by a large fallen tree further up the track)
- Remove track. It narrows and becomes part of the 98 Downhill track which is too steep and slippery for walkers

- Tracks that cross the stream are removed by planting and the stream channel is reformed for approximately 20 metres to the south. This should restore water flow and catch water seepage from the slopes above. In this way the main track is likely to be drier and easier to use and maintain. Ambiguity about which track to take will no longer be an issue. In this way wayfinding is improved.
