*Pedestrian-Vehicle Accident Review: Human Factors
Behavioural Assessment*

Prepared By Jared Thomas, Grace Rive, Bill
Frith, and Samuel Charlton

Opus International Consultants Limited

Date: 20-07-12
Reference: 528089.00
Status: Final

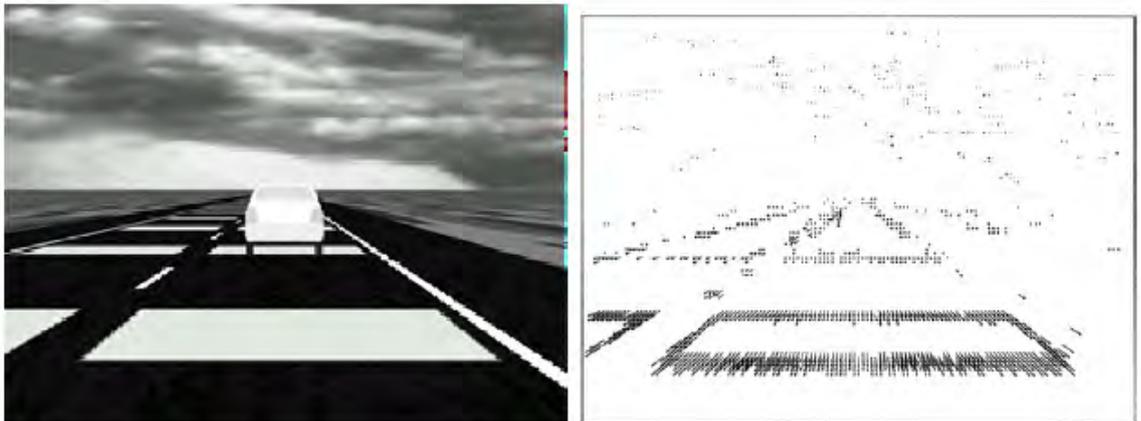
Figure 1: Bituminous pavement with chromatic bands, including global optical flow representation (Santos et al., 1999)

¹Chromatic bands are rectangles of contrasting coloured pavement within the road surface, as seen in Figure 1. Real world examples of contrasting horizontal colour on the road surface can include road markings or paved locations.

In relation to road surfaces, Santos et al. (1999) found evidence that different road surfaces affect the accuracy of motion detection of vehicles. Vehicle motion detection was more impaired in the situation of bitumen pavement with chromatic bands¹, a pavement with high optical flow density (which increases visual motion of the scene around the vehicle; see Figure 1), compared to other road surfaces such as bitumen or concrete without chromatic bands (see Figures 2 and 3 respectively; Santos et al., 1999). This finding led the authors to conclude that over-signalised roads could have dangerous implications for motion detection, meaning the number and type of signals required on a road should be carefully considered to ensure a safe environment (e.g. chromatic bands should be used where required to signalise designated crossings but excessive signage should be avoided).

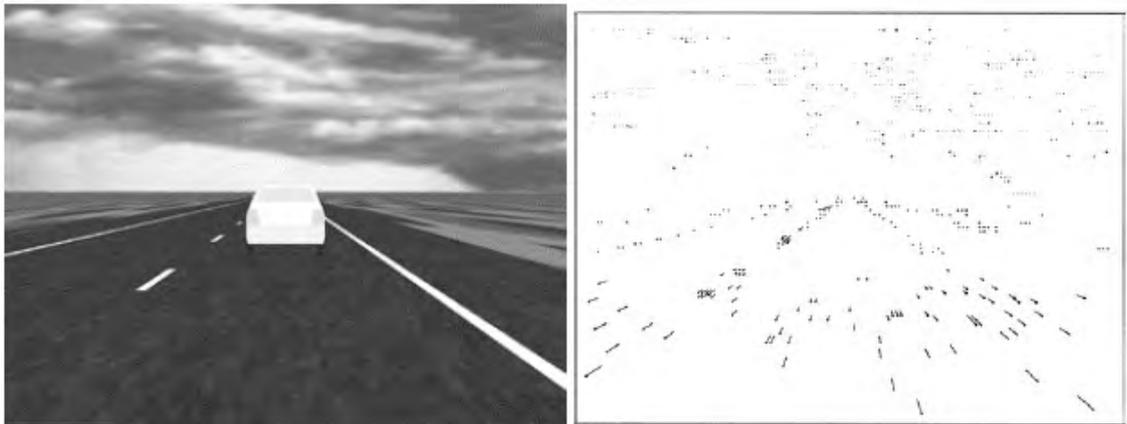
Figure 2: Bituminous pavement without chromatic bands, including global optical flow representation (Santos et al., 1999)

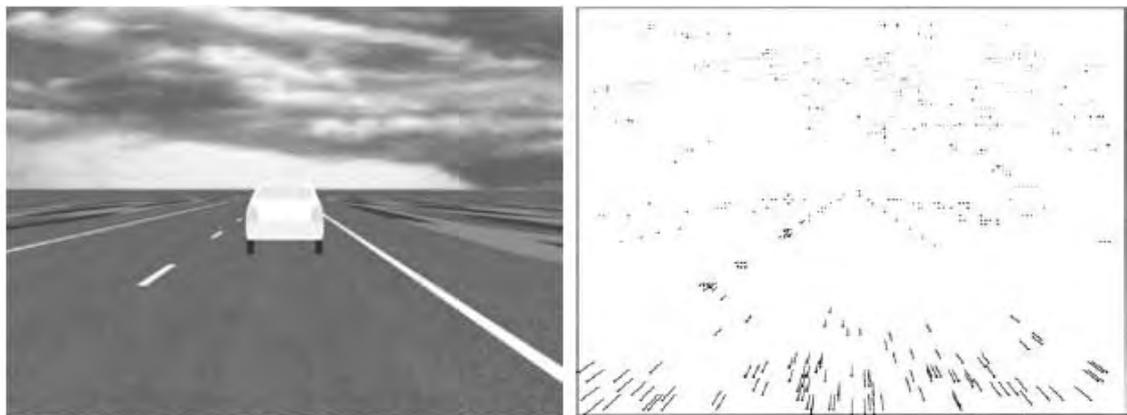
Figure 3: Concrete pavement without chromatic bands, including global optical flow representation (Santos et al., 1999)

The current evidence therefore shows road surfacing is an important consideration when aiming to improve motion detection of vehicles and therefore pedestrian safety. Research shows contrast (e.g. between concrete pavement and bitumen pavement) is of low importance to this with optical flow instead having important implications; over signalised roads potentially pose a hazard (Santos et al., 1999). Age related deficiencies in vehicle motion detection are well documented and vary by gender. Gender differences are also apparent in gaze targets and crossing compliance and these additionally vary by crossing type.

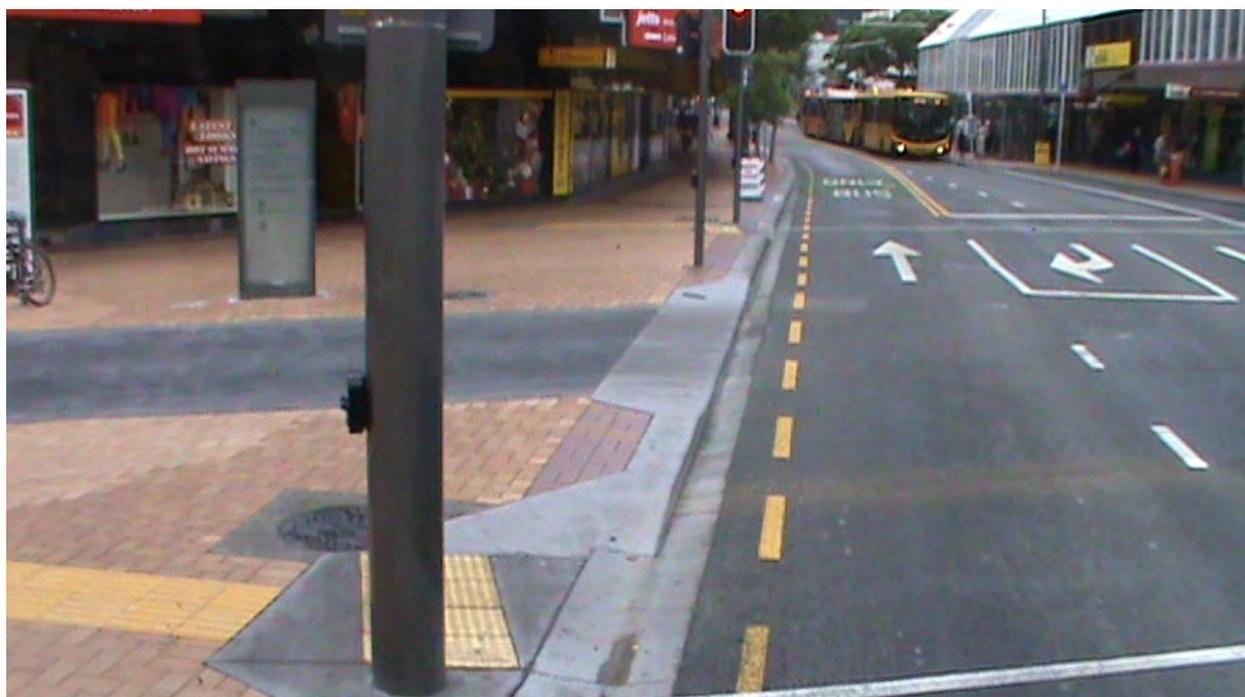
A camera was mounted inside a bus and footage recorded for one full day (see Figure 5 for a screenshot of the view from this camera). Over the course of the day, the bus travelled a number of routes, including travelling the length of the 'Golden Mile'³ around ten times. Some of this footage was compromised due to heavy rain and condensation build-up on the inside of the windscreen. Footage of two full passages through the Golden Mile was reviewed and pedestrian behaviour recorded. Only pedestrians crossing in front of the bus in question were observed and their behaviour coded.

Figure 5: Screenshot of view from bus camera

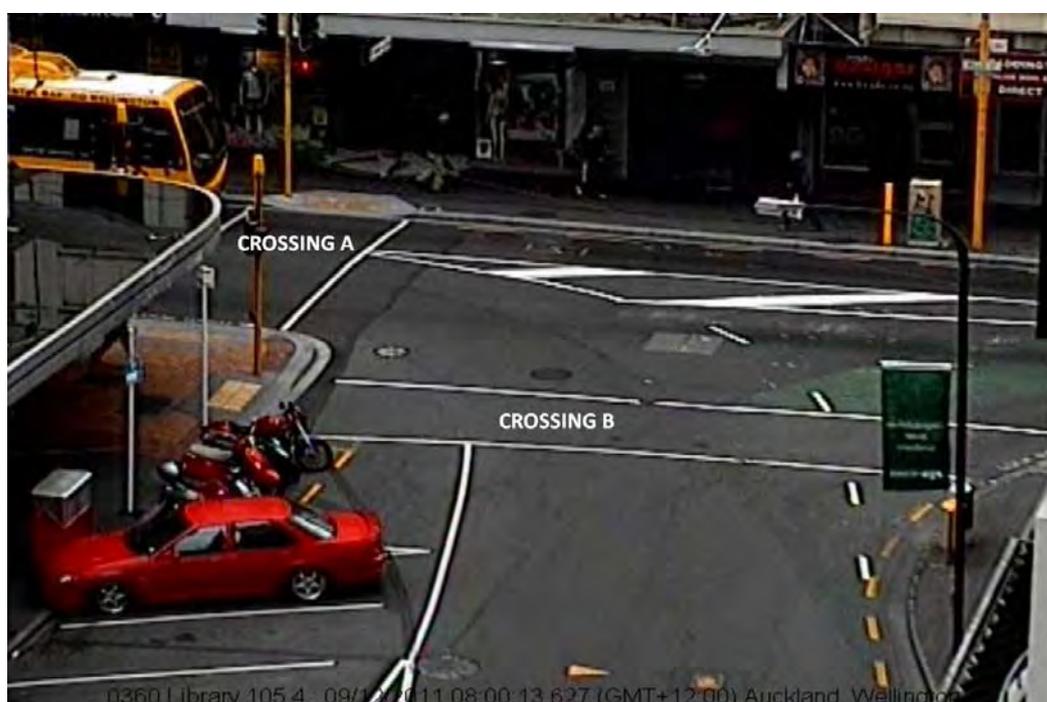
The CCTV camera at this intersection is mounted on the Central Library building, providing a view of both the crossings at the end of Mercer Street, as displayed in Figure 6. As can be seen, the lights on the far side of Willis Street (Crossing A) are visible from this angle, therefore it was possible to accurately record whether pedestrian crossings were temporally compliant on this crossing. Light phase timings could also therefore be accurately observed from this view. The light on the front intersection (Crossing B) was not visible, however, which meant recording of temporal compliance and light phases for this crossing was slightly more difficult.

Figure 6: Screen shot of CCTV view of Mercer Street/Willis Street intersection.

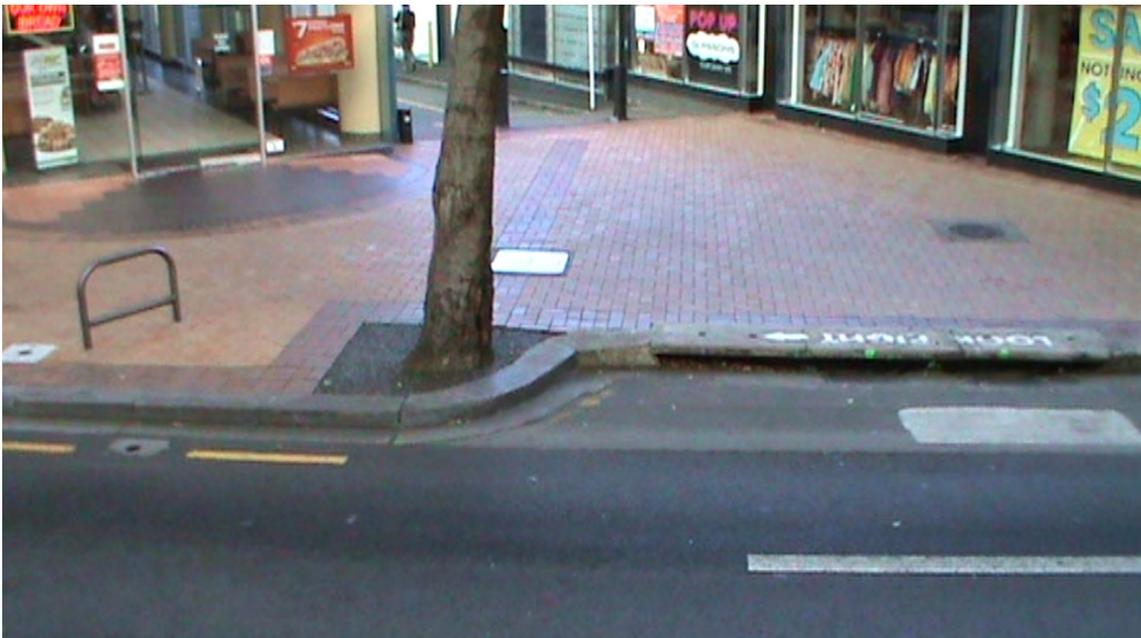
The traffic on Manners Street is bus only. Visibility prior to crossing in the section selected is relatively high, with average gaps of about 4.37m between the vertical roadside furniture.

Figure 7: Screenshot of camera view at Manners Street site

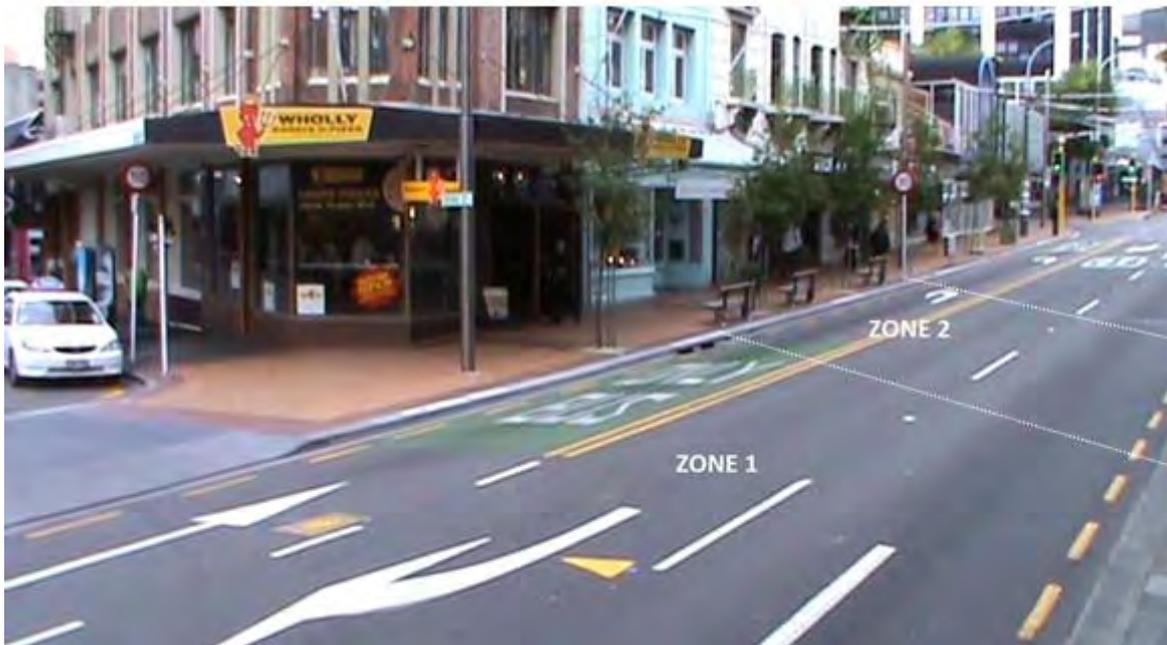
Traffic on Willis Street heading South is bus-only (see left lane in Figure 8) and traffic on Willis Street heading North (see middle and right lanes) is a mix of vehicle types. North-bound traffic is higher in frequency than South-bound, so there is also interest in any expectation effect, such that pedestrians may be more focussed on the North-bound traffic.

Figure 8: Screenshot of camera view at Willis Street site

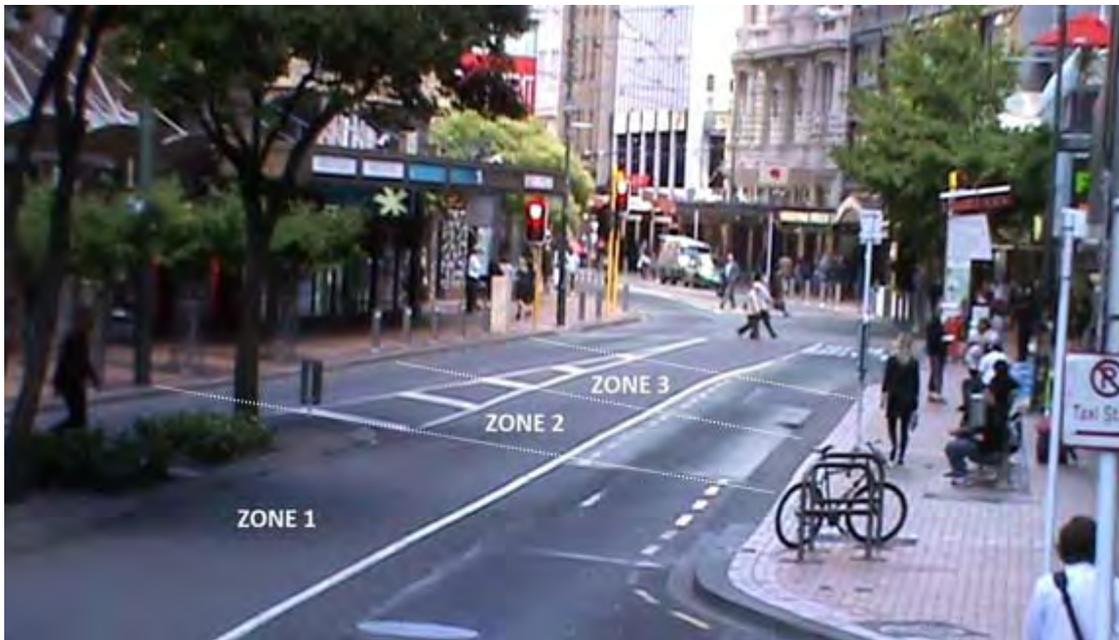
Traffic on Lambton Quay is a mix of buses and private vehicles. As can be seen in the figure below, visibility is impeded for pedestrians crossing from the left within Zone 2. Within Zone 1 there is also some visibility impairment on the median strip. Stationary buses at the stop on the right hand side also create a visibility issue for pedestrians crossing from this side within all three zones (depending on the number of buses present).

Figure 9: Screenshot of camera view at Lambton Quay site

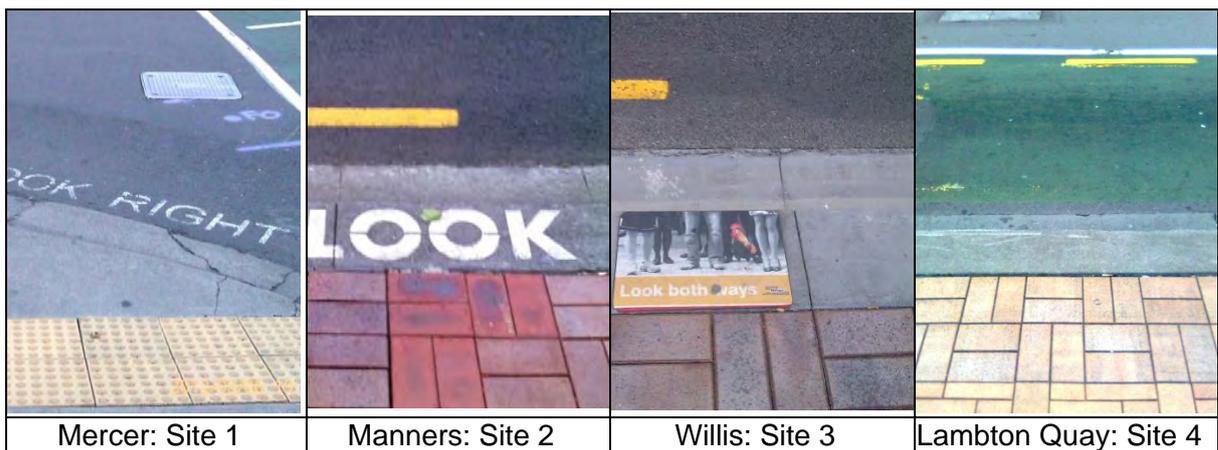
Colour contrast at the road threshold at all four fixed sites (and for most of the Golden Mile) was reasonably high (see Figure 10), with the use of:

- Tactile surfaces at the signalised crossing
- Strong use of coloured pavers
- Bus lane colour
- Bold messages (signalling the need to look)

Figure 10: Colour contrast photos at the kerb-street threshold by site.

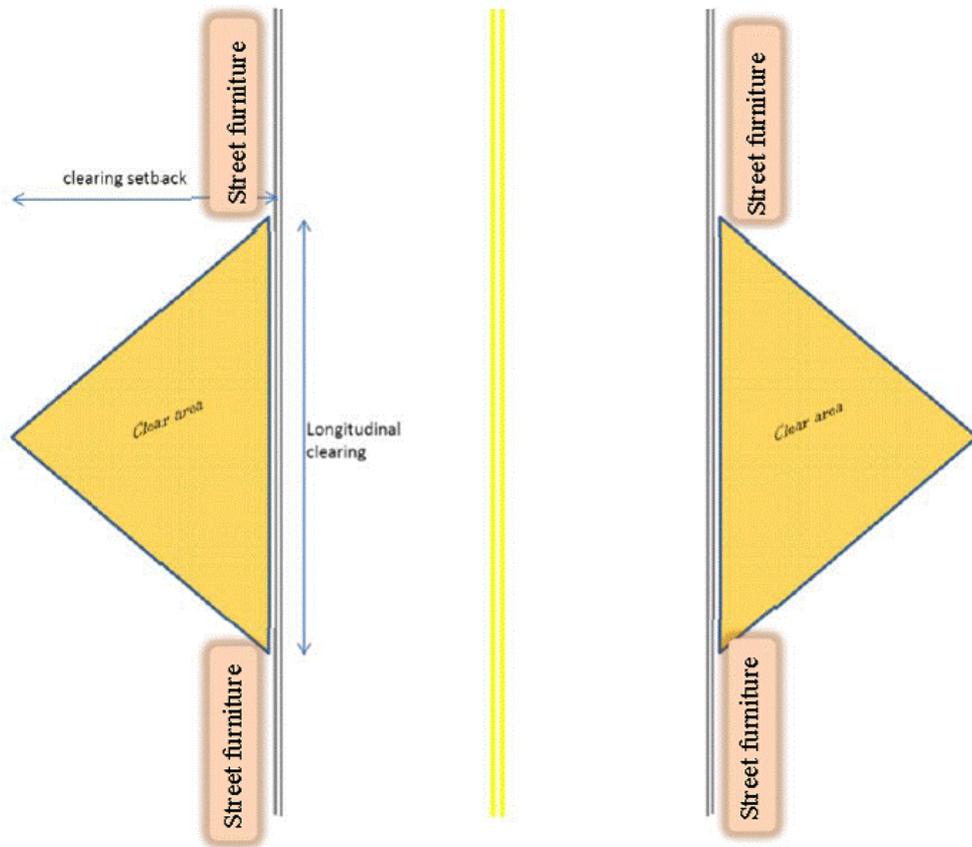
Clear zones have the benefit of high visibility. Another positive aspect of clear zones is that pedestrian behaviour prior to crossing at these locations appears to be safer, with more active looking strategies and greater likelihood of pausing prior to crossing. The use of permeable physical barriers, using wide, low infrastructure (such as park benches) can help filter foot traffic to the clear zone. GHD (2012) produced the following depiction of a clear zone (see Figure 11).

Figure 11: Clear zone treatment (Source: GHD companion report)

Safer behaviour occurs in the Willis Street Site in Zone 1, an area that is 94% clear of furniture (it contains one pole and one tree) and is approximately 12 meters in length. Therefore, the clear zone does not need to be completely free of infrastructure, nor does it need to be a particularly large area of clearance.
