**SOUTHERN CROSS HEALTH
TRUST**

**Geotechnical Assessment
Southern Cross Hospital
Extension-Wellington**

Report prepared by:
TONKIN & TAYLOR LTD

July 2008

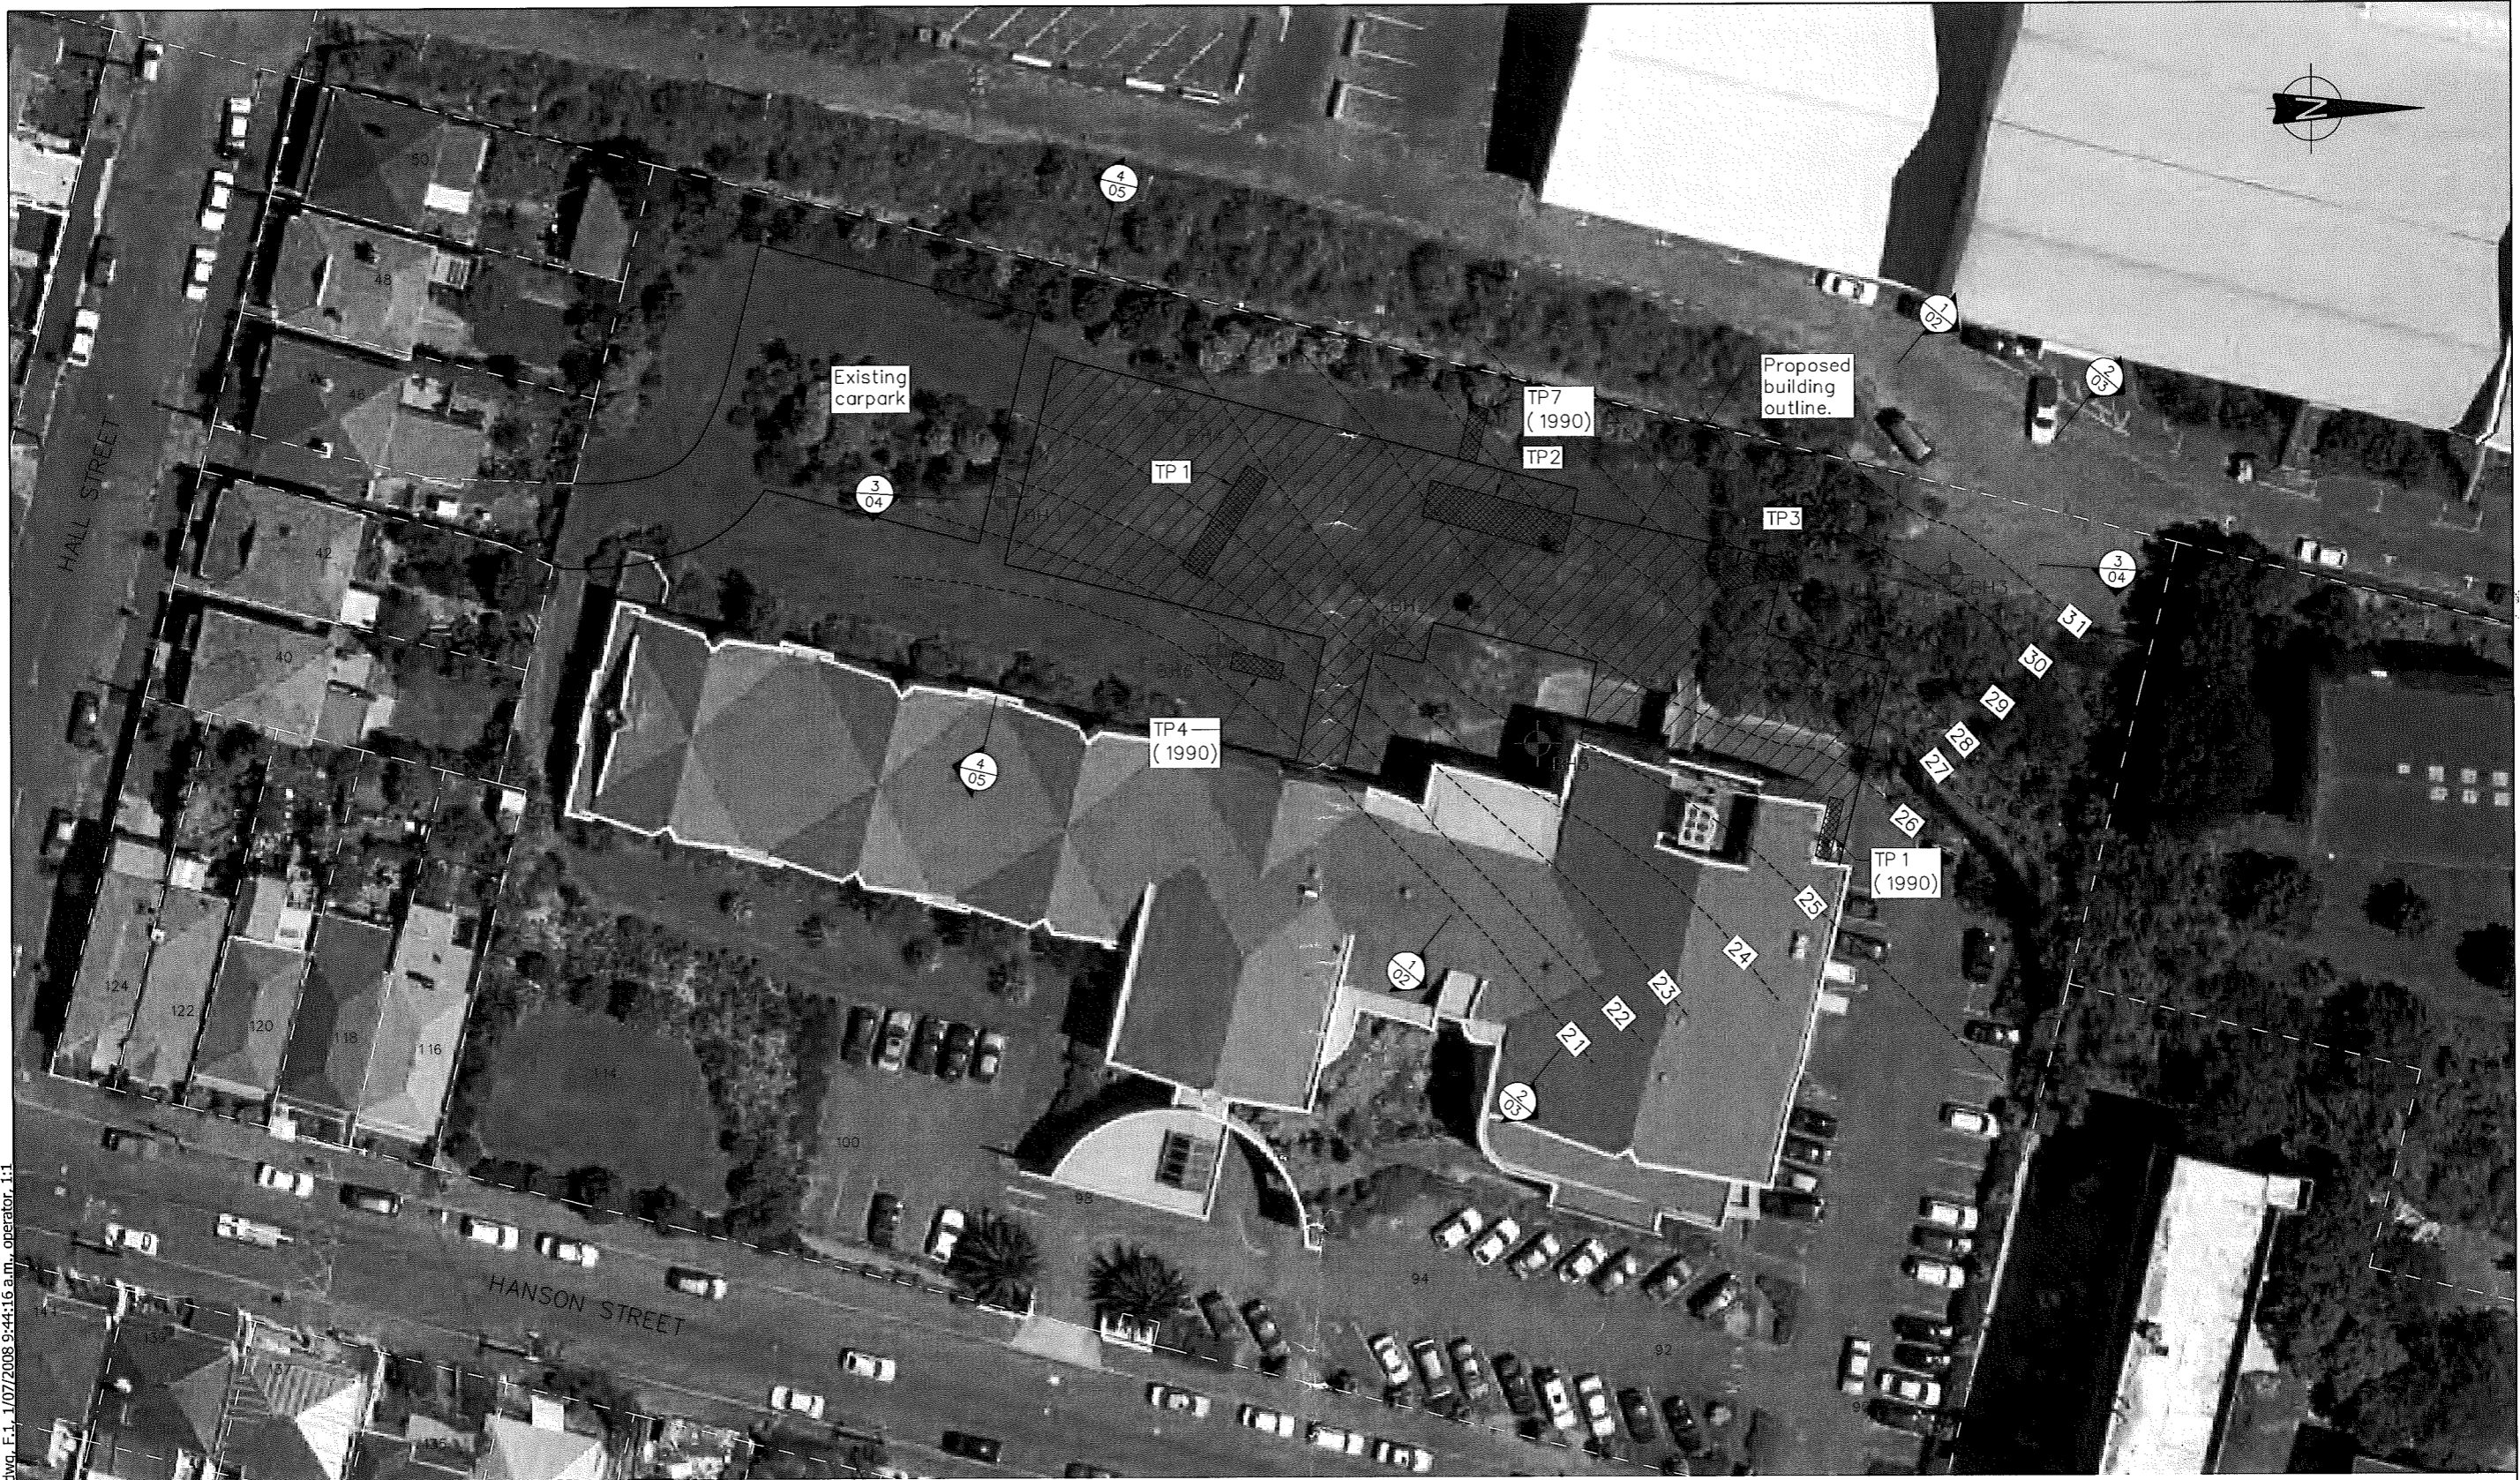
FIG. No. Figure 1 REV. 0

Borehole locations are shown on Figure 1 (Appendix A). Field supervision was undertaken by T&T. Logs of the field investigations are provided in Appendix C.

Figures 2 to 5 (Appendix A) show interpreted cross sections through the site based on geotechnical investigation results. Figure 1 shows the inferred rock head contours across the site.

The site comprises land to the west of the existing Southern Cross Hospital on Hanson Street, Newtown. Figure 1 shows the proposed building locations relative to the location of the existing Hospital building and property boundaries. Beyond the western property boundary is the Wellington Indoor Sports Centre. This neighbouring property is owned by WCC and leased to third parties. A small area of land within the property boundary of Southern Cross Hospital is used by the neighbouring lessees as car-parking.

Bored cast in-situ piles are likely to be the most practical solution for heavily loaded foundations. The piles will be required to be embedded at least three times the pile diameter into insitu HW rock. The piles will be up to approximately 9m total length (from the existing ground level) in the south east corner. The required depth will reduce from this maximum across the site. Figure 1 shows the inferred rock head elevations across the site.
