MAKARA/OHARIU COMMUNITY BOARD

MINUTE ITEM ATTACHMENTS

Makara Beach Community

Ex-cyclone Gita Residents Meeting

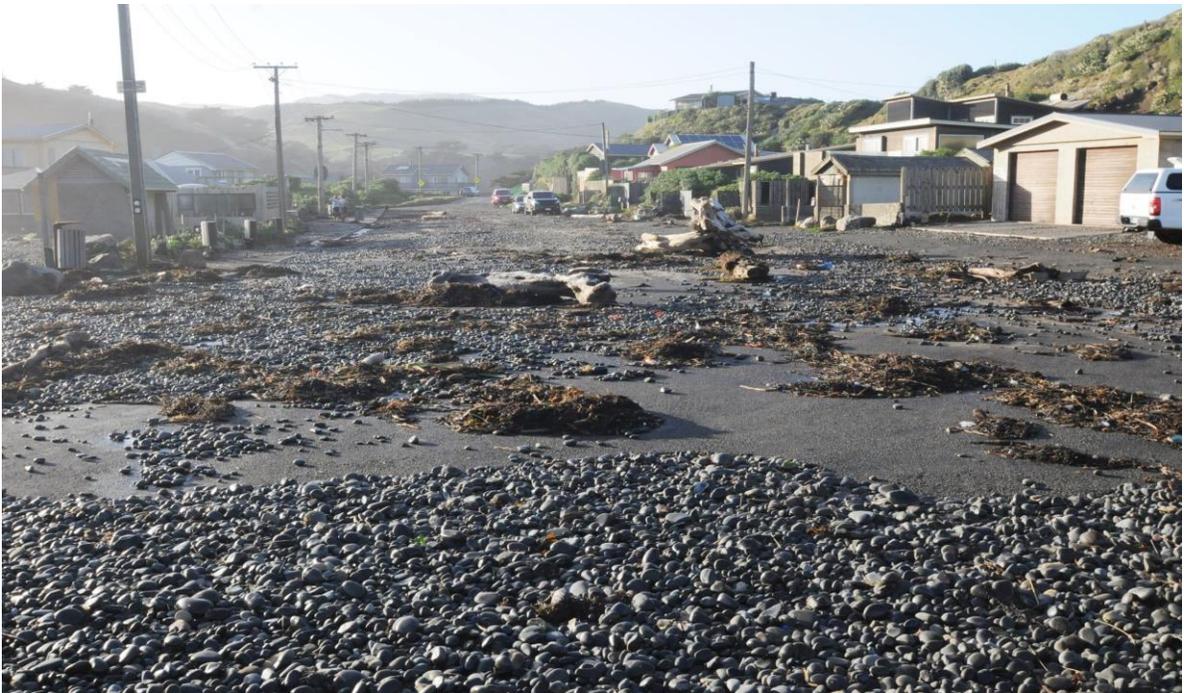
Image taken from the beach looking east down Makara Road Wednesday 21st February.

On 21st February 2018, ex-cyclone Gita made landfall on the southwestern coast of Wellington causing gale force winds and extensive rainfall. After midnight, a storm surge occurred which resulting in seawater flooding the beachfront pushing a significant amount of driftwood, debris and rocks onto Makara Road and the public car park area in front of Makara Beach Café. This created a significant amount of damage to the local café itself, several homes, garaging and boat sheds on Makara Road and Estuary Street.

Based on observations made both during the storm and afterwards, the seawater was largely funneled via the car park which we believe was due to its lower level of elevation in relation to the surrounding area.

The local café bore the brunt of the seawater surge funneled through the carpark which then drained into surrounding properties on Makara Road and Estuary St causing significant damage.

Large amounts of driftwood and debris were pushed as far as the intersection of Makara Rd and Estuary St with several boat sheds and garages suffering severe damage as a result.

1. Return the beachfront to its original state of elevated sand dunes. This was the natural state prior to the New Zealand Government at the time removing these in preparation of a potential enemy invasion during WW2.

3. Current drainage within the public carparking area is inadequate, resulting in several flooding events over the past several months. Elevation of the car park area was also discussed as a potential solution.

5. Some of properties were protected through bollards and chain which run along the beach frontage by the reserve. This prevented the driftwood flow however, the beachfront reserve has dramatically changed since the storm and many bollards/chains have been lost. These will need to be replaced with further consideration to be done around the addition of more bollards in front of the carpark as a possible preventative measure for future events.
