Speaking notes for Wellington Proposed District Plan Hearing Stream 2

Amanda Mulligan and Chessa Stevens, heritage experts appearing on behalf of Wellington Heritage Professionals

Pre-1930 Character Area Review

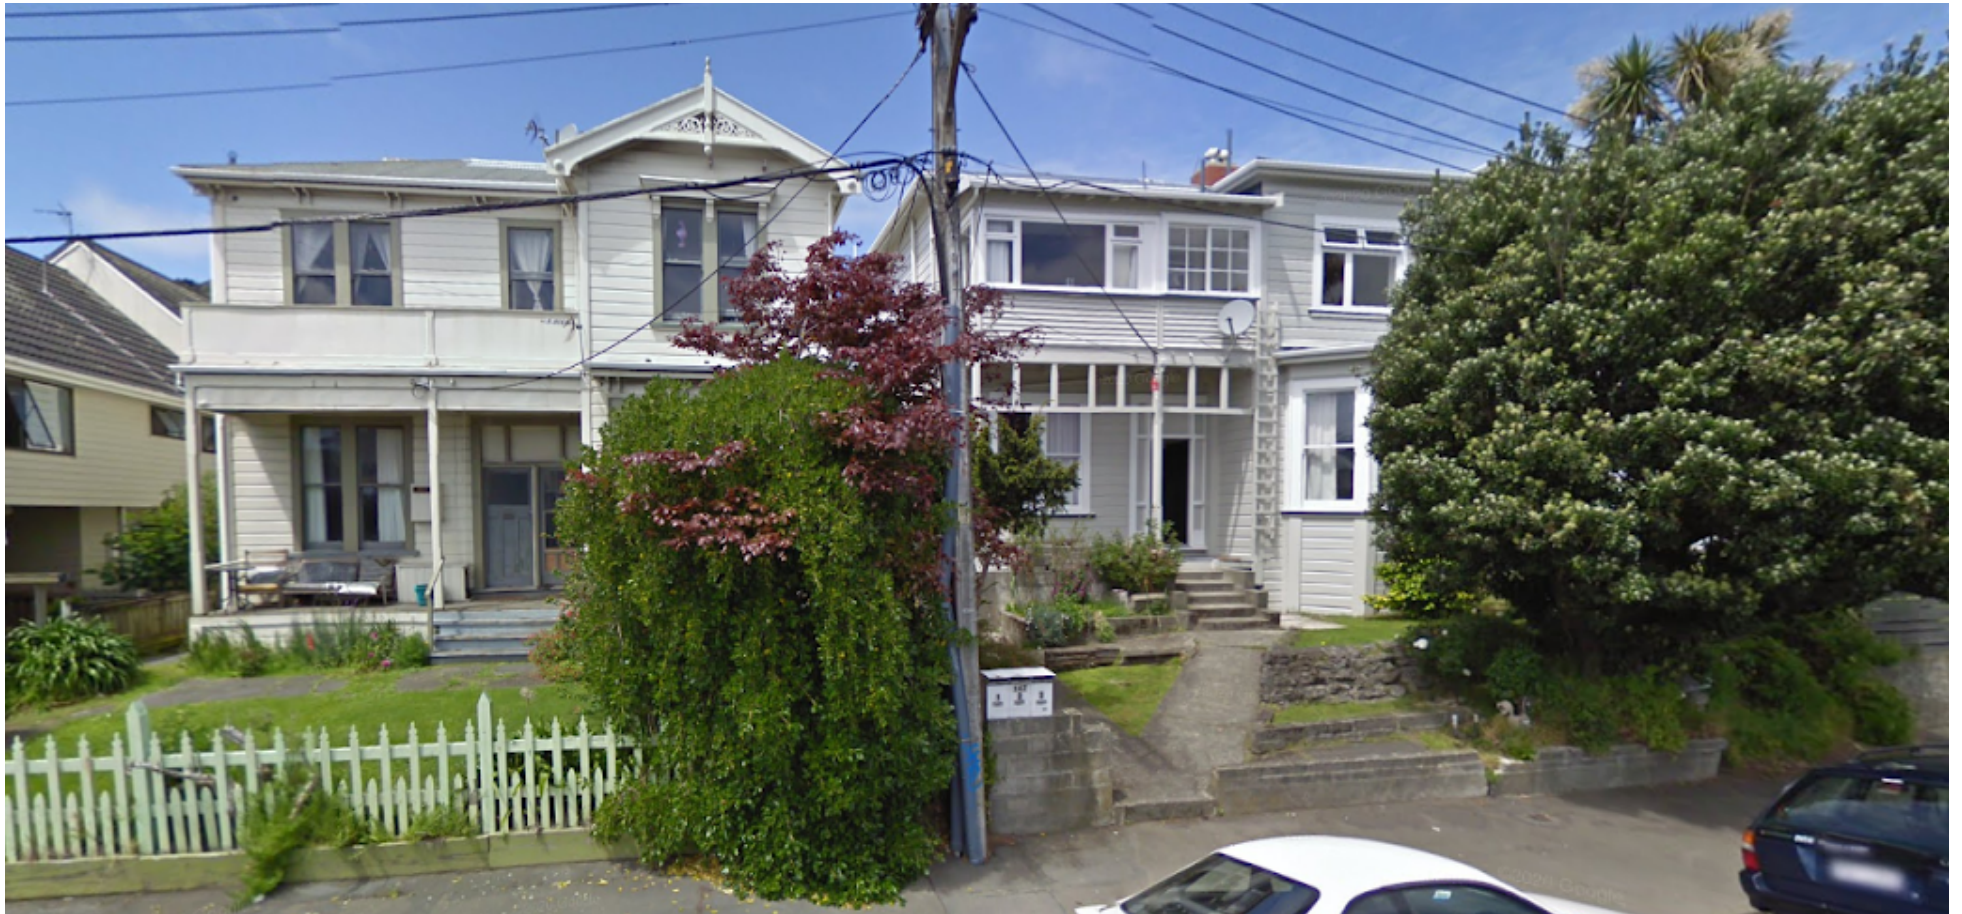
145 and 147 Brougham Street (noting that there has been vegetation growth since this photograph was taken, but no visible changes to the fabric of the buildings themselves).

- 5.2. 145-151 Brougham Street, being three two-storeyed Victorian dwellings (now divided into flats); 3 and 5 Paterson Street which are double-bay villas (5 being more considerably modified than 3); and 7 Paterson Street which consists of three buildings of different ages, one of which was built for Waring Taylor in 1868.

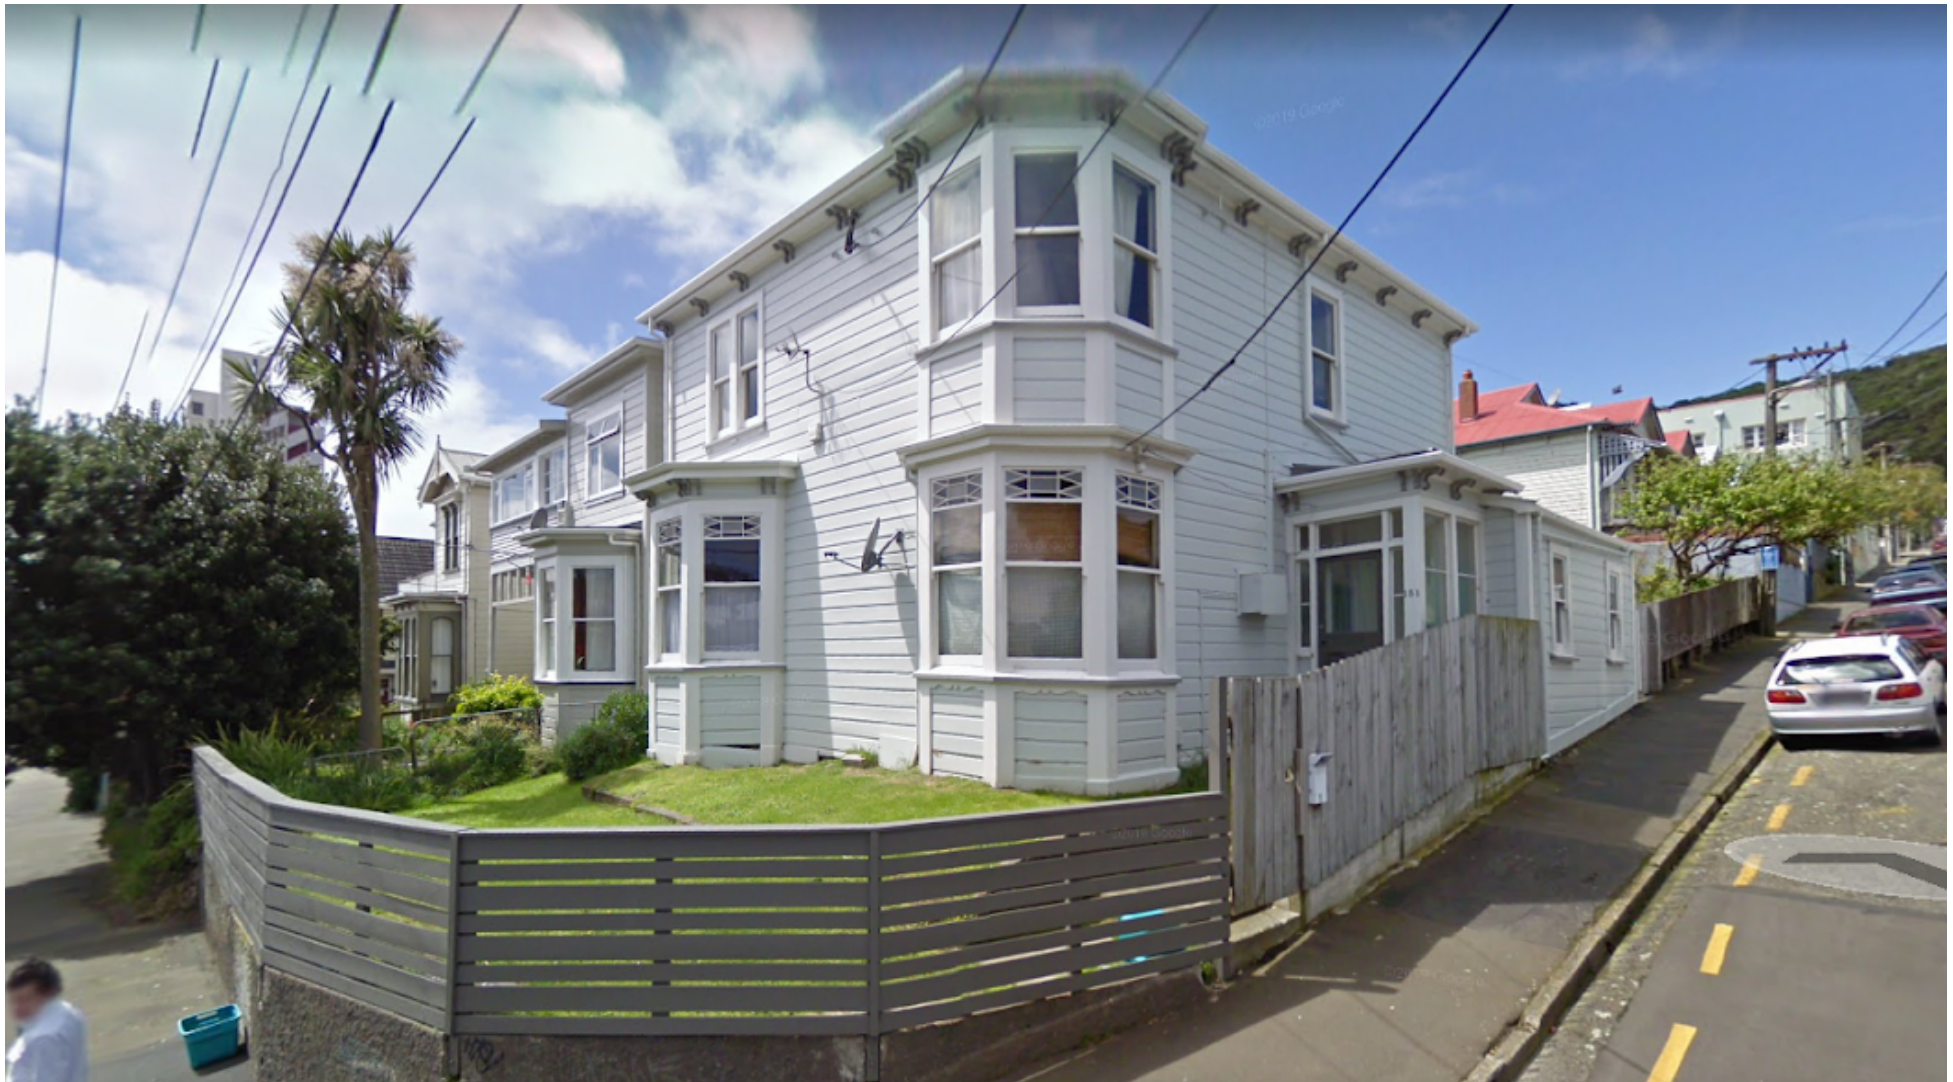
151 Brougham Street, with 147 and 145 Brougham Street on the left and 3 Paterson Street on the right (noting that there has been vegetation growth since this photograph was taken, but no visible changes to the fabric of the buildings themselves).

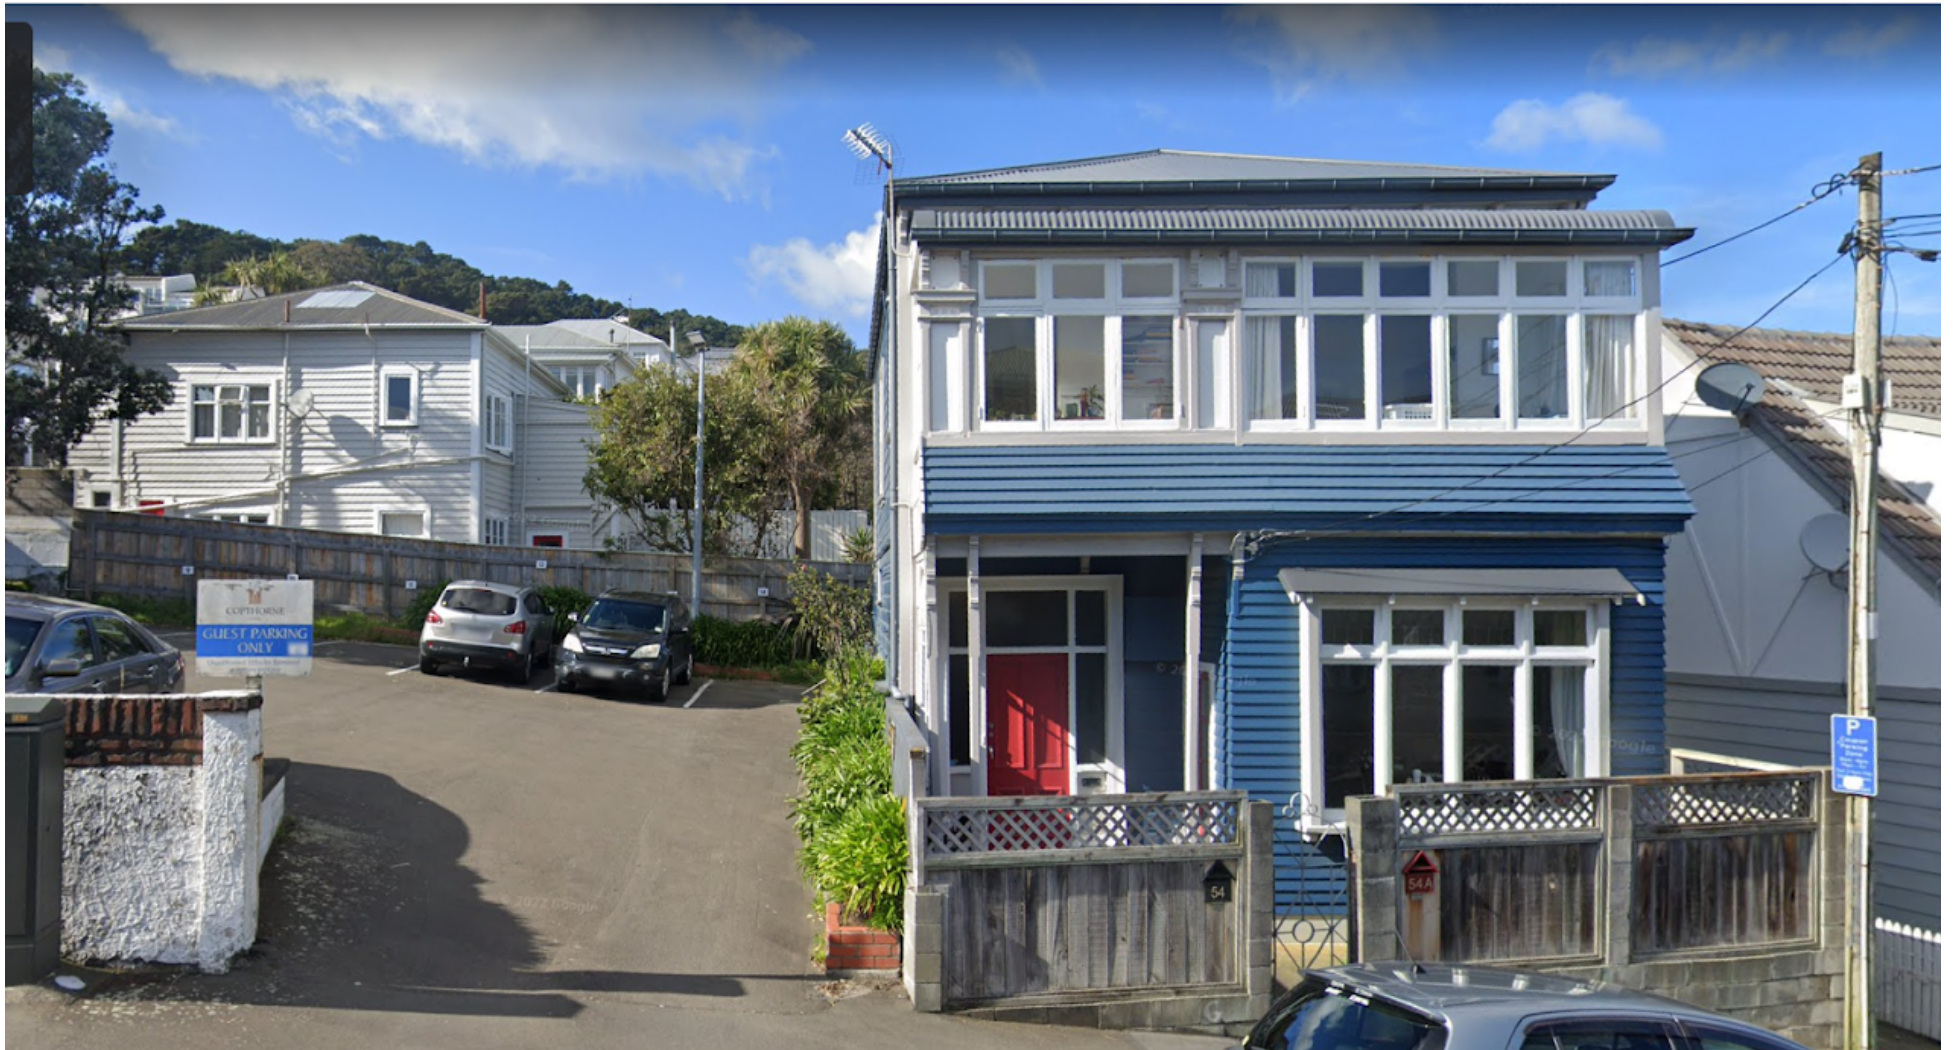
54 Roxburgh Street (west) on the right, with the side of 60 Roxburgh Street on the left. 60 Roxburgh Street is within the Primary/Contributing area indicated in the report, while 54 is in the Neutral/Detractive.

and 54 Roxburgh Street, which is a two-storey single-fronted Victorian townhouse modified in c.1920s.
