# Memo

<b>To:</b>	<b>Marie Gudopp</b>	<b>Job No:</b>	<b>1000057</b>
<b>From:</b>	<b>Emilia Stocks</b>	<b>Date:</b>	<b>27 July 2020</b>
<b>cc:</b>	<b>Dejan Kirbis (WCC), Andrew Kennedy (T+T)</b>		
<b>Subject:</b>	<b>Shelly Bay Shed 8 July 2020 Update</b>

## **Shed 8 Building, Shelly Bay, Wellington Geotechnical Completion Report - Temporary Repairs Works**

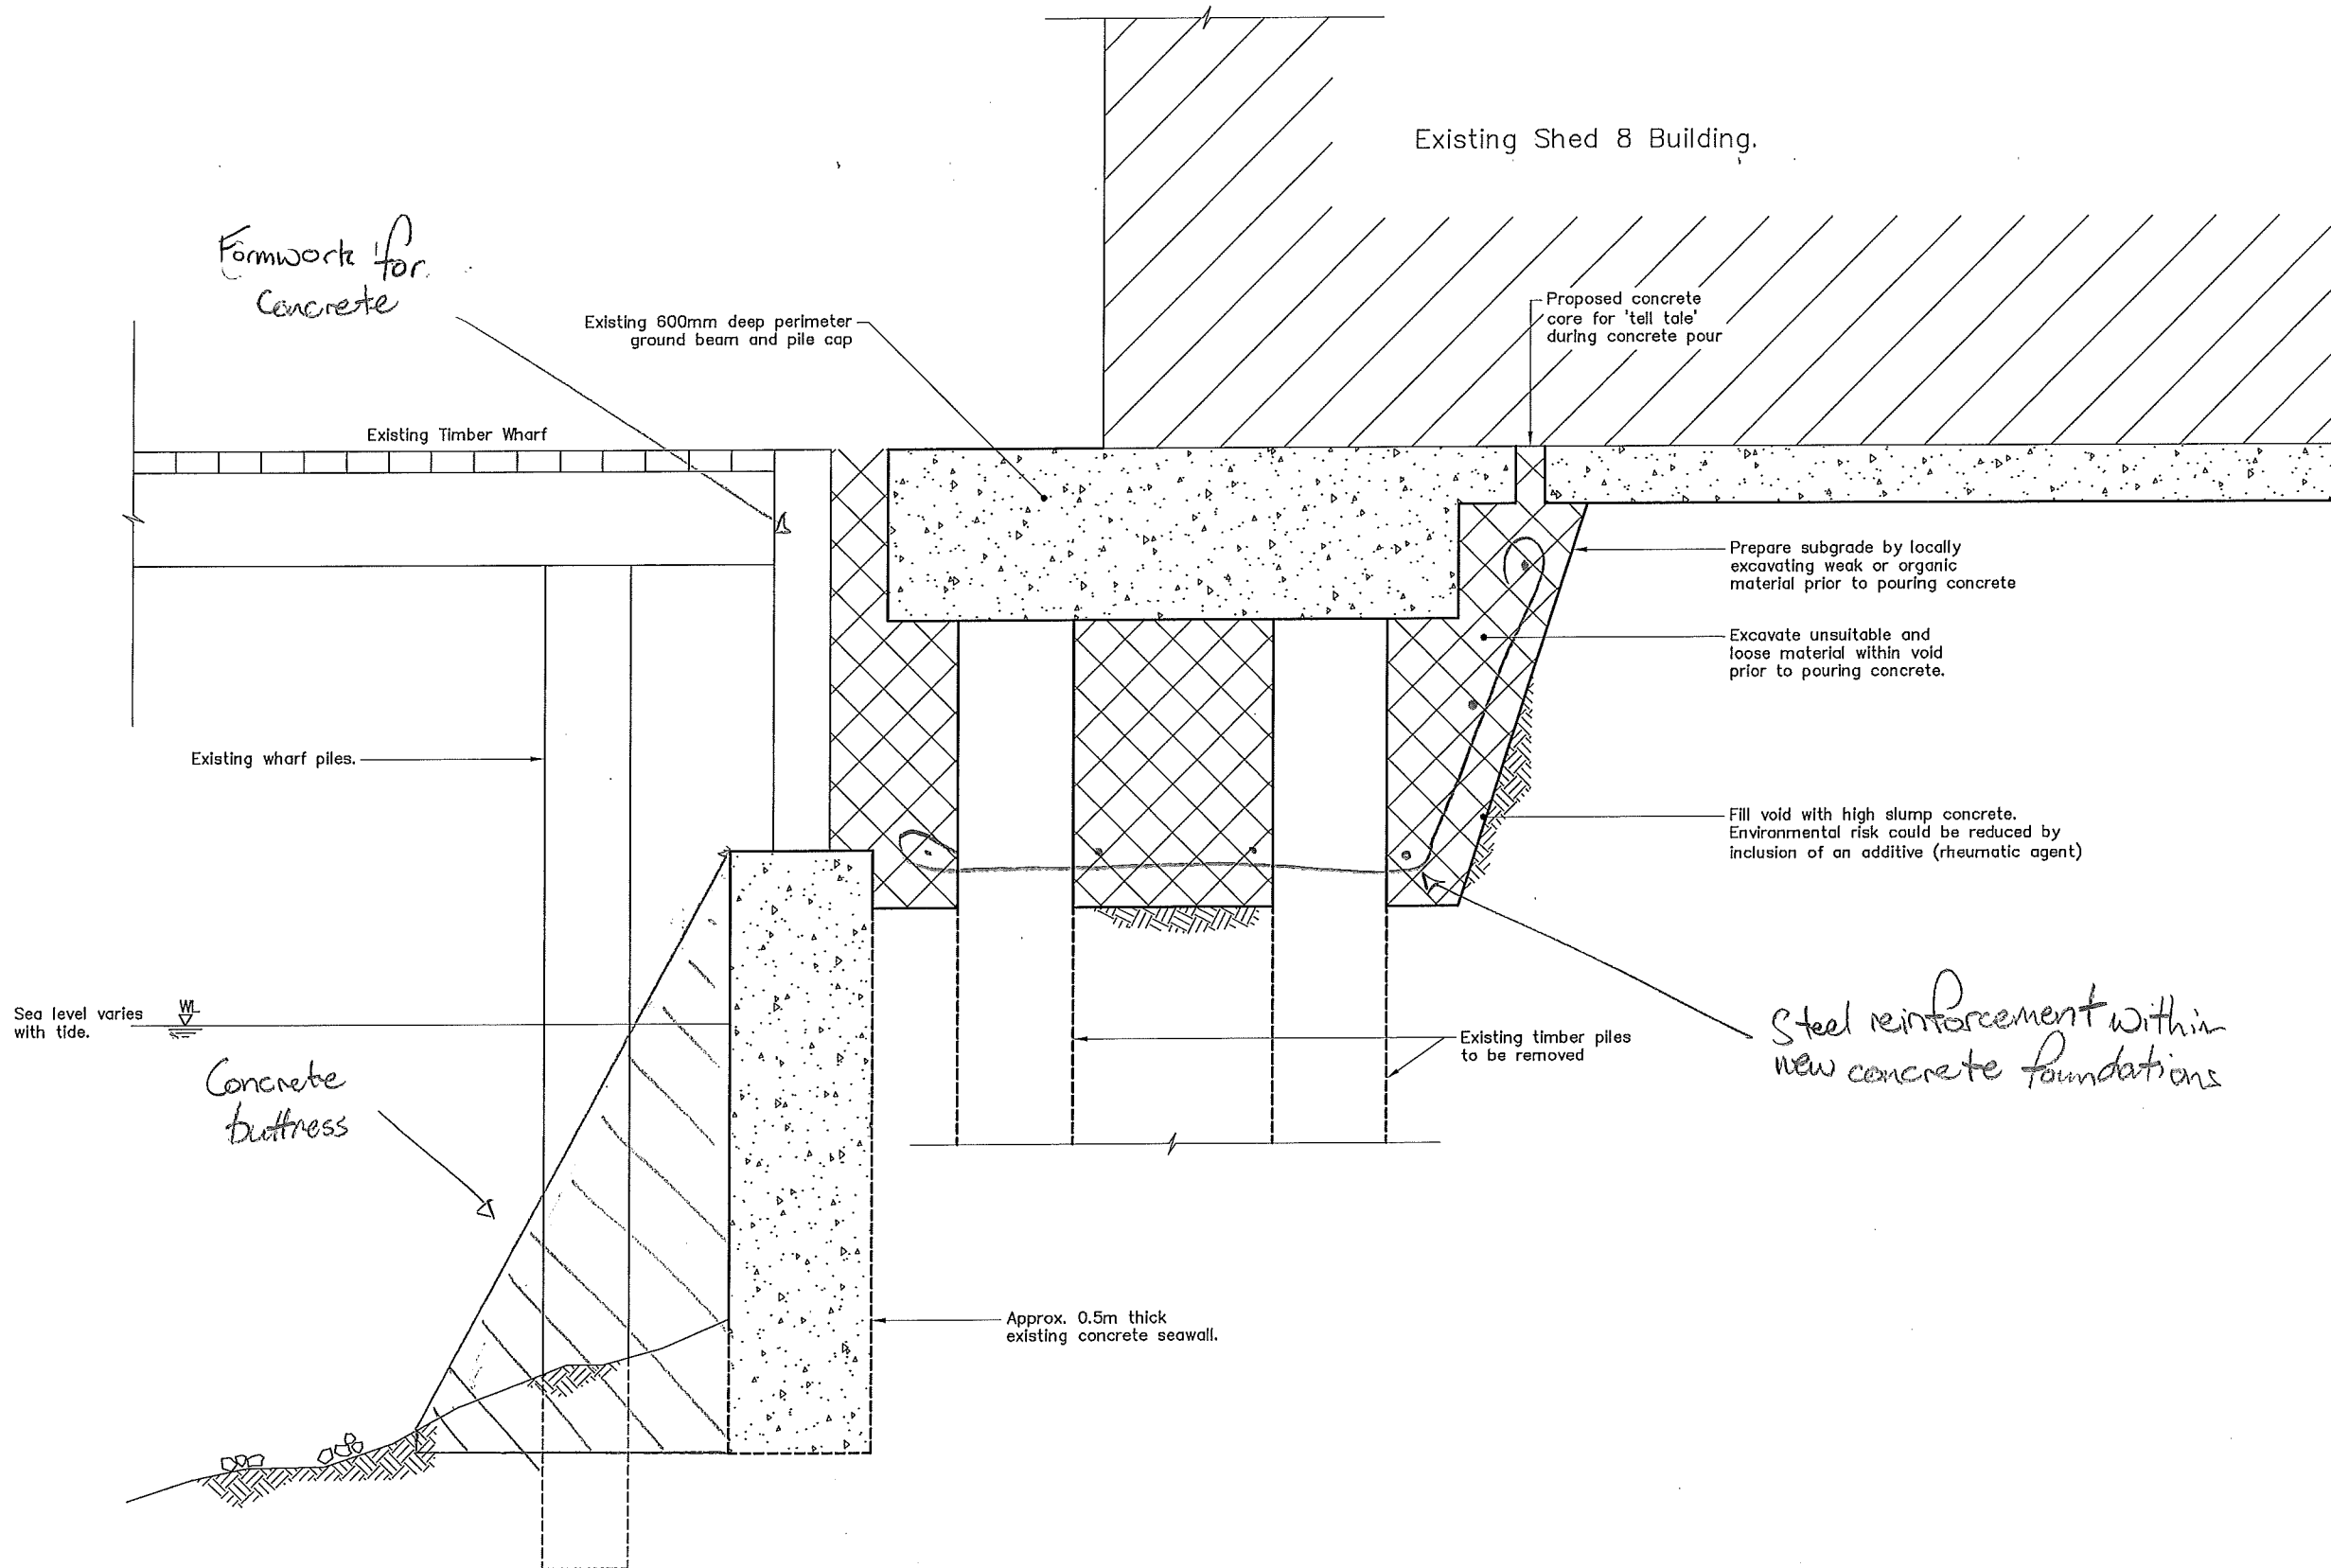
<b>Tonkin &amp; Taylor</b> Environmental and Engineering Consultants Level 4, 2 Hunter St, Wellington www.tonkin.co.nz	DRAWN	DSW	May 15	WELLINGTON CITY COUNCIL SHELLY BAY SHED 8 FOUNDATION REPAIRS Concept Repairs Ground Beams	FIG. No. Figure 4 – Concrete Armour Seawall REV. 0
	DRAFTING CHECKED				
	APPROVED				
	CADFILE :	\\85856.0040-F01.dwg			
	SCALES (AT A3 SIZE)	1:25			
PROJECT No.	85856.0040

C2 (Stage 2)	Armoured seawall – rock <ul style="list-style-type: none"> <li>Armour rock to be placed on seaward side of seawall</li> </ul>	3	x	✓	✓	x	<ul style="list-style-type: none"> <li>This option appears to be comparatively cheaper than the other proposed options and protects the land while allowing current building structure to remain</li> <li>The extent of the armour rock will impact on future repairs to the existing wharf</li> </ul>
C3 (Stage 2)	Armoured seawall – concrete <ul style="list-style-type: none"> <li>Similar to Option C1, however concrete mass wall is constructed instead of rock armour</li> </ul>	4	x	✓	✓	x	<ul style="list-style-type: none"> <li>This allows a smaller footprint than a rock armoured seawall</li> <li>Resource consent and special control measures during construction are likely to be required</li> </ul>
D1	Secant pile wall <ul style="list-style-type: none"> <li>Continuous secant pile wall to be constructed in between existing seawall (land side) and the building</li> </ul>	5	✓	✓	✓	✓	<ul style="list-style-type: none"> <li>A long term solution that allows future developments on the wharf whilst remaining inside the current footprint of existing building foundations</li> <li>Structural connection of secant piles to foundations may be required if there is a risk of liquefaction induced settlement</li> </ul>

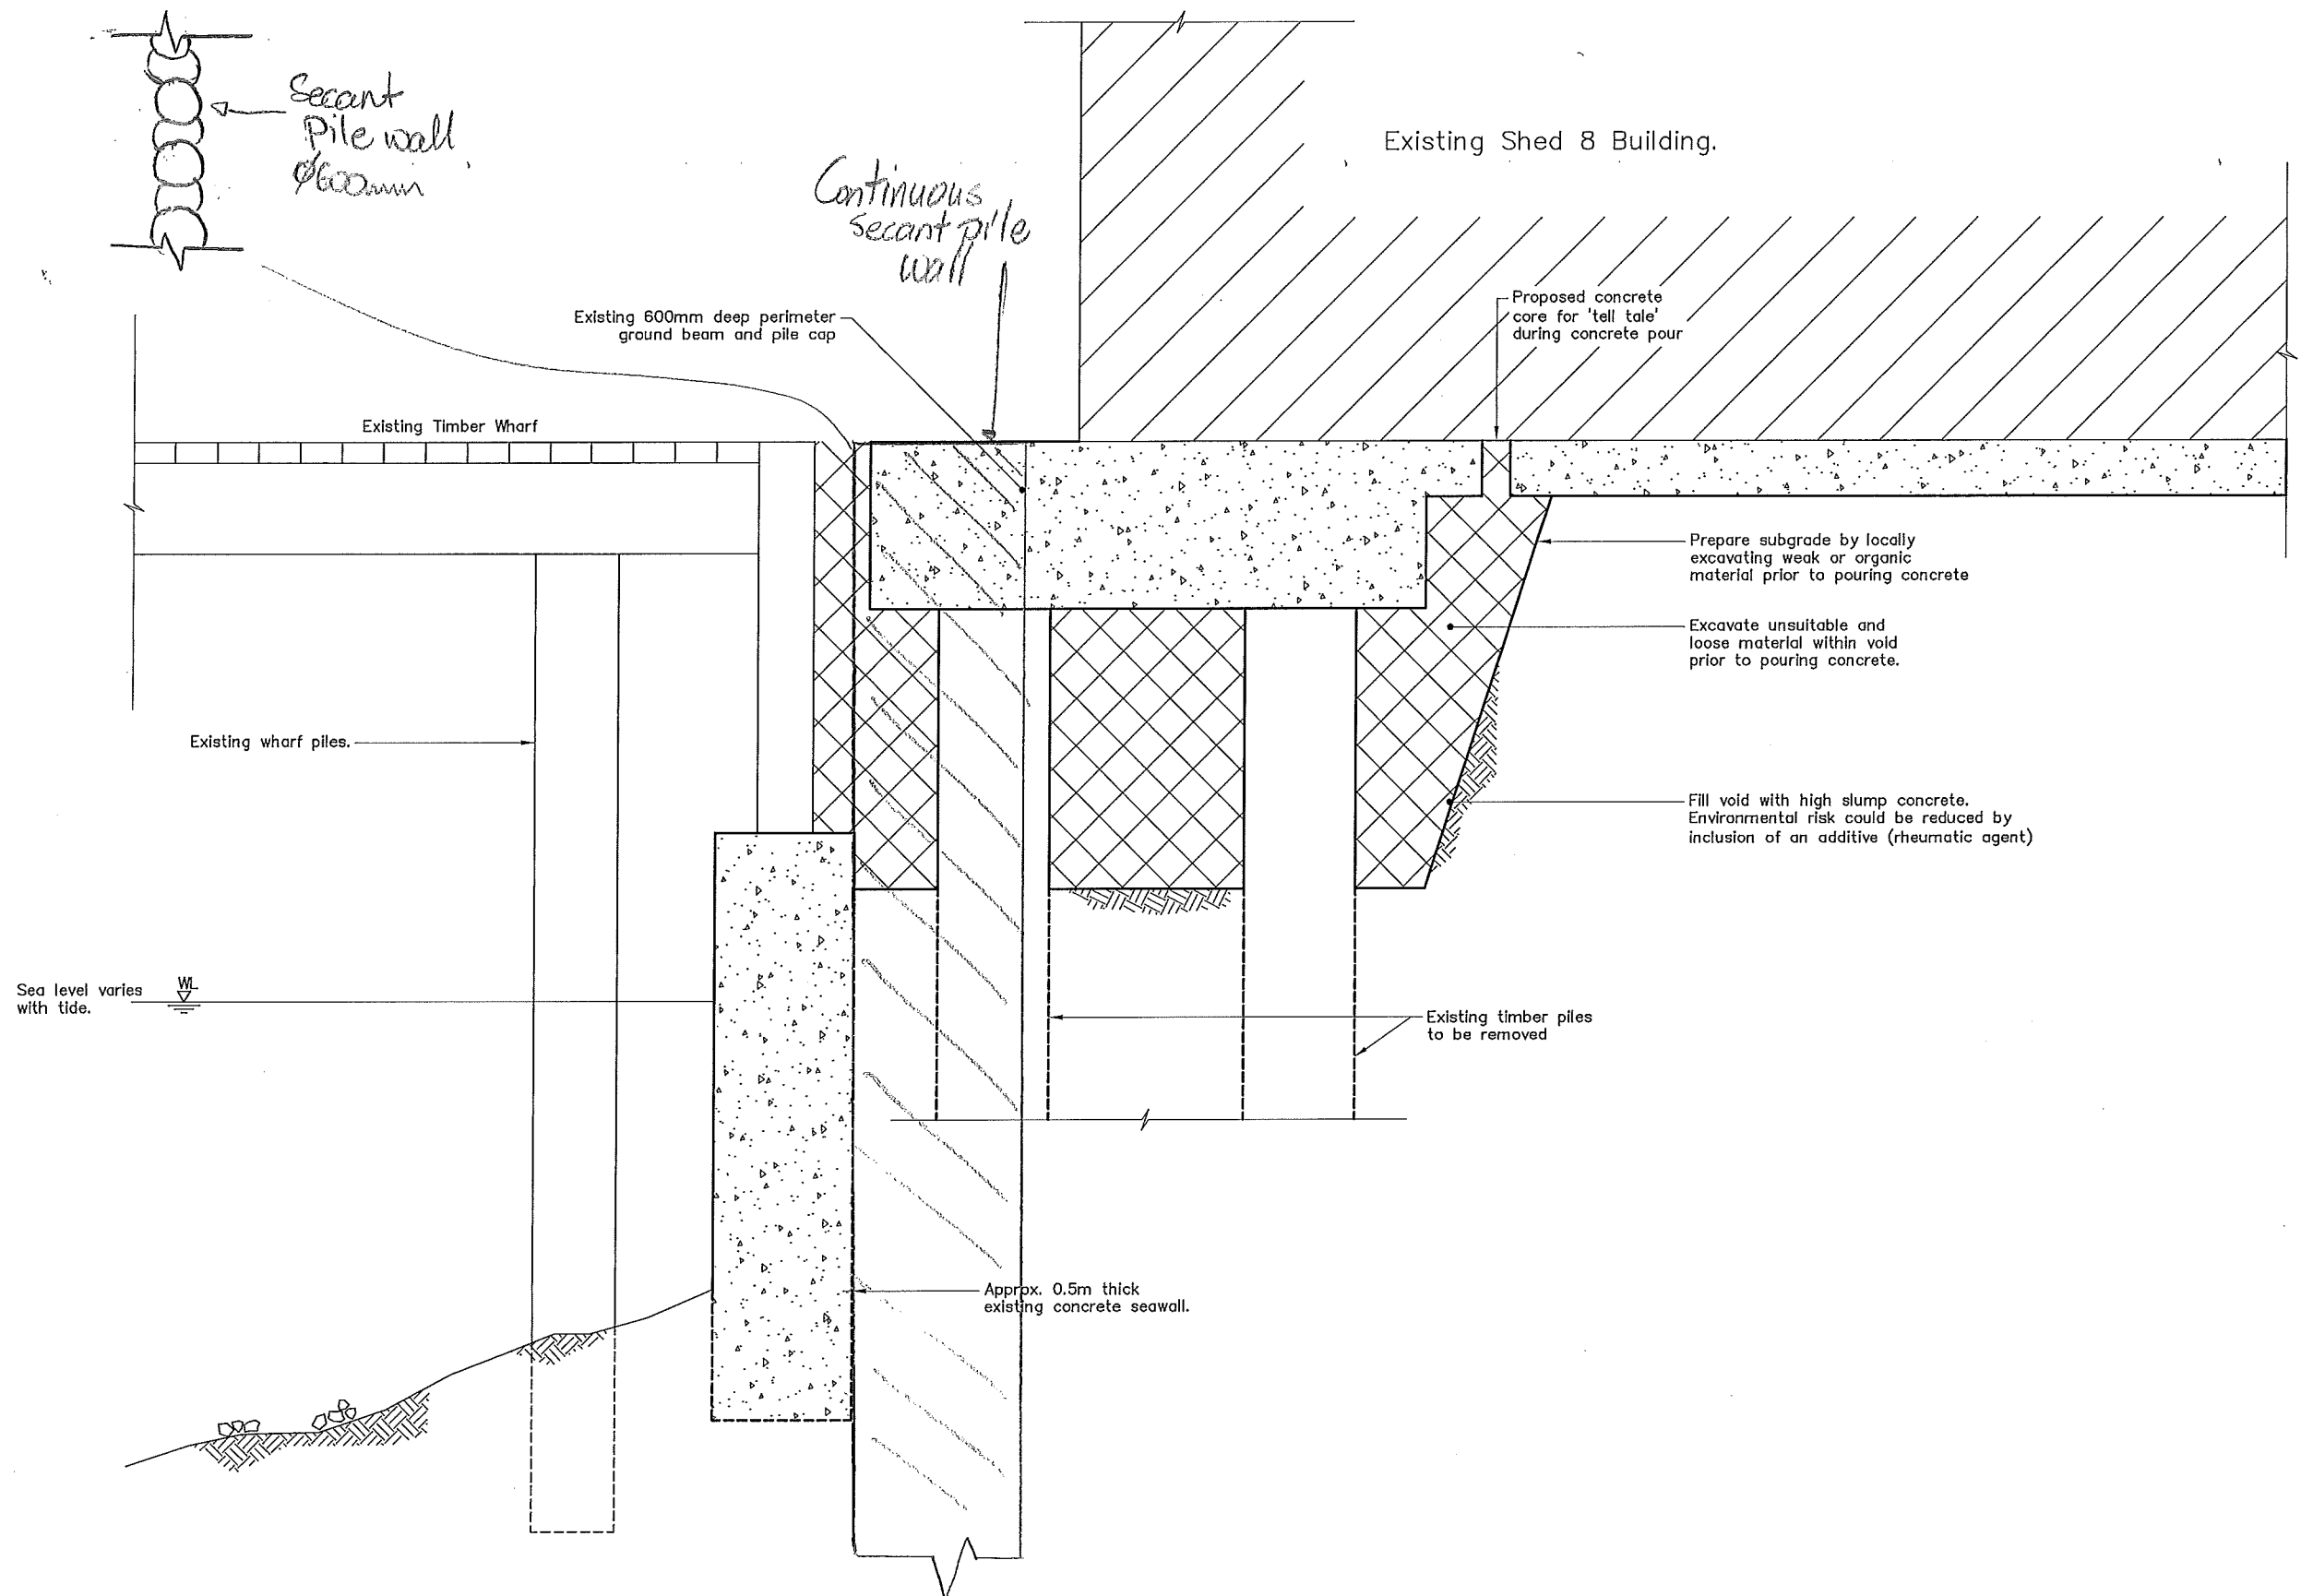
<b>Tonkin &amp; Taylor</b> Environmental and Engineering Consultants Level 4, 2 Hunter St, Wellington www.tonkin.co.nz	DRAWN: DSW May 15 DRAFTING CHECKED: APPROVED:	WELLINGTON CITY COUNCIL SHELLY BAY SHED 8 FOUNDATION REPAIRS Concept Repairs Ground Beams	FIG. No. Figure 5 – Continuous Secant Pile Wall REV. 0
	CADFILE: 85856.0040-F01.dwg SCALES (AT A3 SIZE): 1:25		
	PROJECT No. 85856.0040

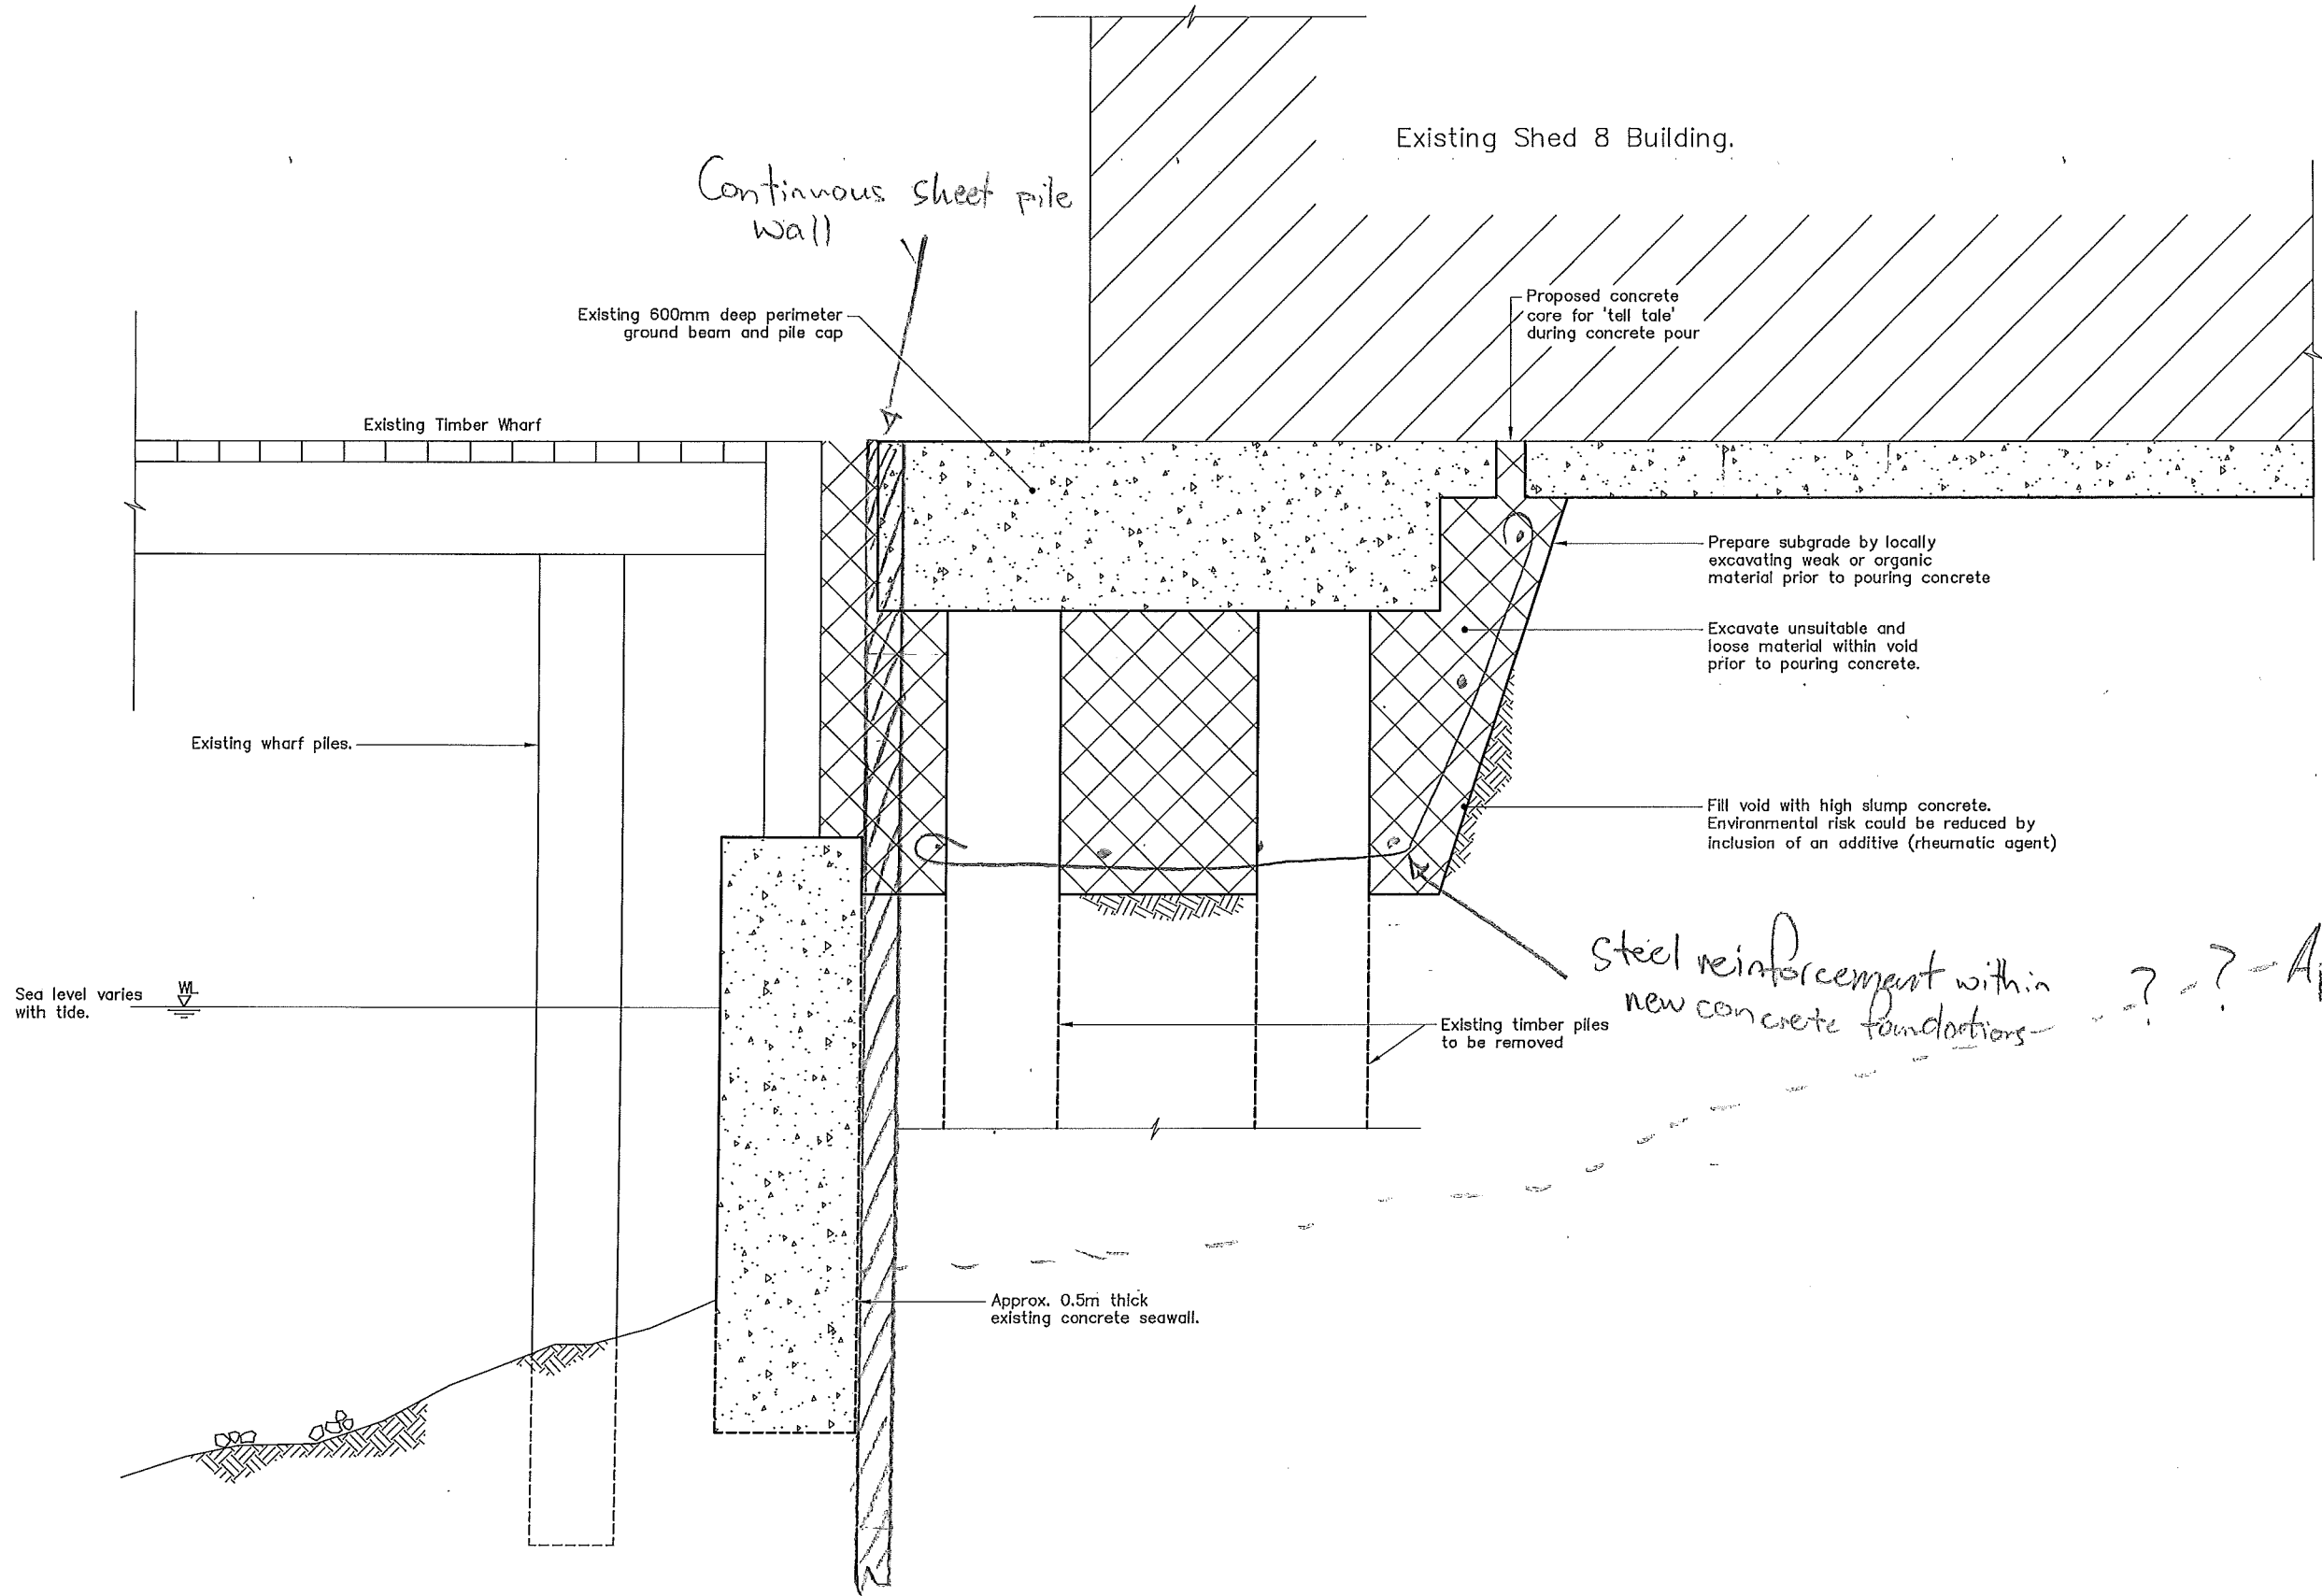
<b>Tonkin &amp; Taylor</b> Environmental and Engineering Consultants Level 4, 2 Hunter St, Wellington www.tonkin.co.nz	DRAWN: DSW, May 15 DRAFTING CHECKED APPROVED	WELLINGTON CITY COUNCIL SHELLY BAY SHED 8 FOUNDATION REPAIRS Concept Repairs Ground Beams	FIG. No. Figure 6 – Continuous Sheet Pile Wall REV. 0
	CADFILE : 85856.0040-F01.dwg SCALES (AT A3 SIZE) 1:25		
	PROJECT No. 85856.0040

D2	Sheet pile retaining wall <ul style="list-style-type: none"> <li>Continuous sheet piles to be driven in between existing seawall (land side) and the building</li> </ul>	6	✓	✓	✓	✓	<ul style="list-style-type: none"> <li>A long term solution that allows future developments on the wharf whilst remaining inside the current footprint of existing building foundations</li> <li>Piles may refuse to penetrate into rock depending on weathering profile</li> </ul>
D3	Piles to support existing seawall <ul style="list-style-type: none"> <li>Ø600 piles to be constructed at 1-2m centres alongside existing seawall (seaward side)</li> </ul>	7	✓	✓	✓	✓	<ul style="list-style-type: none"> <li>This solution improves the lateral capacity of the existing seawall as opposed to creating an entirely new continuous wall</li> </ul>

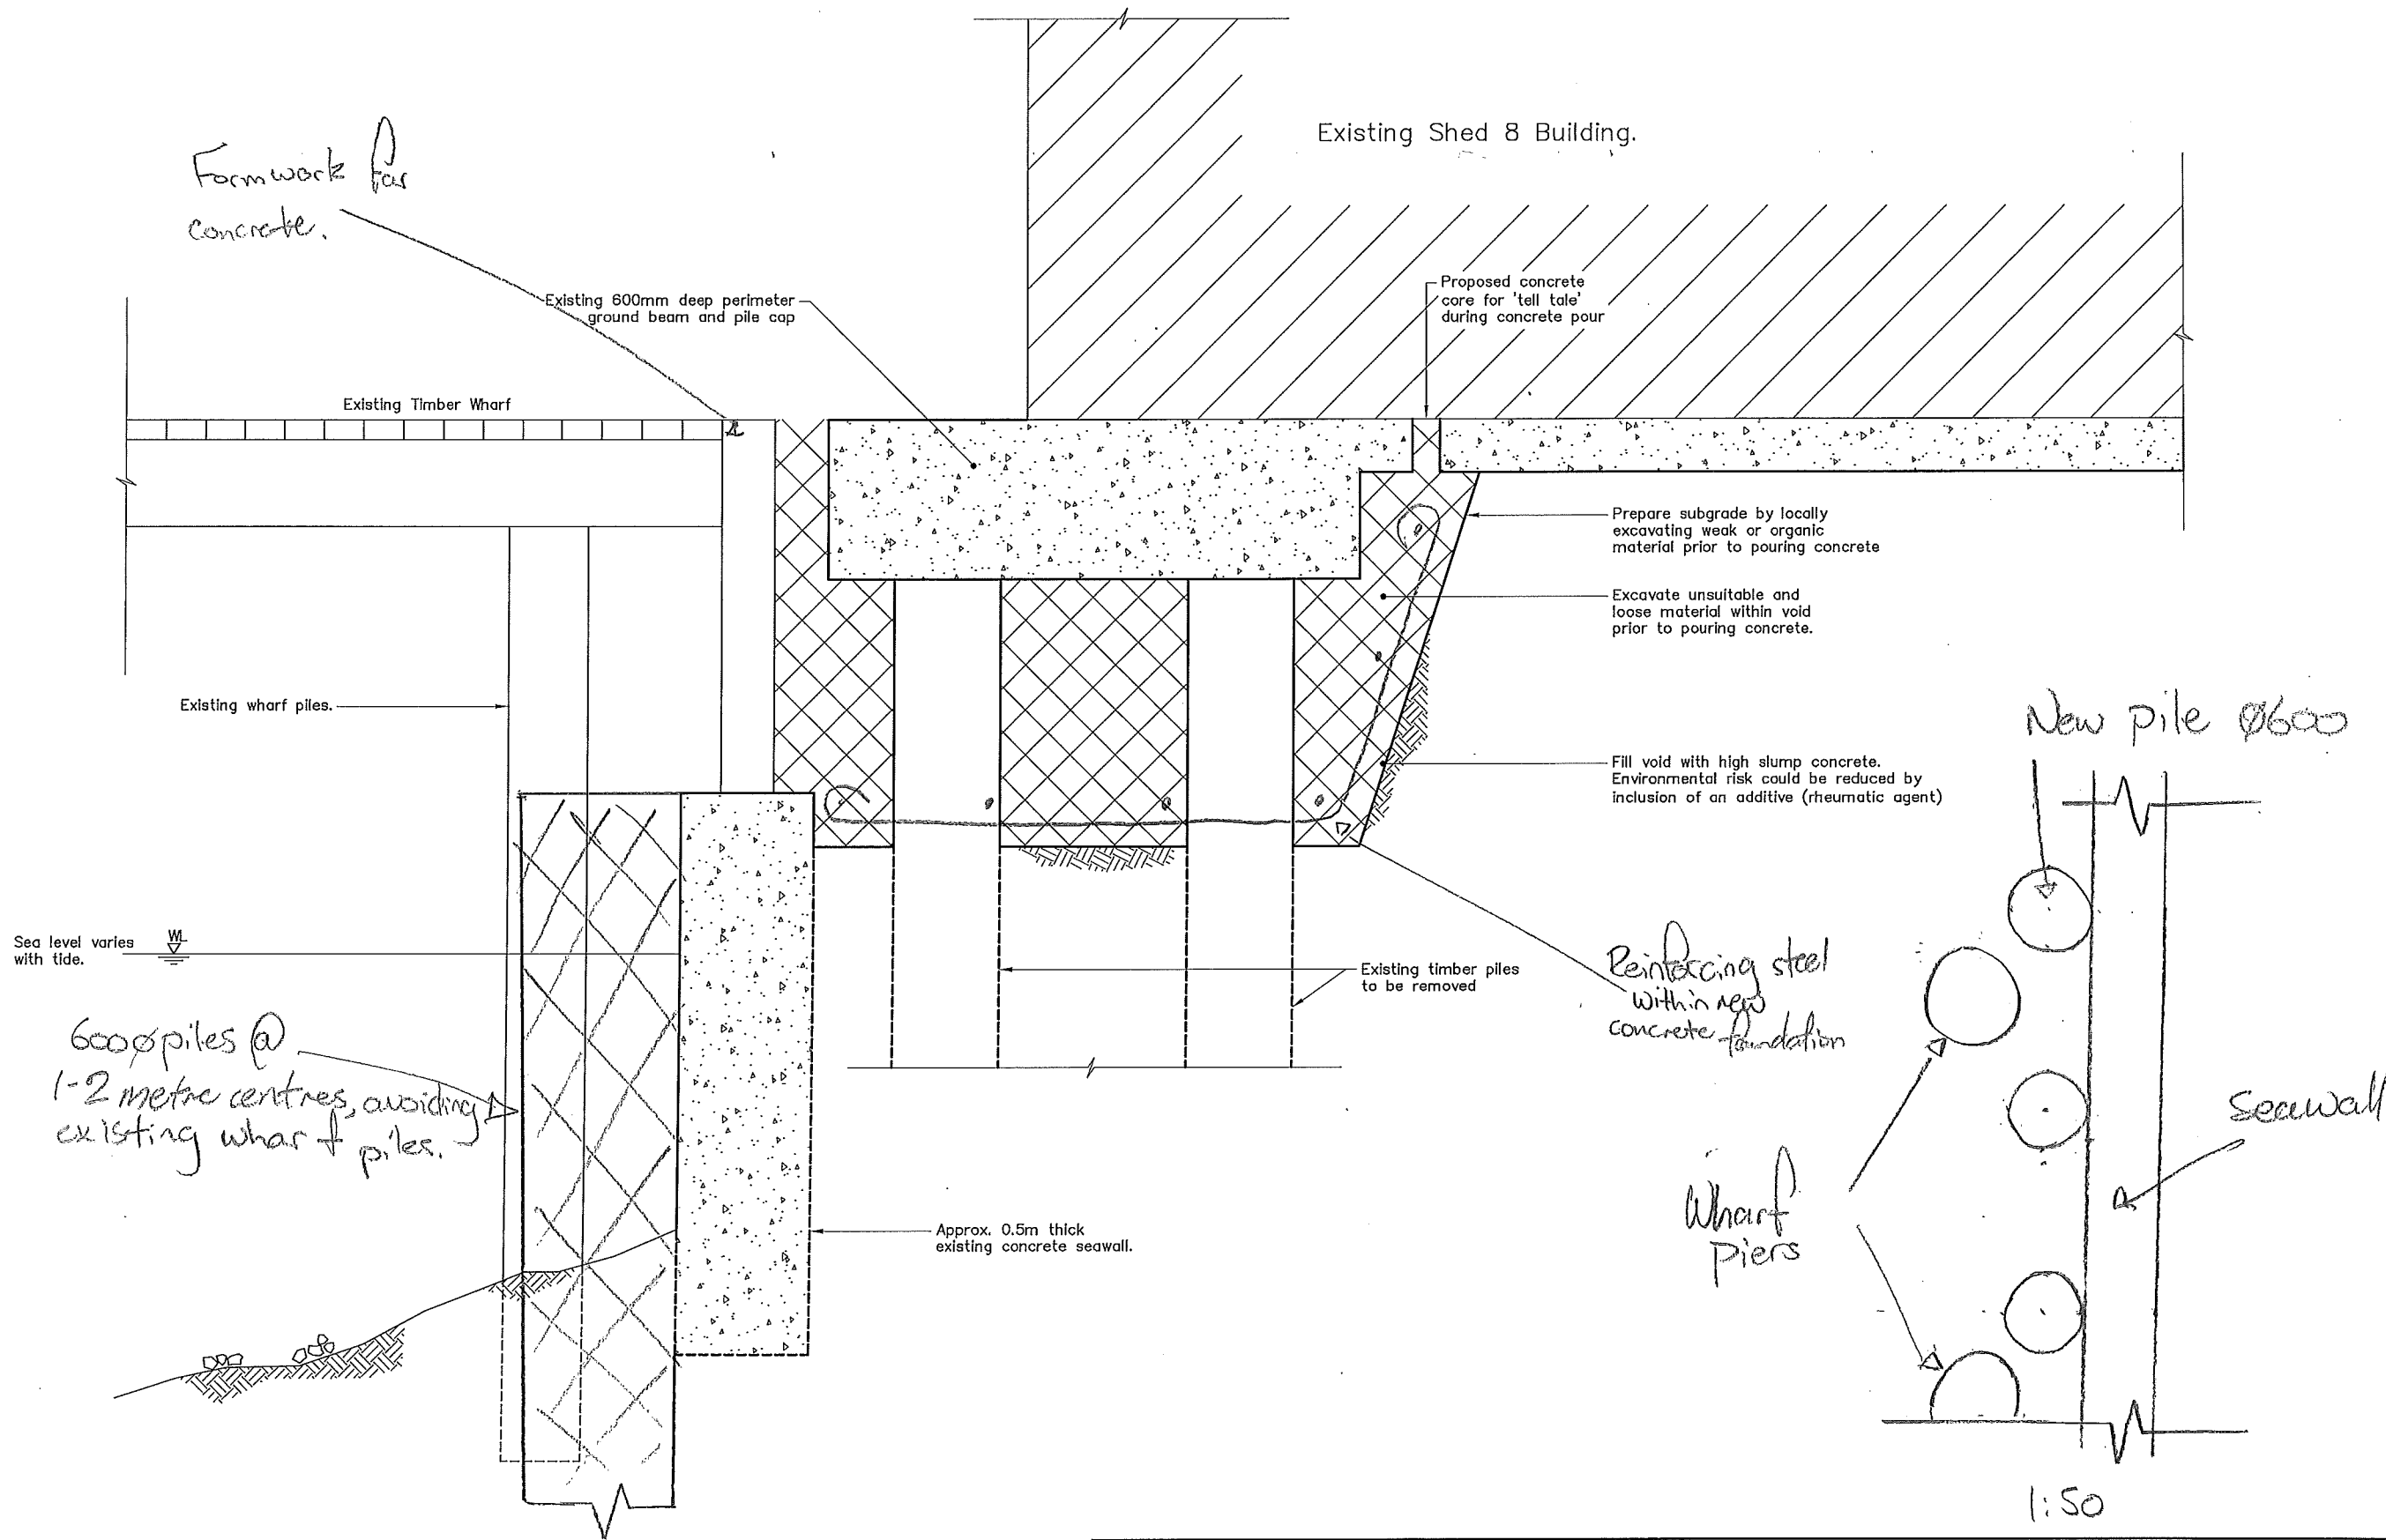
DRAWN	DSW	May. 15	DRAFTING CHECKED			APPROVED			<p>WELLINGTON CITY COUNCIL SHELLY BAY SHED 8 FOUNDATION REPAIRS Concept Repairs Ground Beams</p>	
	DRAWN	DSW	May. 15									
	DRAFTING CHECKED											
	APPROVED											
<p>CADFILE : 85856.0040-F01.dwg SCALES (AT A3 SIZE) 1:25</p>	<p>PROJECT No. 85856.0040</p>	<p>FIG. No. Figure 7 - Support of Current Seawall</p>	<p>REV. 0</p>
