Beca Infrastructure Ltd report on the Golden Mile Restoration Project - Stage 4 Post Construction Safety Audit and Wellington City Council response

14 July 2011

1 Introduction

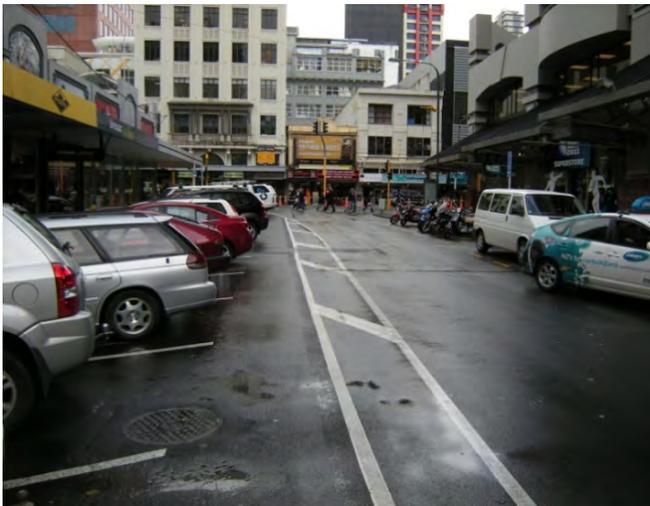
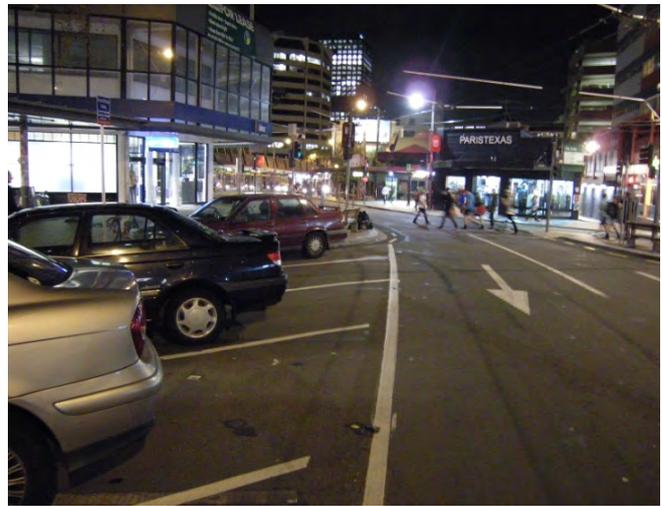
The on-street parking using a variety of parallel and angled parking attempts to provide a self-managed speed environment whereby drivers slow down to let other motorists park and enter/exit parking bays as shown in photos 2 and 3. The expectation behind this is that drivers will act in the correct manner. We note that angled parking may lead to nose-to-tail accidents as a result of drivers reversing into the traffic stream.

This type of parking is typically used safely in similar situations across the city, where traffic speeds are low.

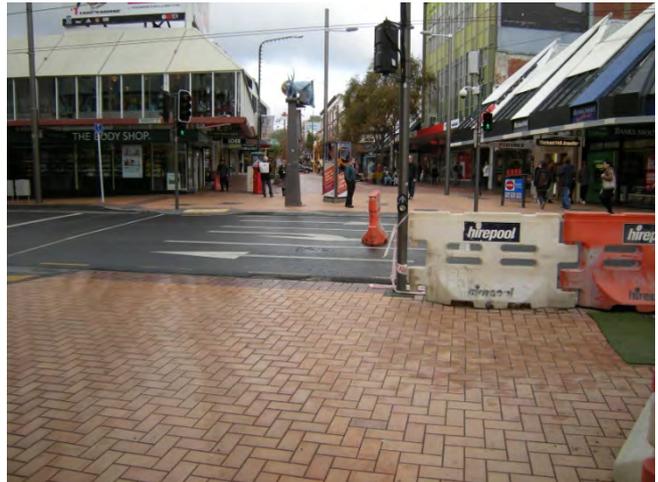
Photo 33

The pedestrian crossing has three call points, with the centre point located in the middle of the intersection, at the dropped kerb vehicle access, see photo 32 and 33. This places pedestrians and vehicles on the same piece of pavement and may lead to pedestrians being struck by motor vehicles.

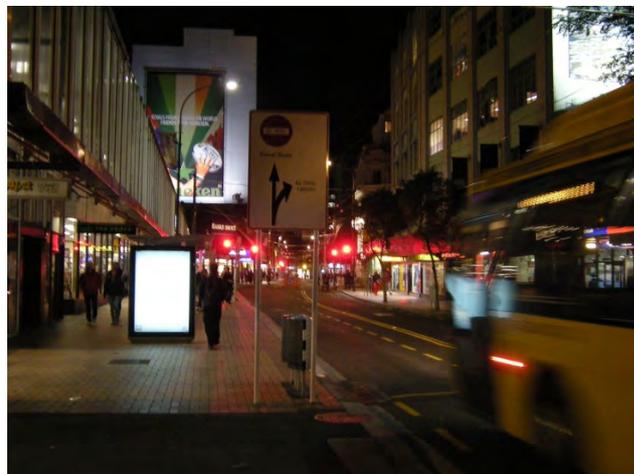
Photo 34

The road sign directing all traffic, other than buses, into Cuba Street is not clear and the text size makes it difficult to read. In addition, the sign is not reflectorised and is difficult to see at night. Refer to photo 34.

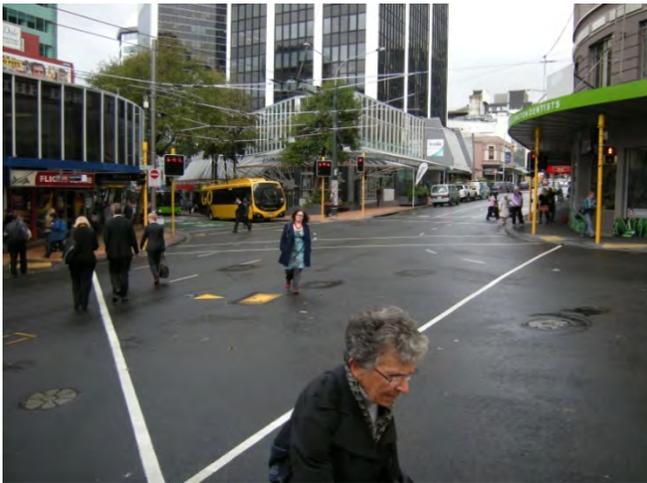
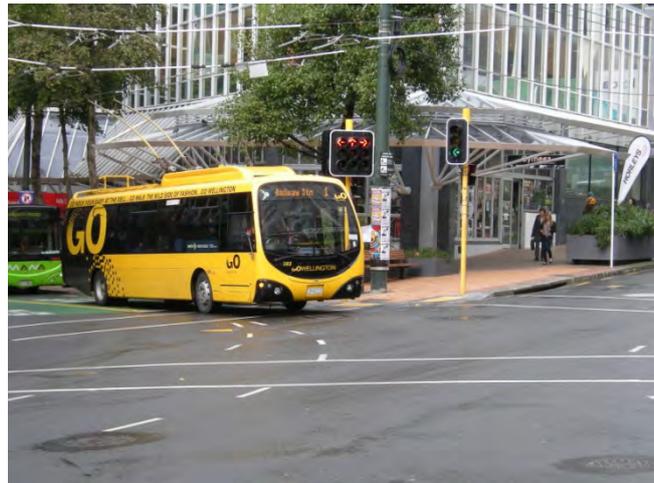
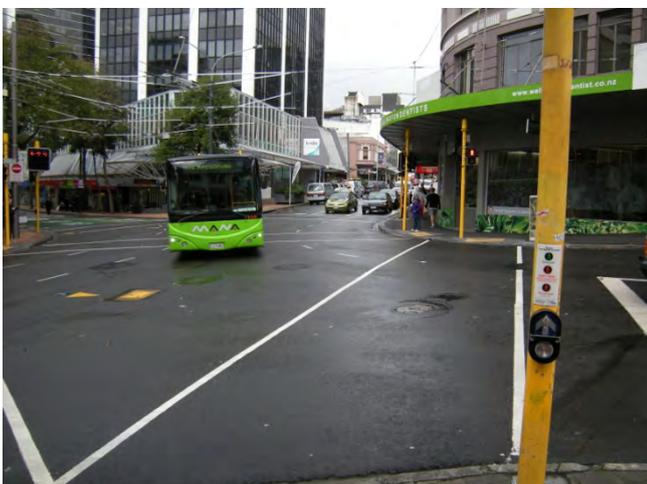
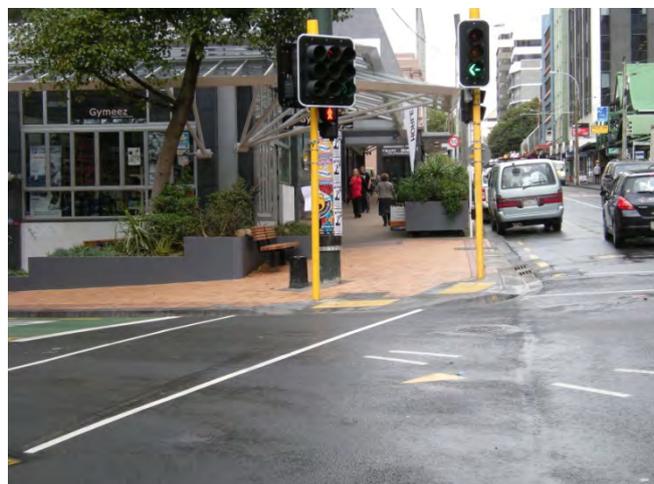
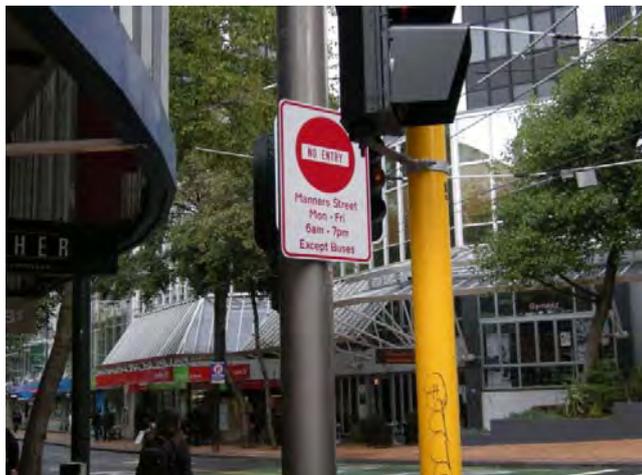
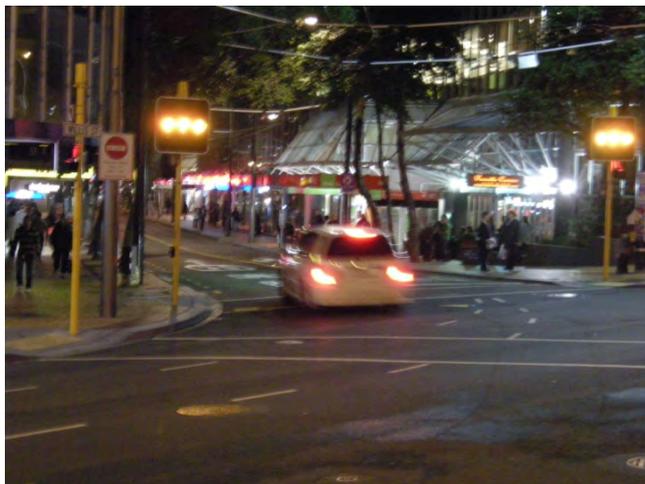
Traffic from Boulcott Street is confronted with a large number of traffic signal aspects to observe, located at the end of Manners Street. Straight-through traffic to Manners Street is only given a green signal at certain unrestricted times during the day. The road sign detailing the restriction is small and difficult to read and may result in some confusion to road users possibly waiting for the straight-through green signal during bus-only times. The intersection arrangement is shown in photos 39–44.

The sign observed is positioned at the intersection and complements other information available to the motorist at this intersection. In advance of this sign there is one on Boulcott Street to give motorists advanced warning of the prohibition on general traffic in Manners Street during business hours. As suggested the effect of the signs will be monitored and improvements made as appropriate.

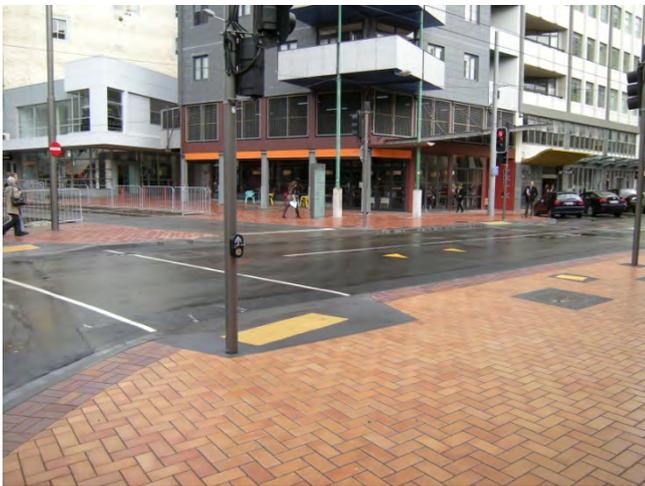
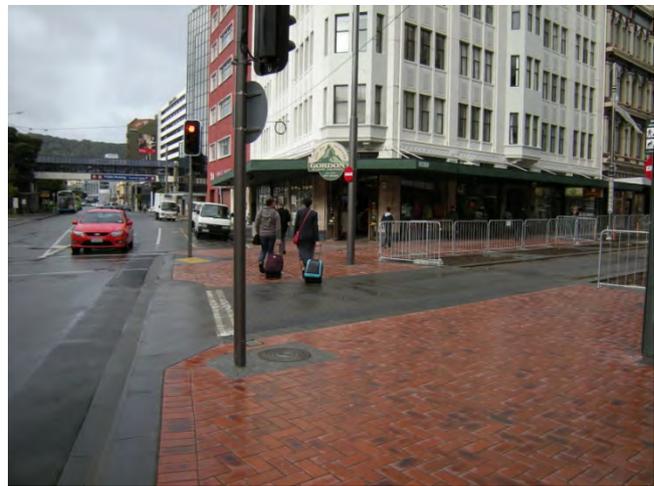
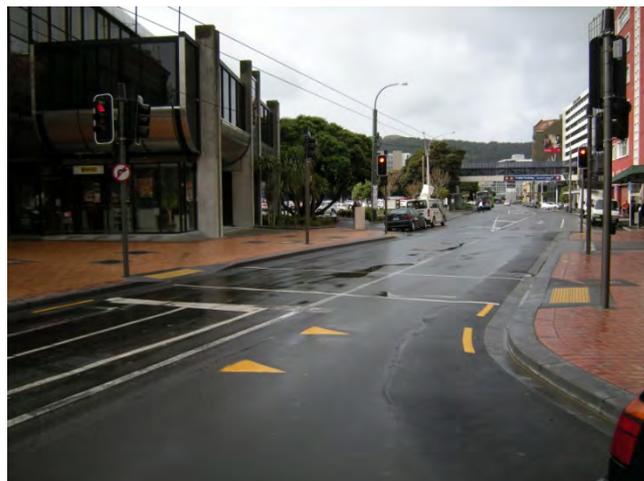
The size and positioning of the no-right turn and no-entry signs results in the signs not being clearly visible to motorists. See photos 47–49.

The signs have been positioned on existing poles to minimise clutter. Their size has been reduced to minimise any obstruction to pedestrians. The effectiveness of the signs will be monitored and, if necessary, will be repositioned or increased in size as appropriate.
