Wellington City Council Targeted Assessment Programme

following the
Kaikoura Earthquake of 14 November 2016

Technical Report

7 May 2017

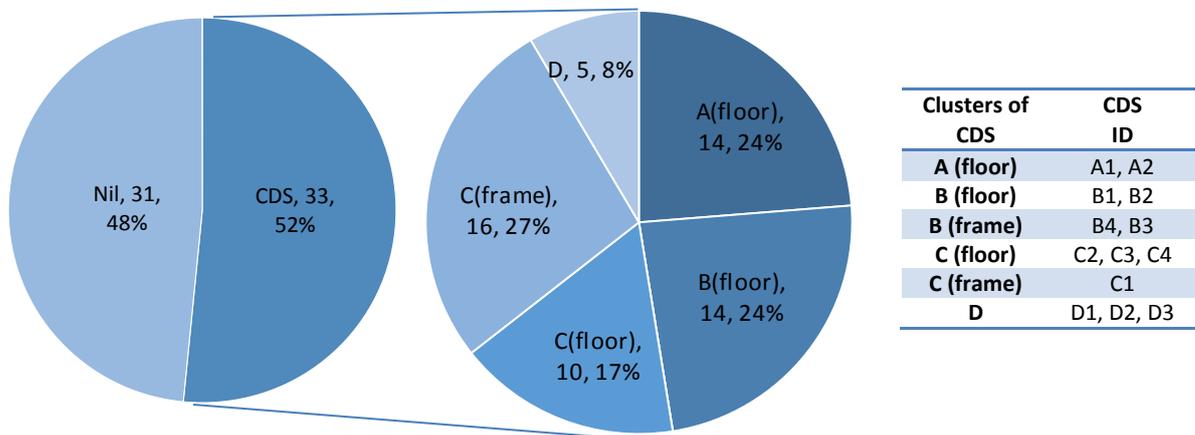
Figure 5: Critical Damage States reported across 64 TDE Buildings

Figure 5 provides a summary of the Critical Damage States from Table 1 reported across the TDE buildings. None of the 64 buildings experienced CDS A2 (*Significant damage to support for flange-hung double tee floor units*), B3 (*Loss of lateral support for columns over multiple storeys*), or B4 (*Shear damage to corner columns*). As a result, the only CDS category relating to damage in the lateral system is C1 (*Plastic hinge damage*). All other identified CDS relate to damage in the floor system (A1, B1, B2, C3, C4) or non-structural elements (D1, D2, D3).

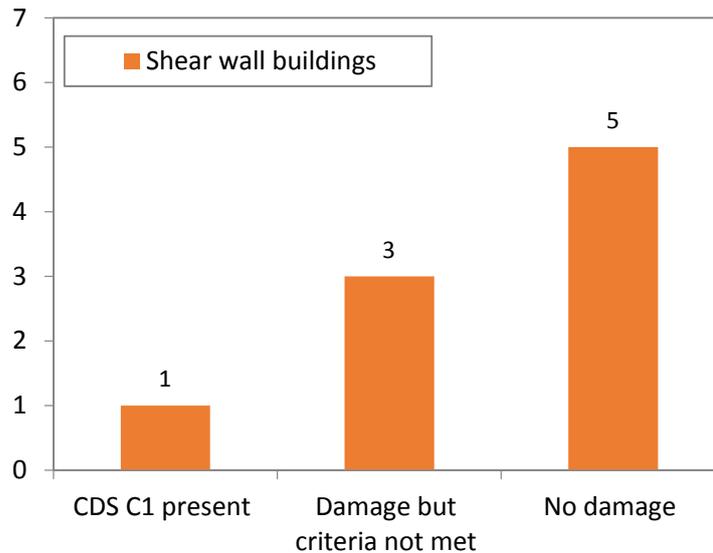
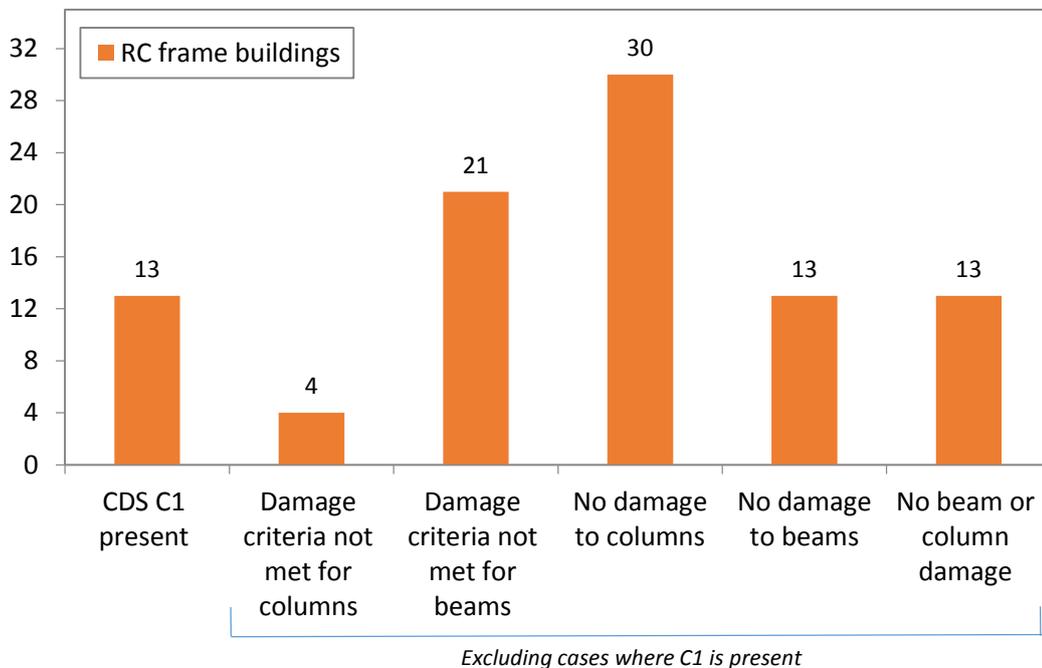
Figure 6: Damage to primary lateral system in (a) Shear wall and (b) Moment-frame buildings

In terms of primary structure, most of the damage recorded was to the beams of moment-resisting frames. As shown in Figure 6, for the nine buildings with structural walls as the predominant lateral load resisting system, wall damage meeting the criteria set out in the TDE guidelines was only noted in one building; three others had light damage to the walls.

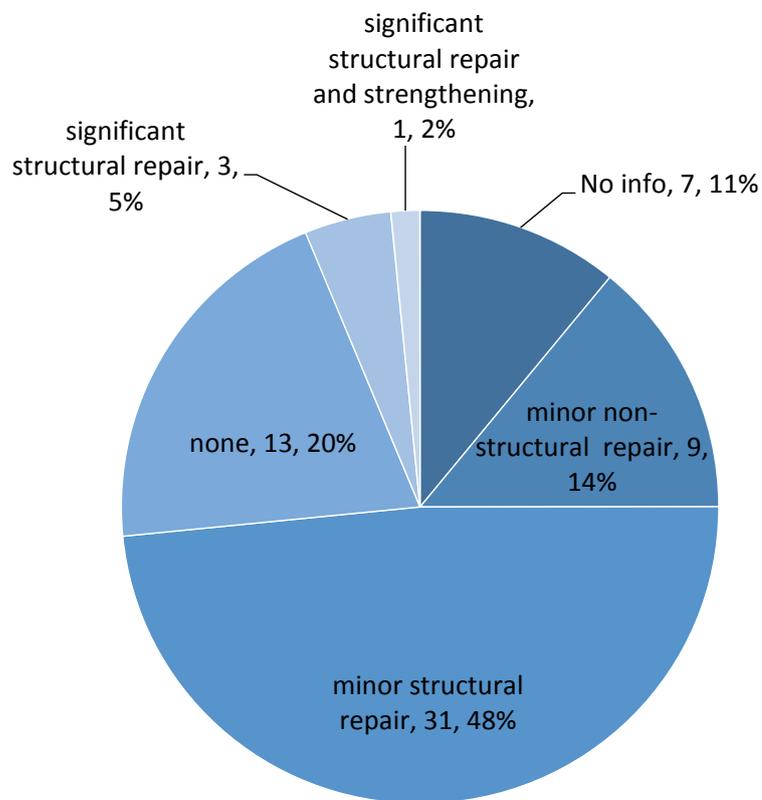
Figure 7: Summary of structural repair/strengthening recommended

The Targeted Damage Evaluation reports summarised the investigations undertaken, the nature of the damaged observed and recommended actions for the building owners. The recommendations for further action are summarised in Figure 7 below. None of the TDE reports recommended demolition of the building.

Where short-term repairs or remediation were found necessary, it is understood that all of these buildings have either already been repaired or the affected areas have been isolated pending repairs.

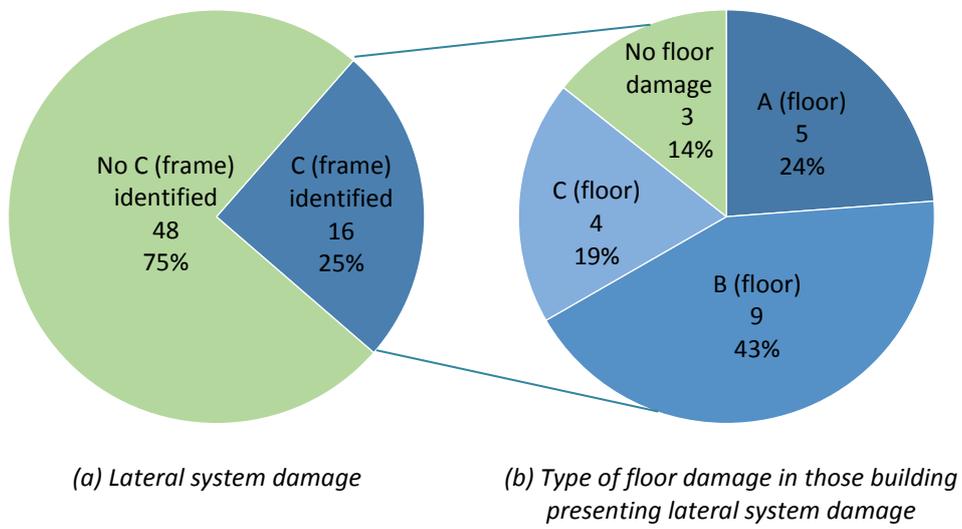
Figure 9: Lateral system damage vs Floor damage

Buildings experiencing damage to the moment-resisting frames tended to also experience damage to the floor system. This observation is illustrated in Figure 9 which indicates that 67% of the buildings experiencing CDS C1 frame damage also exhibit either CDS A or CDS B (floor damage). In contrast, Figure 10 indicates that a building with floor damage is not necessarily accompanied by damage in the frame. The latter conclusion may be the result of the frame being considered undamaged if it exhibits fine cracks (due to reinforcement present in the frame elements), while any width of crack was classified as CDS damage in hollowcore floors due to the brittle nature of unreinforced hollowcore units.

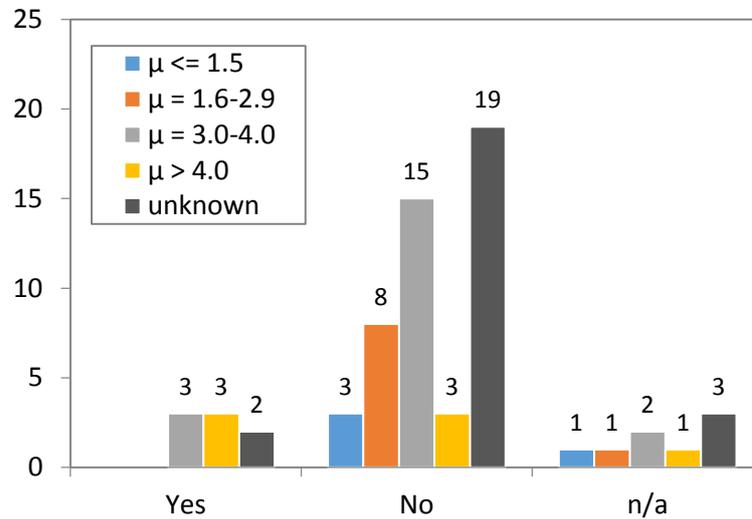
Figure 11: Relationship between design ductility and presence of beam elongation

Beam elongation tended to occur in buildings designed for higher ductility. Figure 11 shows that buildings with design ductility below 3 did not exhibit beam elongation. This figure only includes the 64 TDE buildings; consideration of the eight significantly damaged buildings would strengthen this relationship.

The presence of beam elongation generally reduced the seating width for units spanning into corners, but with the exception of Statistics House, sufficient residual seating of precast units was maintained. In restrained beams away from the corners, hinging was often less significant, with cracks that had generally closed up leading to minimal residual elongation.

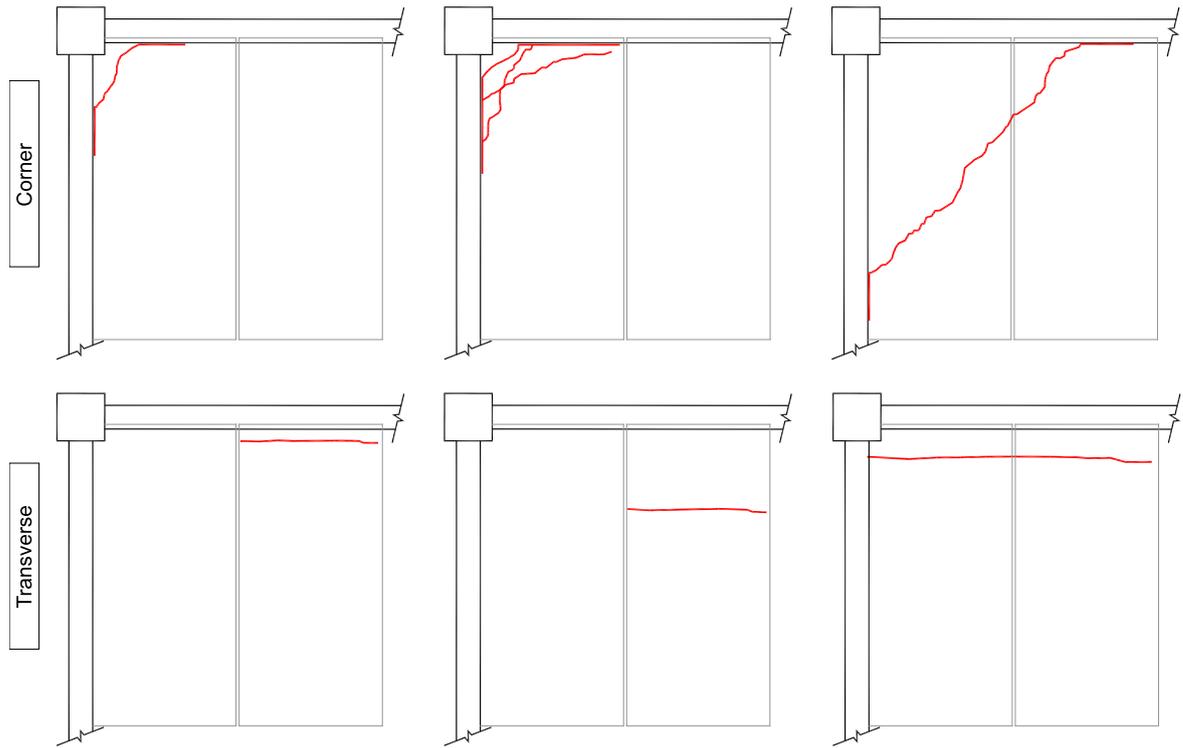
Figure 13: Plan views of typical crack patterns observed in floor units (from below or from above)

The most commonly observed damage pattern was cracking of floor units in the floor plate corners. Figure 13 indicates this corner cracking typically takes one of three forms:

- 1) localised with only one or two, typically fine, cracks near corner column (examples in Figure 14);
- 2) a complex intersection of many, typically wider, cracks, generally limited to the first unit (examples in Figure 15); or
- 3) a single diagonal crack set back from the corner, crossing more than one unit, and intersecting the frames roughly halfway along the bay lengths.

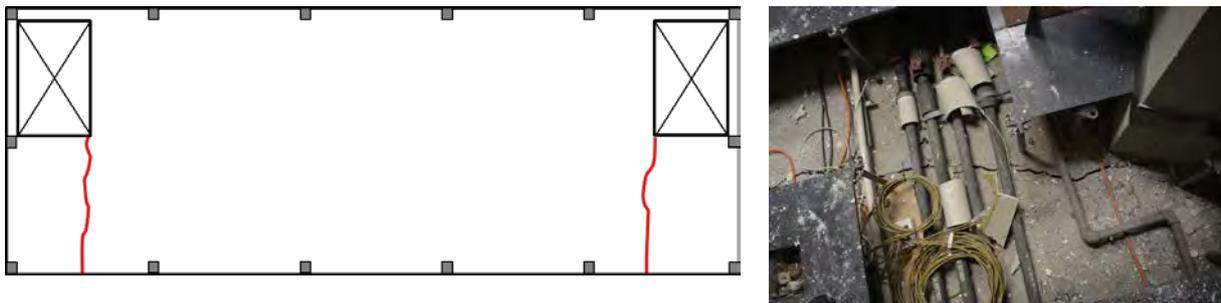
In at least one significantly damaged building, the layout of the structural system led to failure of the diaphragm with wide cracks extending through the topping and hollowcore units (10-15mm wide in some locations with topping steel mesh fracture). The principal crack ran longitudinally along the unit and stepped across cells at discrete locations, with damage to internal webs of the unit being likely. As illustrated generically in Figure 16, connection between the diaphragm and the short seismic frames at perimeter was interrupted by the presence of stairwells, leading to high shear demands on a short length of diaphragm. Floor unit demands were further exacerbated by limited beam elongation in the corner of the building and reasonably high building drifts (estimated at 1.0 - 1.5%).

Figure 16: Generic illustration (plan view) of rectangular perimeter moment frame building with diaphragm failure at openings for stairwells

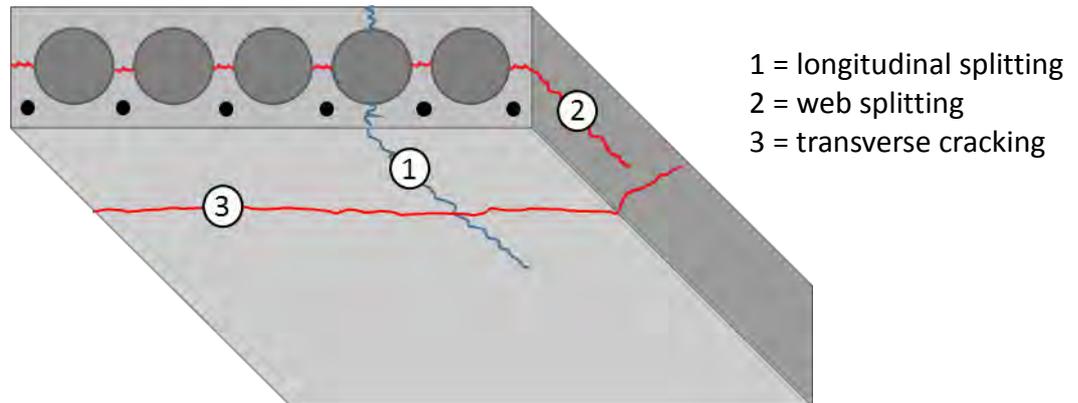
Figure 17: Types of cracks found in hollowcore units

When assessing the critical damage states, it was important to identify whether the cracks in the floor topping concrete had propagated between the joints of precast units or through the unit itself. Different types of cracks found in hollowcore units are shown in Figure 17. Transverse cracking in hollowcore was of particular concern because these units do not include transverse reinforcement, and transverse cracks near the support may impact the bond between concrete and the bottom flange prestressing strand and reduce shear capacity near the support. Transverse cracking in hollowcore units was observed in 14 of the 64 TDE buildings. In three of these buildings the transverse cracks were identified to have propagated diagonally through the web of the hollowcore as illustrated in Figure 17 (CDS A1).

It is noted that a further 11 buildings with transverse cracking were identified where the orientation of the cracking through the hollowcore unit had not been confirmed (and hence have been classified as CDS A1). Further inspection of these units for diagonal web cracking using a borescope camera is recommended.

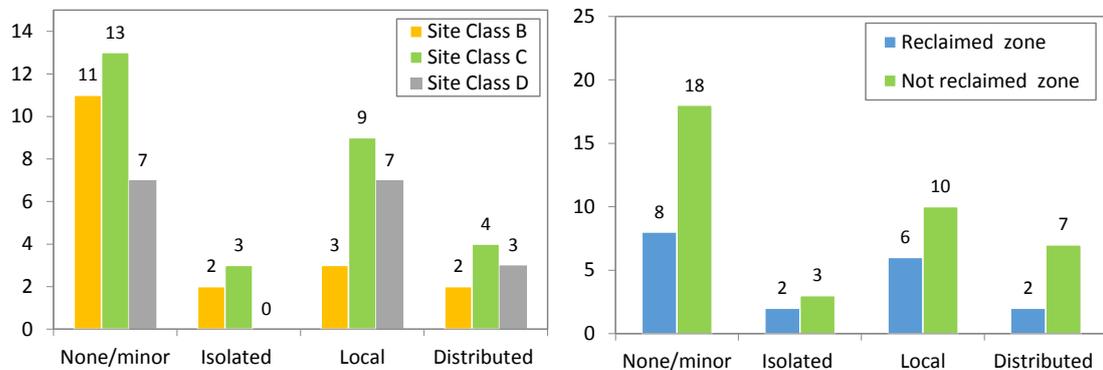
Figure 27: Relationship between damage extent and (a) site class and (b) reclaimed zone

Figure 27 shows the relation between the extent of damage for the TDE buildings and the site class and reclaimed land. There is no apparent relationship with the damage and whether or not the building was located on reclaimed land. This is most likely because the materials used for the reclamation often make up only a small portion of the overall soil profile thickness at each location, and the reclamation materials may be stiffer than the underlying natural deposits. 61% of buildings on site class B (rock) exhibited none/minor damage, while 59% of buildings on site class D exhibited distributed or local damage, indicating an emerging trend of an increase in likelihood of damage with softer (deeper) sites. Six of the eight buildings with significant damage were located on site class D, with the remaining two located on Site Class C but very close to the boundary with site class D.

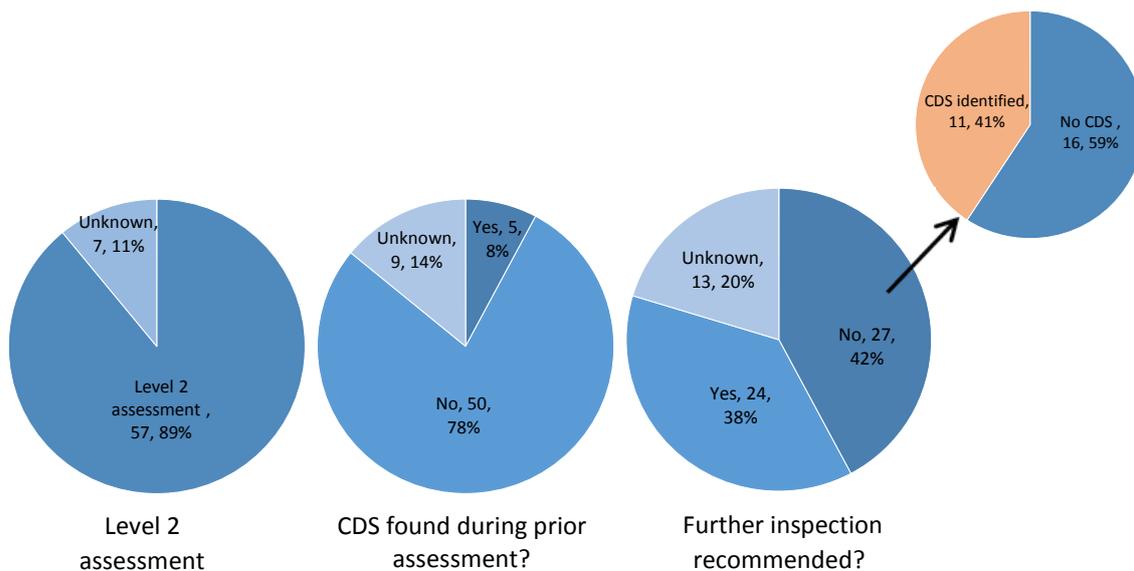
Figure 28: Level 2 assessment information

While only five of the 57 rapid assessment summaries had flagged some form of structural damage meeting critical damage state criteria, 24 had recommended further investigation. Of the 27 buildings where no further investigation was recommended in the Level 2 form or letter, structural damage (i.e. Critical Damage States) was subsequently identified in 11 buildings via the targeted damage evaluation inspections, with two cases of **distributed** frame and floor damage. This information is summarised in Figure 28 following.

This programme has subsequently demonstrated the value of invasive investigations that were targeted at hotspots, which in turn were informed by an engineering understanding of the building and how it was expected to perform. There is a need to review and reconsider guidance on triggers for more intrusive inspections of multi-storey buildings when it is apparent from early event spectra and reports of significant non-structural damage that they are likely to have experienced a significant proportion of their original design loading. This is particularly the case for buildings designed for high ductility, which results in a much lower threshold for inelastic response and associated deformation compatibility issues where precast floor systems are involved.
