# Thorndon Connections cycleway audit – safety and accessibility

30% design audit

November 2022

90% design audit

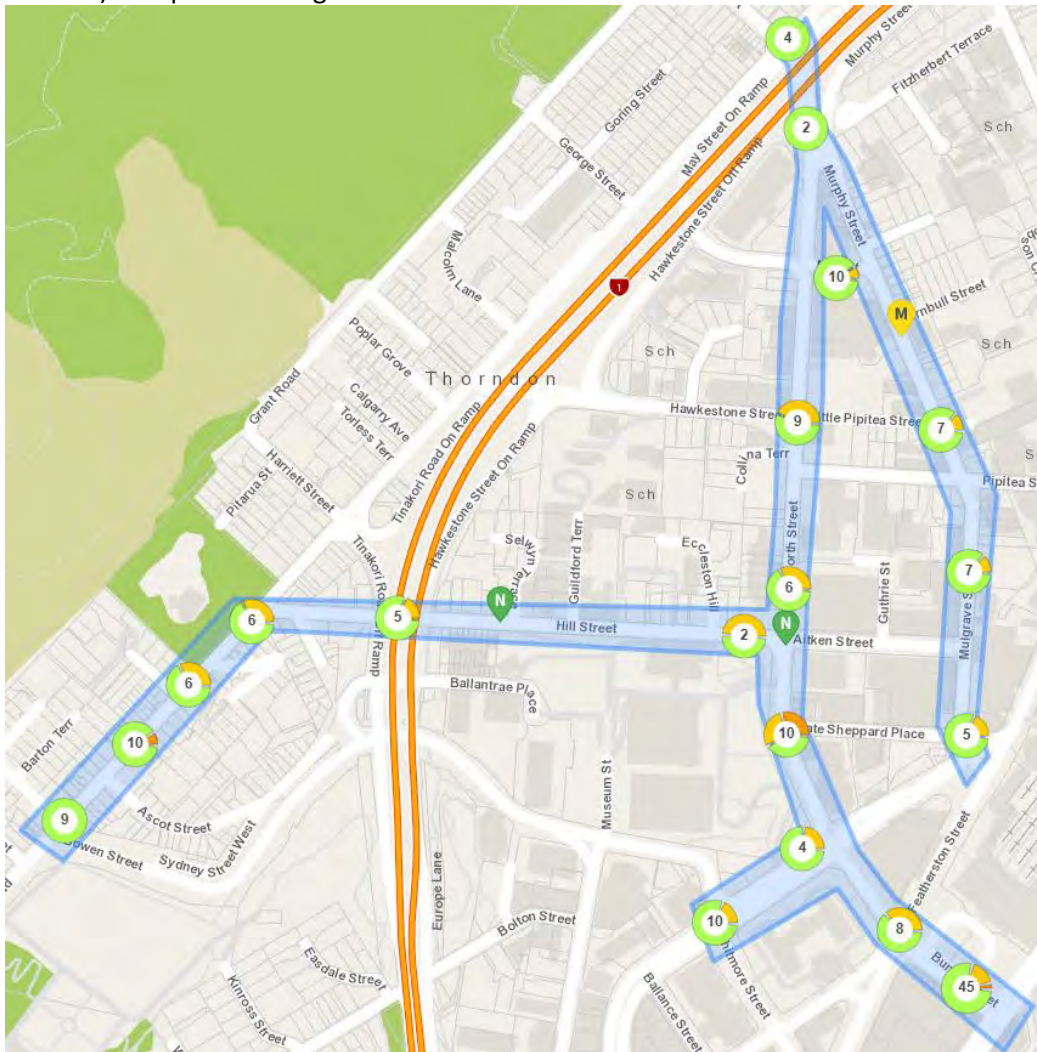
**Figure 3-1: all crashes reported in the proposed Thorndon connections corridor**

A total of 168 crashes were reported along the proposed Thorndon connections project corridor over the five-year period; the user groups and severities involved are detailed in

The largest crash clusters involving motor vehicles are on Bunny Street near the railway station. Other notable crash clusters are present at intersections between Molesworth Street and Kate Sheppard Place, Bowen Street and Tinakori Road, Bowen and Whitmore Street (more information on these clusters are included in Appendix A). These should be considered during the design process.

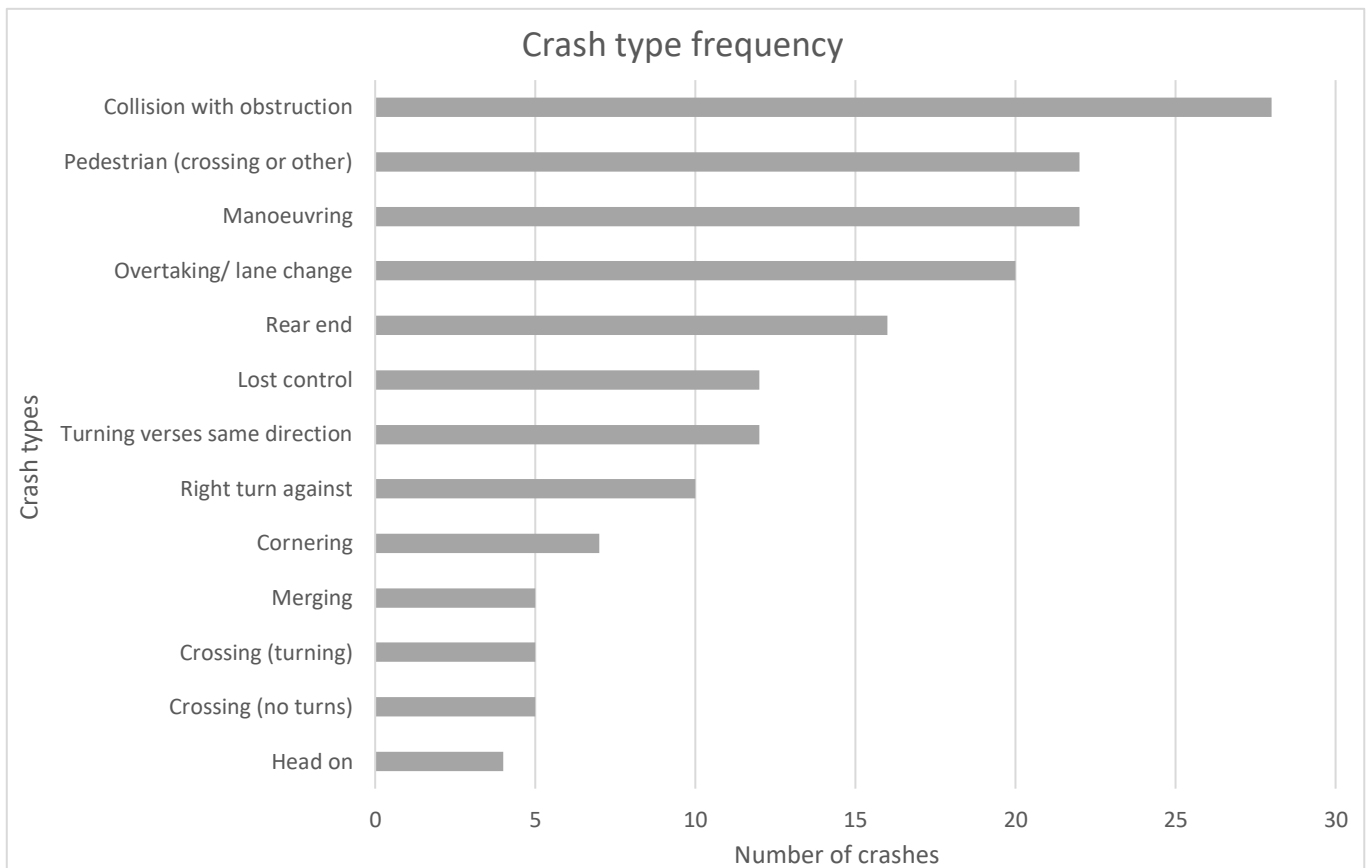
**Figure 3-2: Reported crash factors (grouped)**

The top four crash factors (collision with obstruction, pedestrians (crossing or other), manoeuvring and overtaking/ lane change) all point to the constricting environment of the road and amount of traffic on the route. Given the lack of alternative options, lack of space and the busy nature of the corridor these are unavoidable risks that should be minimised through design.

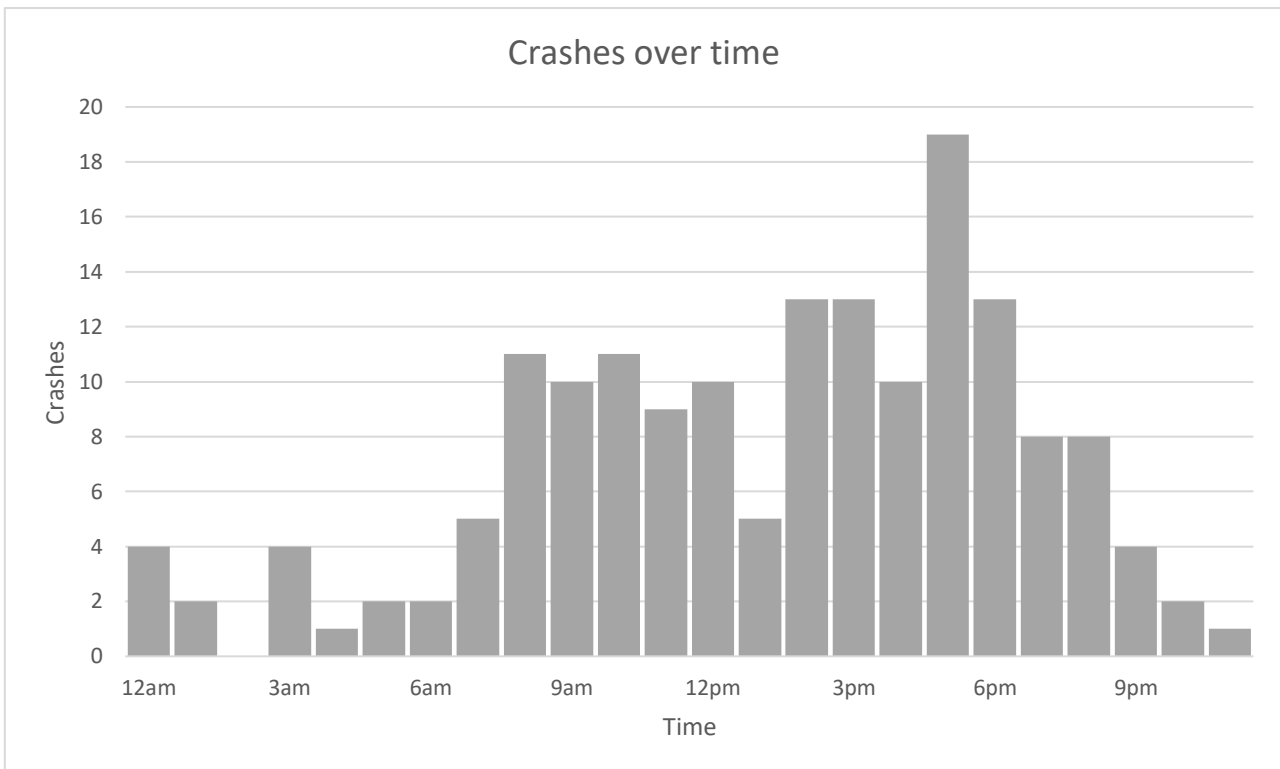
**Figure 3-3: crashes by time of day**

- crashes occurred most on Monday, Wednesday, and Friday (least on the weekend)
- crashes peak with evening traffic peaks (Figure 3-3):
  - 5pm-7pm (evening)
- as stated above, crashes were most often caused by collision with obstruction, pedestrians (crossing or other) and manoeuvring
- crashes involving cyclists most often resulted in no injury (six minor, one serious and nine non-injury)
- crashes occurred most between April – June
- crashes peaked in 2019 and decreased from here in 2020 the increase slightly again in 2021

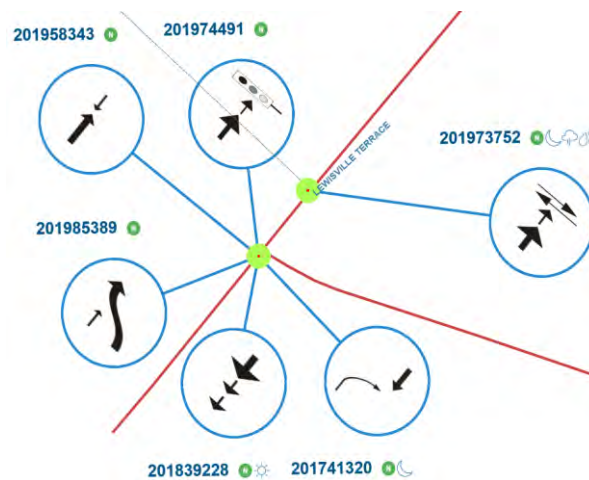
**Figure 6-1: Bowen Street and Tinakori Road intersection crash diagrams**

Crash data for the Bowen / Tinakori intersection shows:

- crashes were most often to do with manoeuvring
- none involved pedestrians or cyclists
- one occurred in wet conditions
- two occurred at night
- crashes occurred the most on Wednesday or Friday
- four of the six crashes occurred in 2019

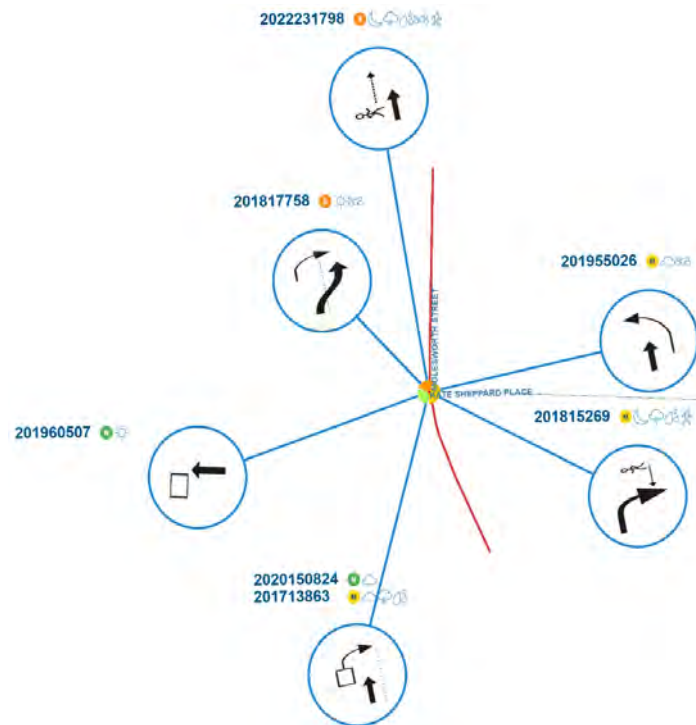
**Figure 6-2: Kate Sheppard Place and Molesworth Street intersection crash diagram**

Crash data for the Kate Sheppard / Molesworth intersection shows:

- crashes were most often to do with manoeuvring
- two involved pedestrians (one minor and one serious)
- three occurred in wet conditions
- two occurred at night
- crashes occurred most on Tuesday or Wednesday
- crashes were well spread between 2017-2022 (with two in 2018)

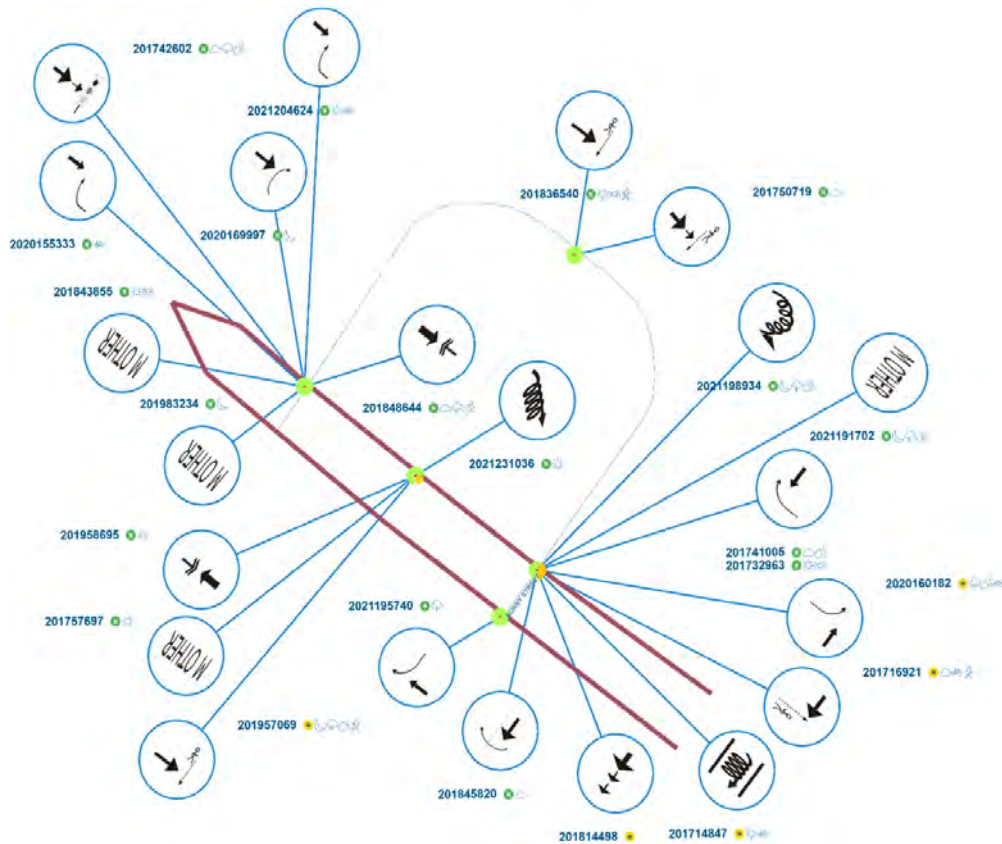
**Figure 6-3: Railway entrance and exit crash diagrams (on Bunny Street)**

Crash data for the Railway station entrance and exit on Bunny Street shows:

- crashes were most often to do with manoeuvring
- five crashes involved cyclists (three minor and two non-injury), three involved pedestrians (two minor and one non-injury)
- most occurred in good weather
- Most crashes occurred during the day
- four of the six crashes occurred on Tuesday, Saturday and Sunday
- five of the six crashes occurred in 2017 followed by 2018 and 2021

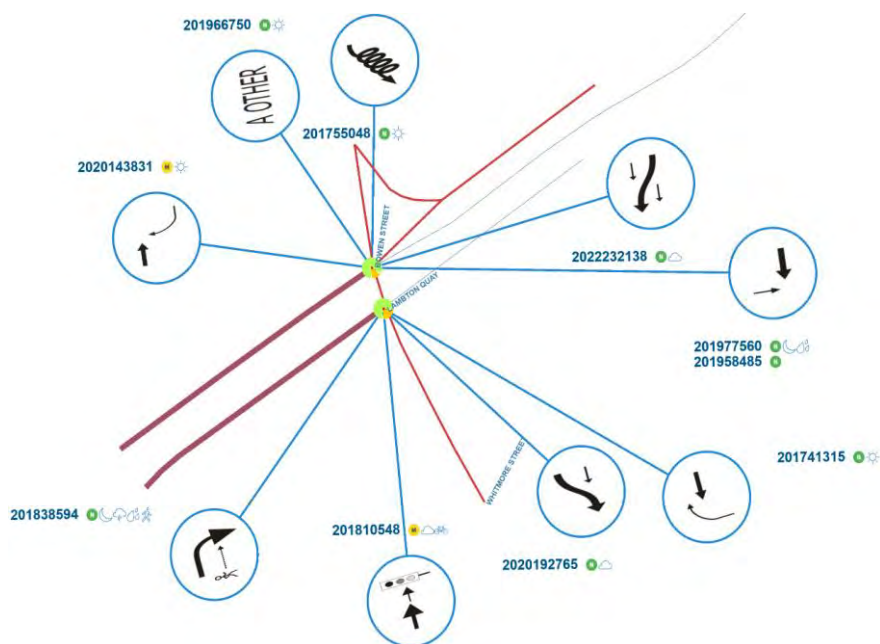
Figure 6-4: Bowen and Whitmore Street intersection crash diagrams

Crash data for the Bowen / Whitmore intersection shows:
