WCC Housing Detailed Seismic Assessments

Berkeley Dallard – Detailed Seismic Assessment

Wellington City Council

Reference: 523020

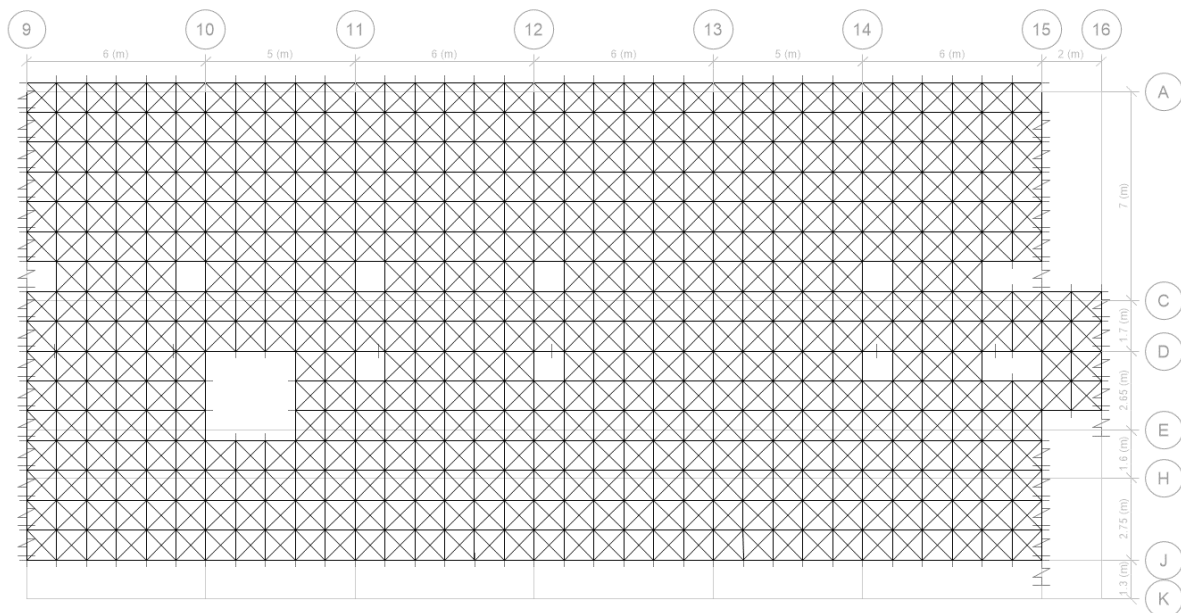
Figure 4-4 Grillage model of Level 8 for the South Building

Due to the complexity of the diaphragms the diaphragm demands were assessed using the Grillage Method as recommended in the Guidelines. It is essentially an automated strut and tie analysis method to obtain demands. Capacities were determined using Appendix A of NZS 3101:2006. Refer to Figure 4-4 Grillage model of Level 8 for the South Building.

The performance of the diaphragms at L10 and roof level are limited by their connections to the vertical resisting elements. The existing connections are Trubolts. The anchors are not compliant with the current NZS3101 C2 requirements. They also have insufficient embedment depth.

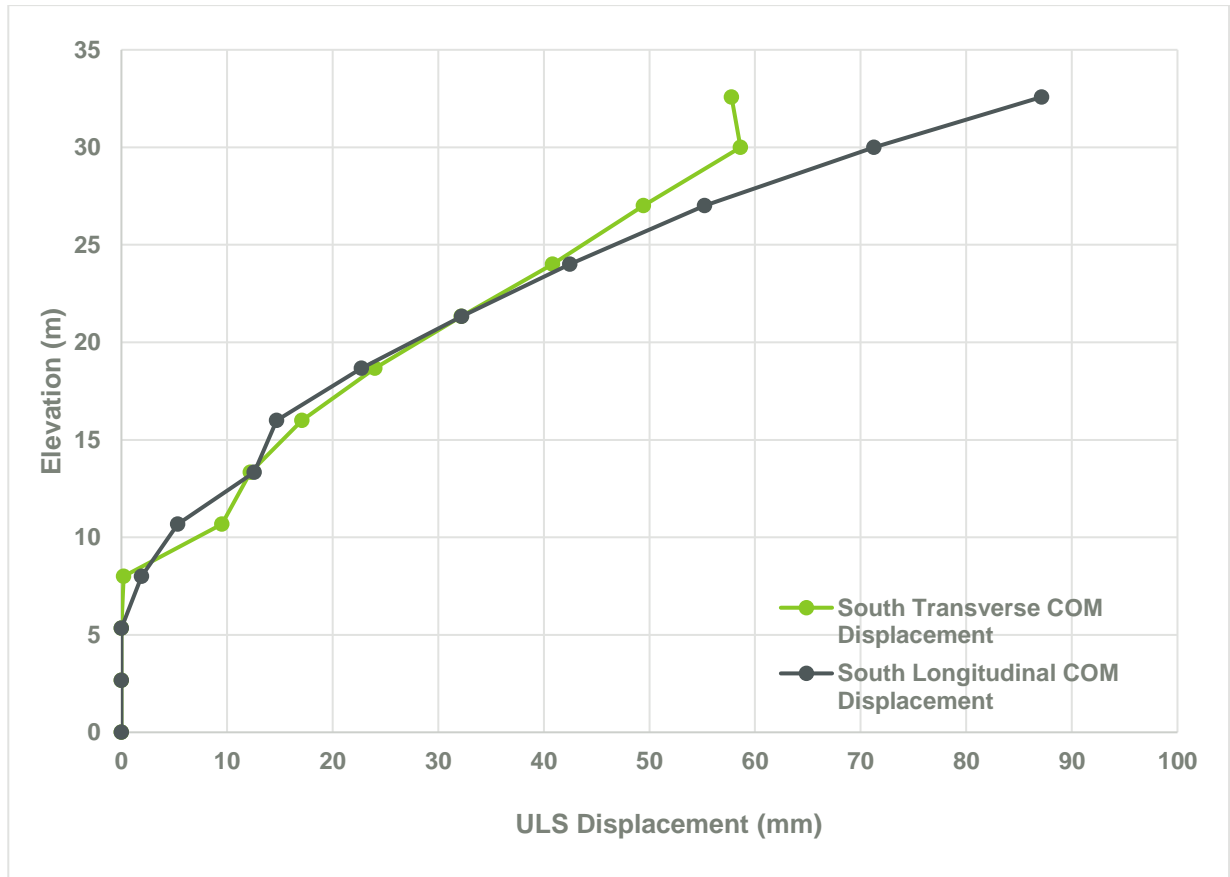
Figure 5-1 Estimated South Building Displacements for 100% ULS shaking

The building displacements up the height of the building obtained from our analyses for 100%ULS shaking are shown in **Figure 5-1** below and **Figure 5-2**.

Table 5-3 and Table 5-4 shows the structures time periods, global ductility demand at 100%ULS and the maximum inter-storey drift under 100%ULS shaking. The storey drift allows for the kdm modification factor and P-delta effects. In both directions, the drift is less than the design code limit of 2.5%.

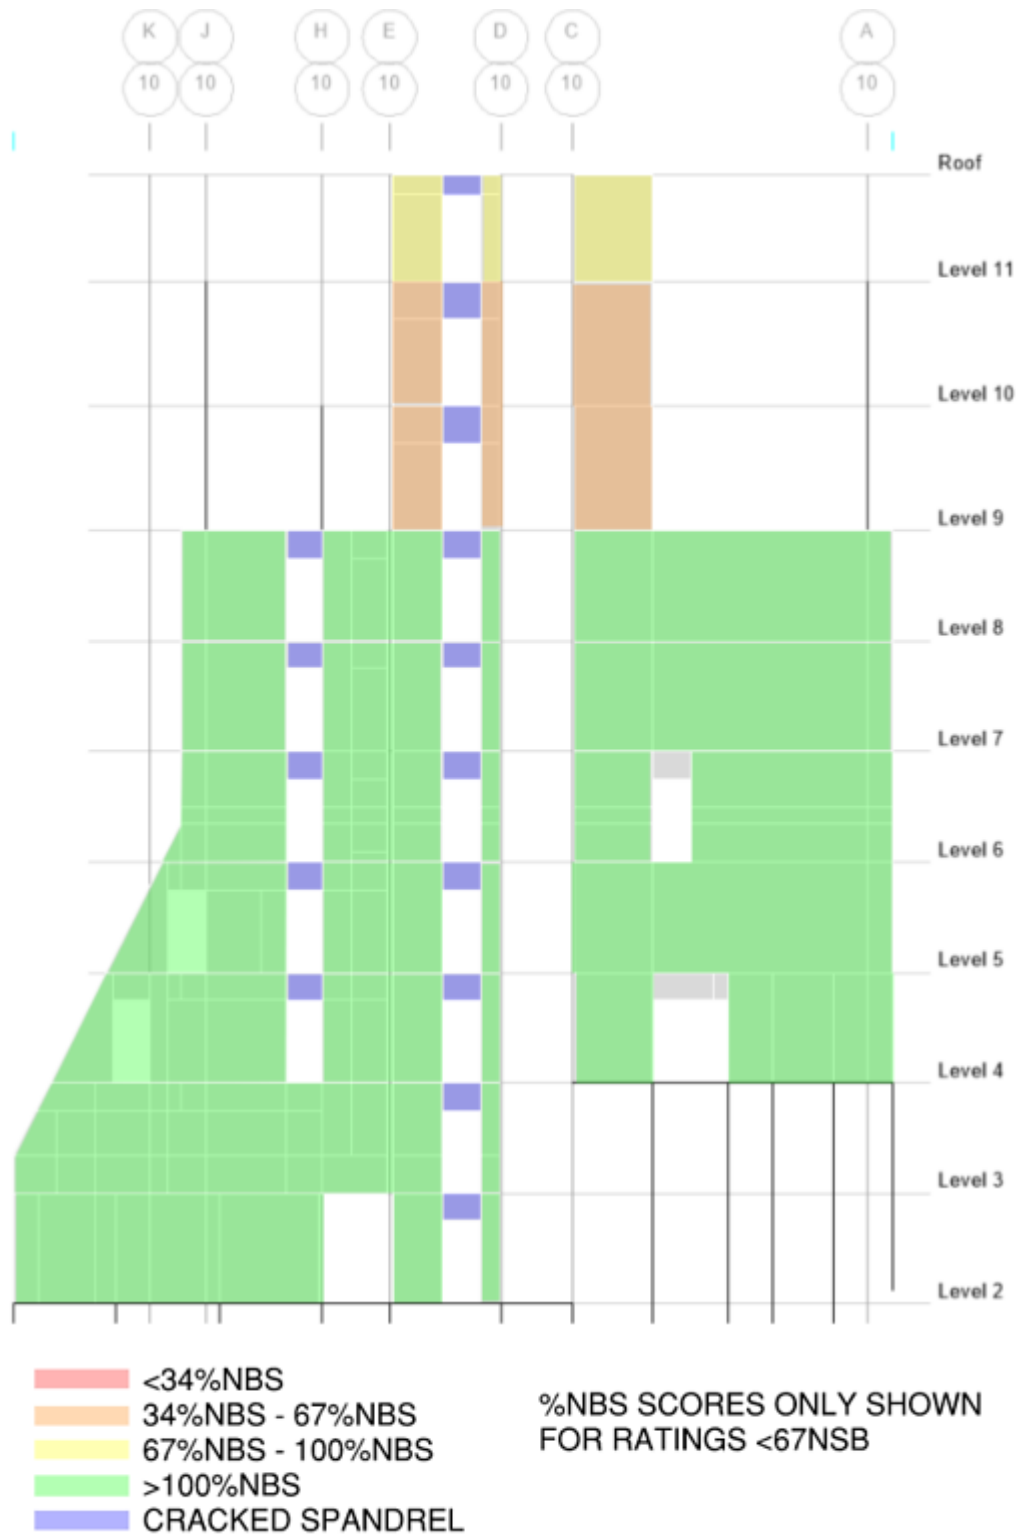
Figure 5-5, Critical Transverse Direction Wall – South Structure

Refer to **Figure 5-3, Critical Transverse Direction Wall – North Structure** and **Figure 5-4, Critical Longitudinal Direction Wall – North Structure** for the critical gridline ratings in the longitudinal and transverse walls in the North Building and **Figure 5-5, Critical Transverse Direction Wall – South Structure** and **Figure 5-6** for the critical longitudinal and transverse walls in the South structure. All critical walls with their scoring are shown in **Appendix H**.

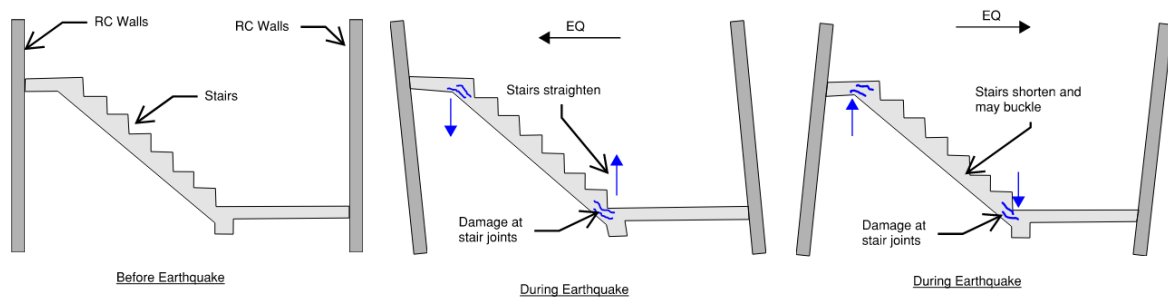
Figure 5-11, Stair's Behaviour During ULS Earthquake Shaking

The stairs were added to the 3D ETABS model to determine how much load they would attract given their proximity to shear walls. The analysis results revealed that the entrance stairs attract some moment and axial demands, even though the stairs are surrounded by RC shear walls. Therefore, the entrance stair does act as an unintentional strut in a design level earthquake. The entrance stair scores 100%NBS based on the stairs tension and moment capacity at the stairs knee joint. Refer to **Figure 5-11** that shows the stair's behaviour during ULS earthquake shaking.

The south and north end of the stairs scores 100% NBS (IL2). These stairs are only 1100mm wide and therefore does attract significant seismic load.

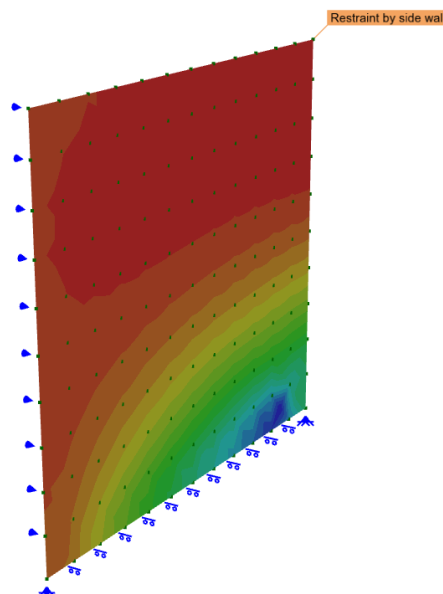
Figure 5-12, 6" RC Shear Wall Stress Distribution Based on Out-of-plane Seismic Parts Loading

The concrete walls at level 11 are considered cantilevers, as the walls have been assessed based on the roof structure not effectively tying the walls together at high level. The roof structure would need to form a reliable diaphragm to restrain the walls out-of-plane. The existing roof structure, as discussed in the section below, has DHS Purlins connected to the timber blocking and the blocking is bolted to the concrete walls, as shown in **Figure 5-13**. Existing timber floor structure has anchored to the existing concrete walls, as shown in **Figure 5-14**. Two options were shown and option 1 of the timber floor connections were assessed at this stage.

The walls score 30%NBS(IL2) out-of-plane seismic parts loading. We note that if these walls were restrained at roof level and level 10, they would score greater than 67%NBS (IL2).

Refer to **Figure 5-12** that shows the RC shear wall stress distribution based on out-of-plane seismic parts loading.
