HUP2-T0-Seismic Assessments

144 Daniell Street - DANH– Detailed Seismic Assessment

Wellington City Council

Reference 525885

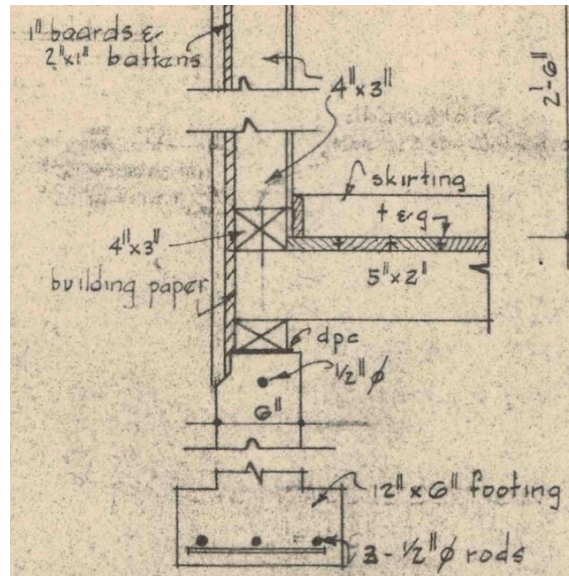
Figure 1-7. Typical Strip Footing Detail

The building is supported by RC strip footings at internal 300x300 piers. The strip footings vary in width from 150–190mm. The foundations are reinforced with a single layer of bottom reinforcement, no top steel or steel stirrups have been placed in the strip footings. The strip footings serve to distribute gravity and vertical seismic forces to the soil below.
