HUP2-T0-Seismic Assessments

WCC Housing Detailed Seismic Assessments

146 Daniell Street – DANI– Detailed Seismic Assessment

Wellington City Council

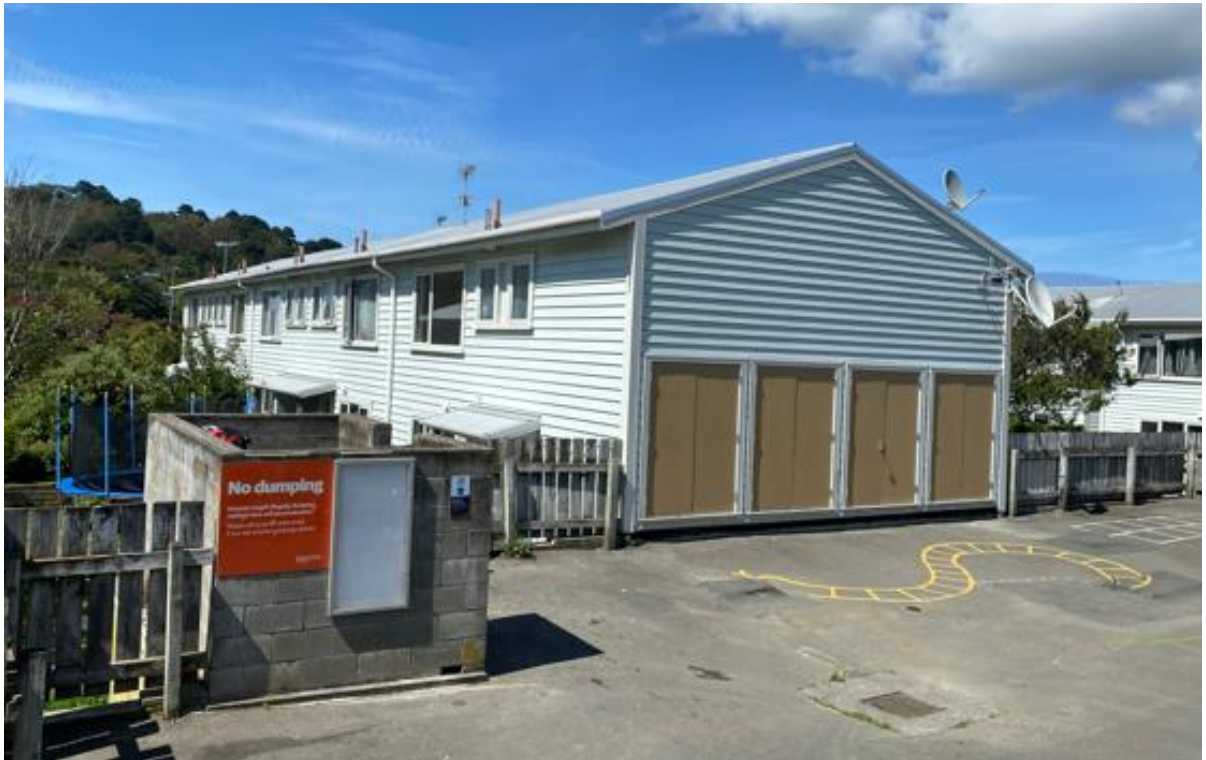
Figure 1-2. Photo of the Building

This DSA report is for the **146 Daniell Street - DANI** (Building I). Figure 1-2 shows a photo of the building.

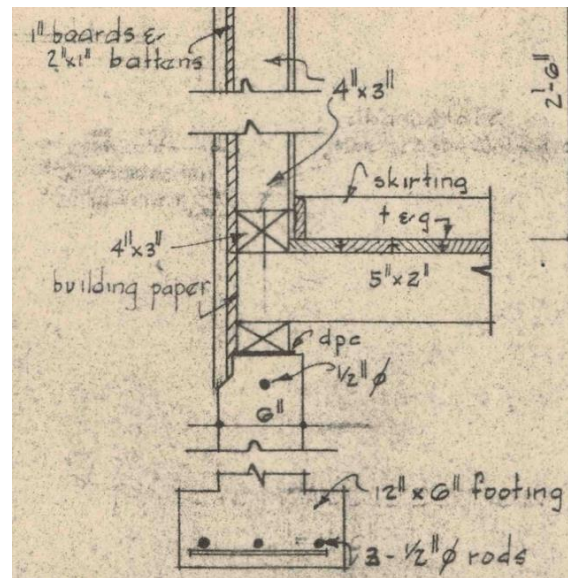
Figure 1-7. Typical Strip Footing Detail

The building is supported by RC strip footings at internal 300x300 piers. The strip footings vary in width from 150–190mm. The foundations are reinforced with a single layer of bottom reinforcement, no top steel or steel stirrups have been placed in the strip footings. The strip footings serve to distribute gravity and vertical seismic forces to the soil below.
