WHAA Detailed Seismic Assessment

16 Glenmore Street

Document Number:
N0541-RBG-WHA-XX-RP-ST-00001

Prepared for Wellington City Council

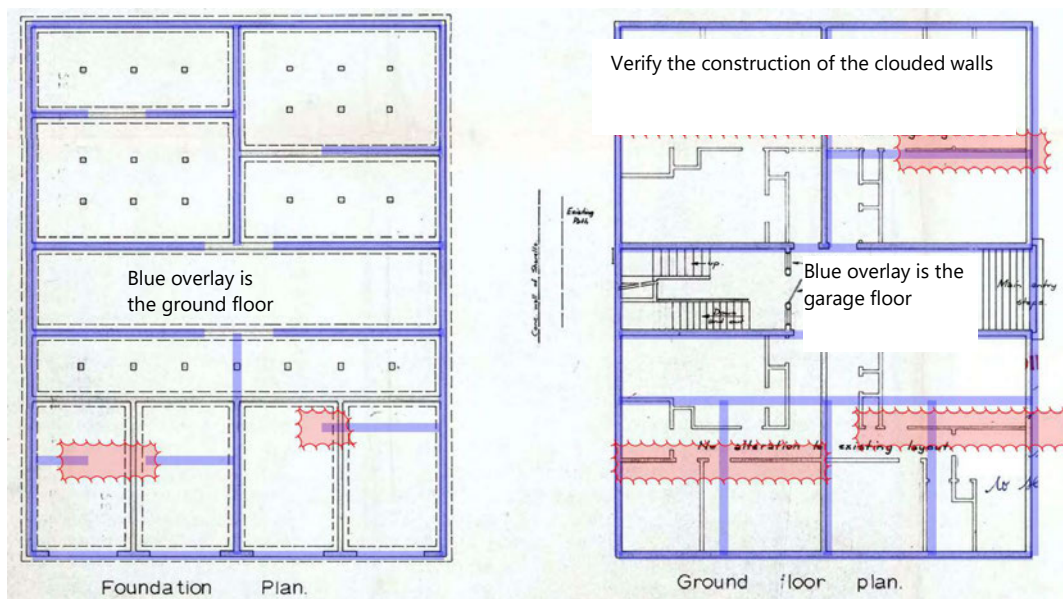
Figure 3: Extent of uncertainty

There are some ambiguities in the 1950 and 1975 drawings about the detailed setting out of the concrete walls inside the units. An overlay of the floor plans from the 1974 set shows unusual small offsets, and some walls with no apparent support. (The garage and first floor are each shown in blue below). For the purposes of this assessment all these walls are assumed to exist. Those walls provide lateral support, so if they are absent the loads will be higher in the remaining elements. A detailed site measure of the interior of the units will be needed to confirm the setting out of these walls.

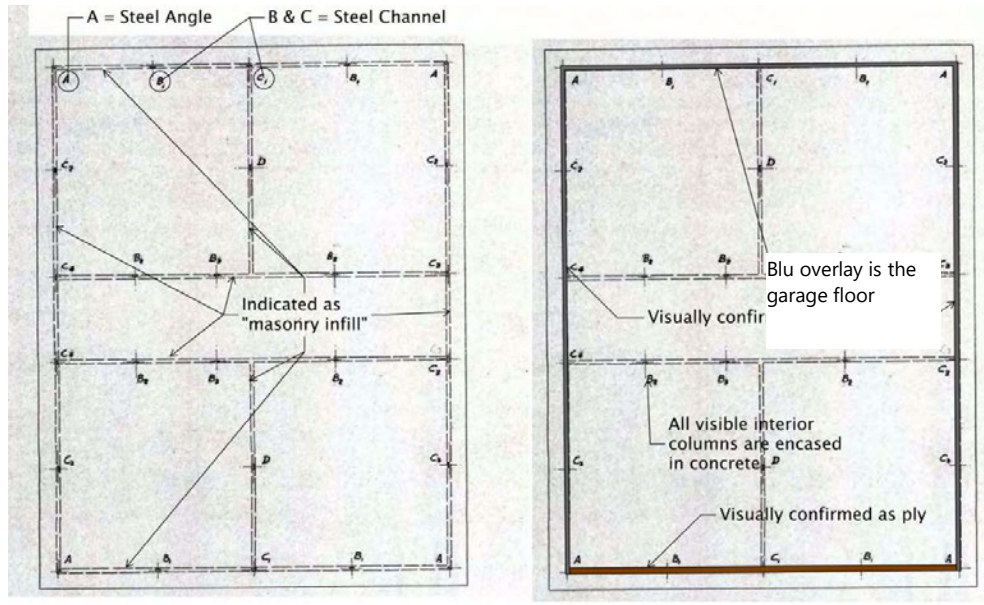
Figure 4: Extent of uncertainty

The construction of the "second floor support structure" is unclear, as conflicting information is shown in different areas of the 1975 drawings, and the 2013 strengthening plan does not show existing structure. The 1975 scheme showed a series of steel posts with masonry infill, but from the accessway into the area a different construction has been observed, as shown below. The detailed construction of the observed concrete elements needs to be confirmed with intrusive investigation. This is shown in more detail in the appendices.

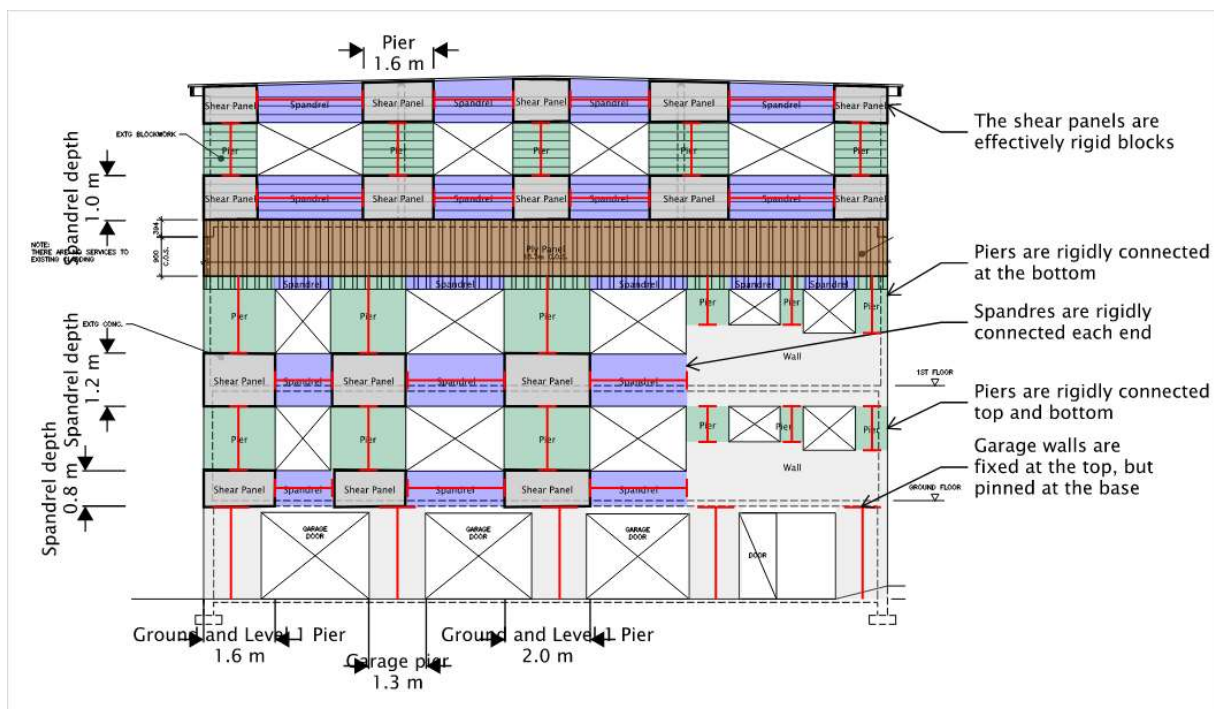
Figure 9: Glenmore Street Elevation Key Features

The analysis shows that the components of the Glenmore Street elevation limit the global capacity of the building. We have summarised the qualitative features of the model in Figure 9 below. The key features of this model are:

- The punched shear walls perform similar to a moment-resisting frame with rigid joints.
- In general the piers are stiffer than the spandrels, which will cause the rotations and damage to be concentrated in the spandrels.
- The shallow foundations don't provide restraint to rotation of the garage walls. They will pivot around the base. Typically free-standing walls cantilever from their base, but in effect these cantilever from the rigid structure above.
- The concrete floors will enforce deflection compatibility between adjacent piers at each level. This means the shorter (vertically) piers will experience relatively higher damage because any deflections will be a greater proportion of their length.

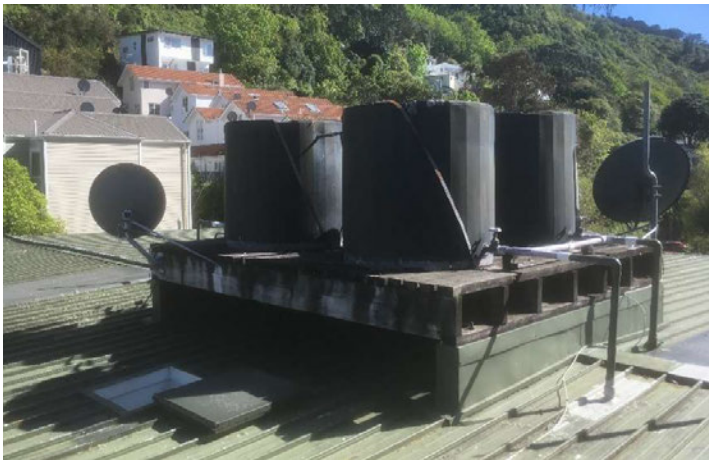
From the photos provided, there is a notional seismic restraint to the tanks on top of the platform, but this is likely to be inadequate for all but the lowest of seismic loads. The bolts connecting the platform to the support walls appear nominal, so the platform could become detached, and the joists for the platform appear to be unrestrained from rotation so can suffer rolling shear failures.

The tanks at roof level are supported on a timber platform with no apparent seismic system.

Sufficient investigation has been conducted to confirm that the existing tanks are inadequately supported and restrained.

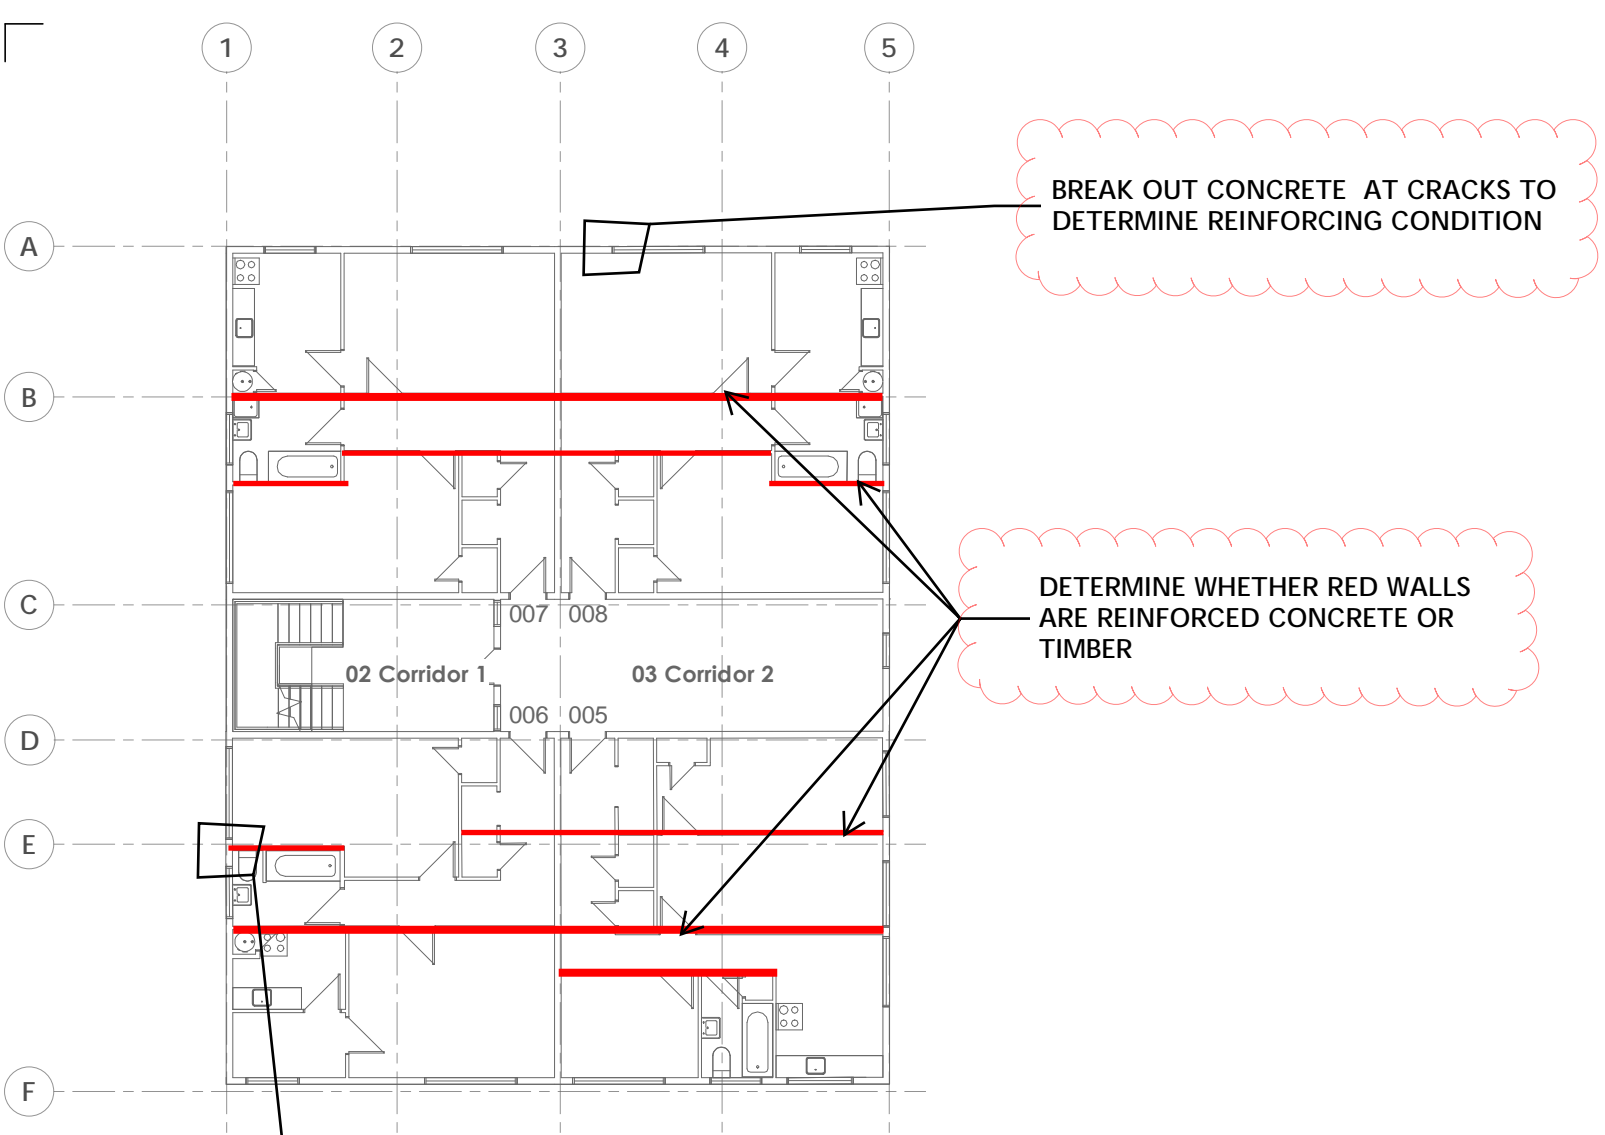
FIRST FLOOR

Cracks have been observed in the exterior of the building. The location of the cracks does not correspond well with cracking that might arise from previous earthquakes, so we infer that these cracks are due to corrosion of the steel. The building has exceeded its notional design life, so it is possible for corrosion to have happened. This can only be determined by further investigation, including breaking out areas with large cracks to examine the steel directly. Refer to annotations in Inspection Photographs.

BREAK OUT CONCRETE AT CRACKS TO DETERMINE REINFORCING CONDITION
