T&T Ref: 85581  
05 October 2012

Wellington City Council  
101 Wakefield Street  
Wellington

## 8-28 Jaunpur Crescent, Broadmeadows - Geotechnical Assessment and Peer Review

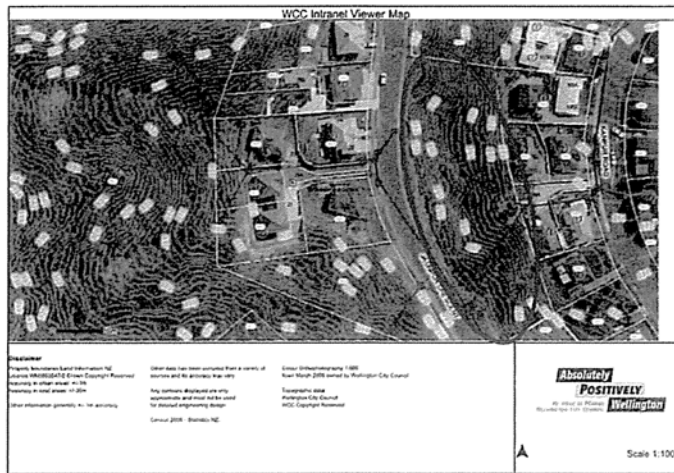
Figure 1 Site Location (taken from WCC City View Website)

The site is located on an east facing slope beside Jaunpur Crescent. The slope is approximately 20m high and has an average slope angle of approximately 30°. The site is circled in red on Figure 1 below.
