# Landscape Features Inventory

## Truby King Park

<b>Truby King Landscape Features</b> <b>120 DUNCAN TERRACE, MELROSE</b> <b>Heritage Inventory Report</b>	
Prepared by	The Heritage Practice Limited 0211396662 <a href="mailto:moira@theheritagepractice.co.nz">moira@theheritagepractice.co.nz</a>
Author(s)	Lianne Cox and Moira Smith
THP reference	116
Date	March 2022
Site visit(s)	2022-05-21 & 2022-05-20
Version	FINAL v1
Reviewed by	Moira Smith, The Heritage Practice
Cover image	Lianne Cox, 2022

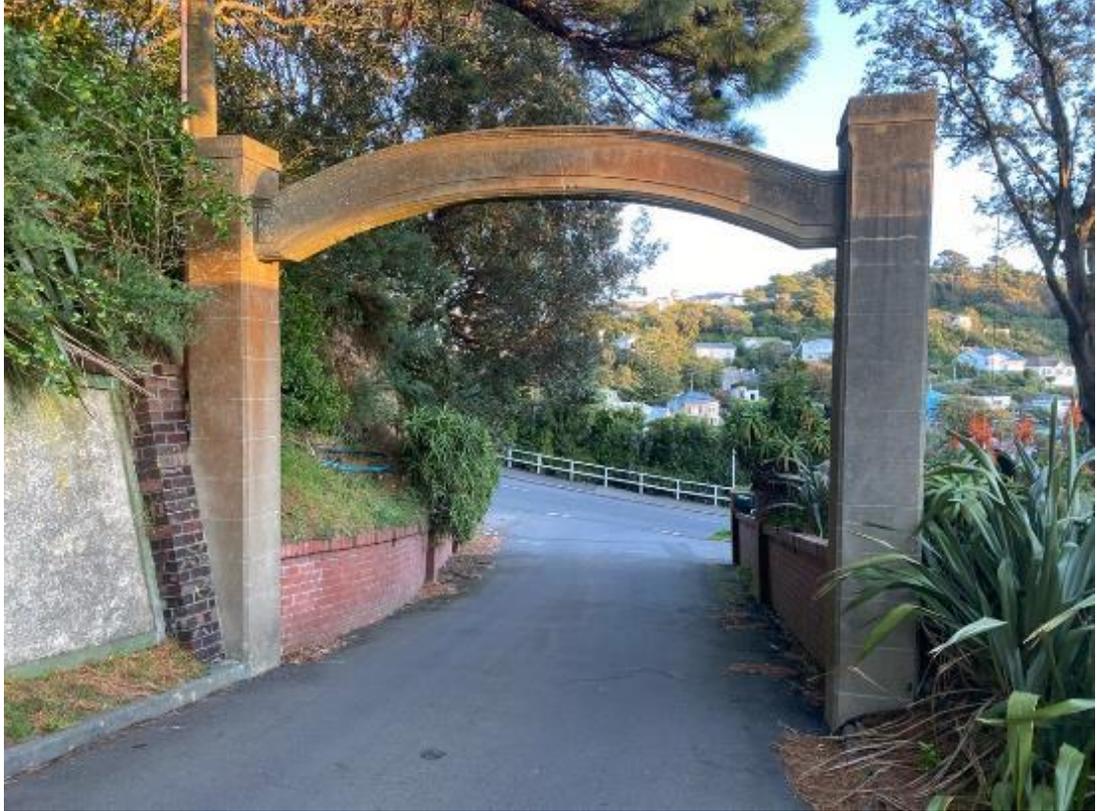
*Figure 3. Entry Arch 'Karitane' looking to Melrose Rd. Note fine detailing to plasterwork to give relief and imitation stone lines on columns.*

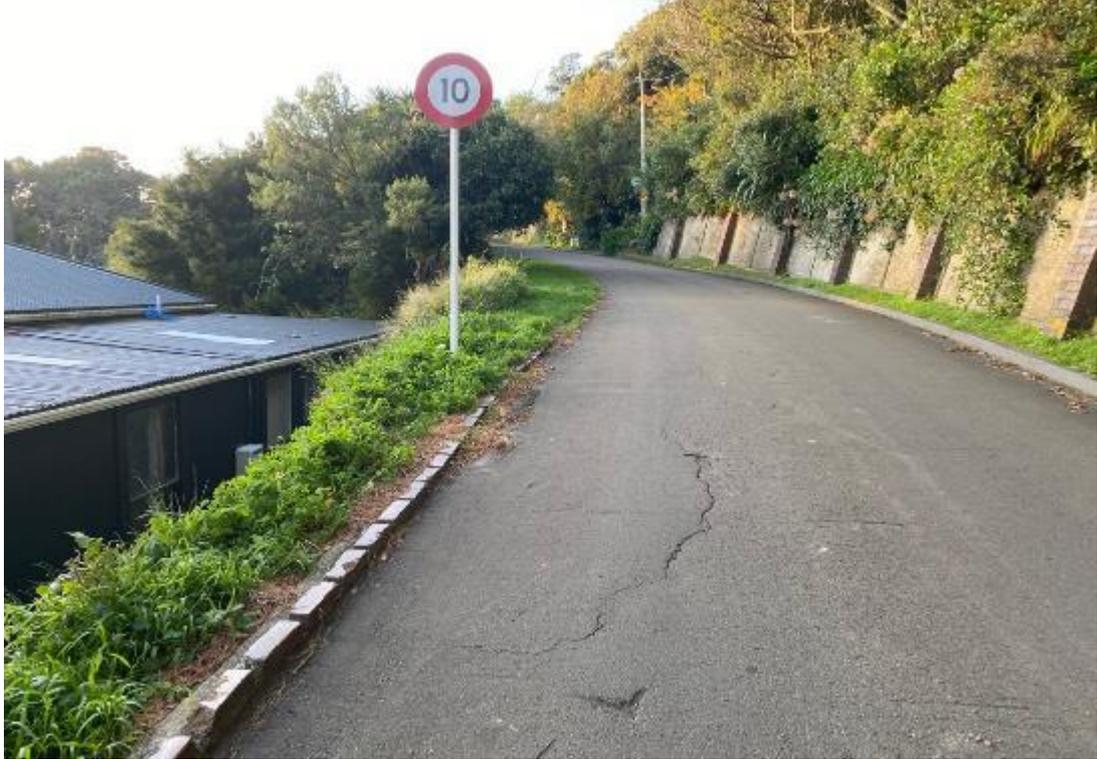
*Figure 4. View north up lower area of driveway. Note brick end-to-end kerb on west (LHS), and concrete kerb with brick/concrete retaining wall to east (RHS).*

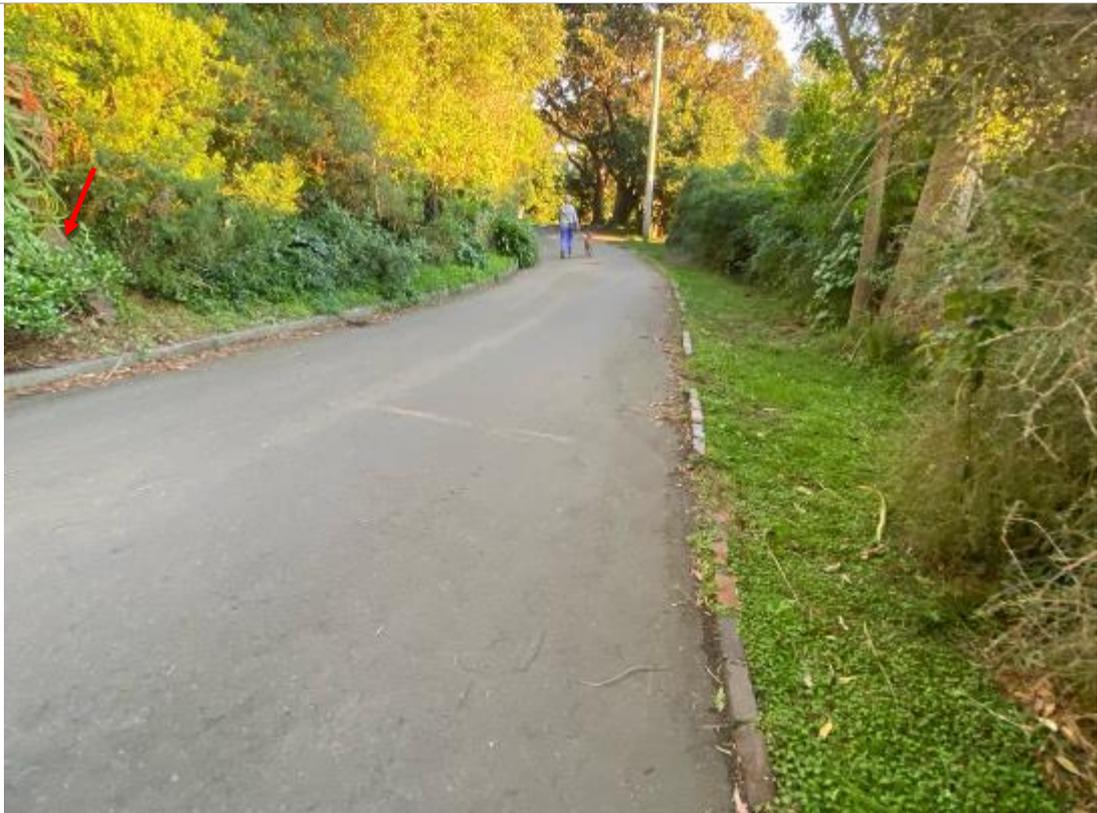
*Figure 5. Looking south, down the first section of driveway. There are occasional pilasters in the undergrowth to the east (LHS).*

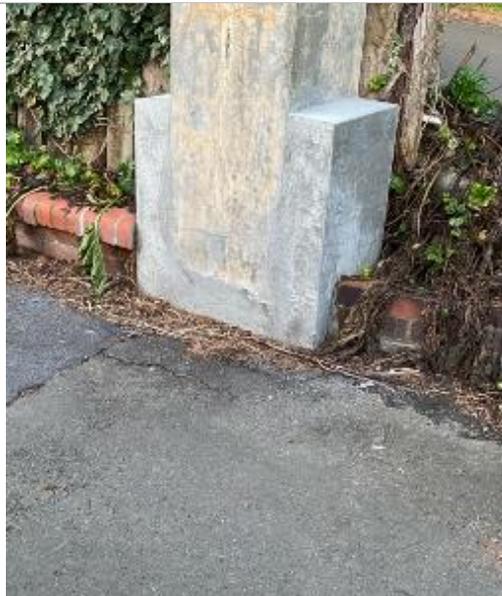
The driveway to the former Karitane Products factory leads off to the west. The entry is marked by a very high plaster finished arch, with 'Karitane Products Society' written on it. The eastern foot of arch appears to have had recent repair work completed. Like the entry arch, there is fine detail in the plaster work and coursing lines on the columns to suggest stone.

*Figure 12. Bottom of 'Karitane Products Society' arch showing recent work, and modern brick garden bed.*

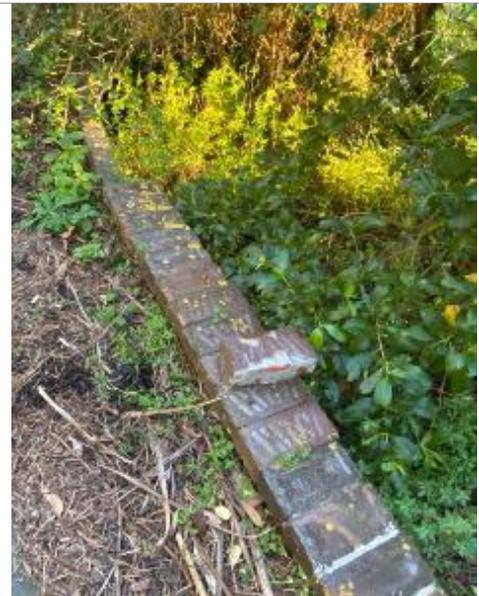
*Figure 13. Side-to-side bricks as a coping - possibly this is a retaining wall rather than a kerb. Note it changes to a kerb in the distance.*

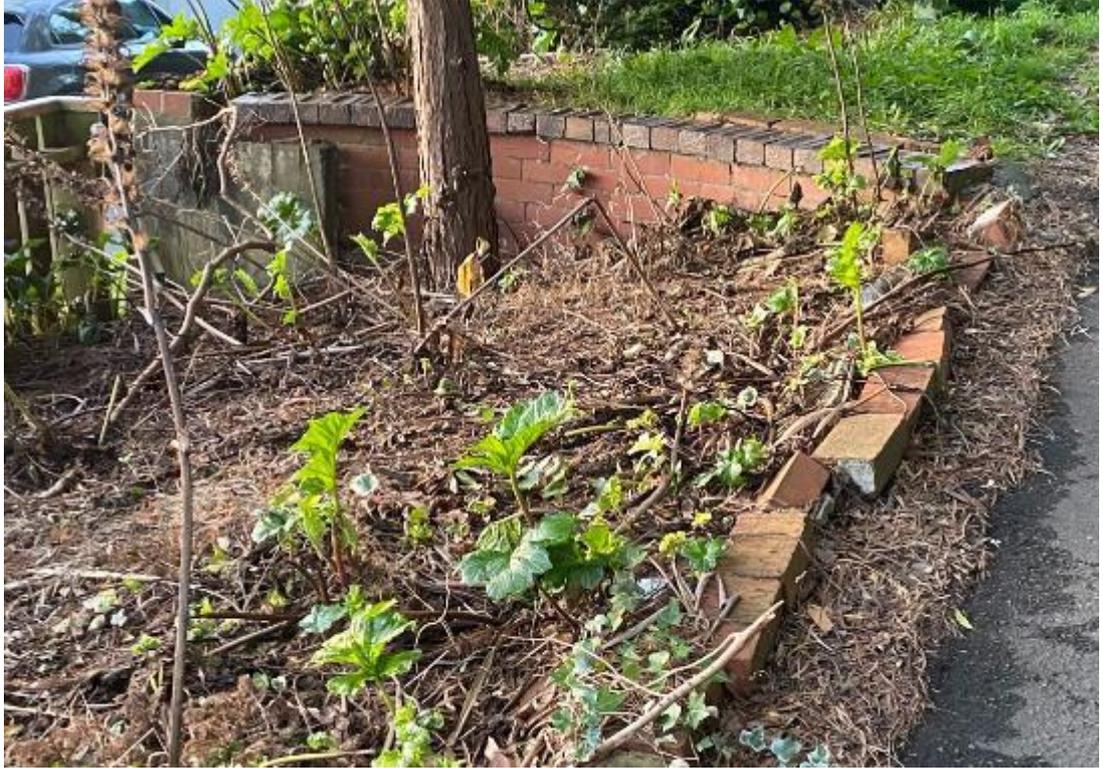
*Figure 14. Retaining wall at west of lower drive forming passing bay? Note difference in brick orientation on coping for retaining wall and kerbing.*

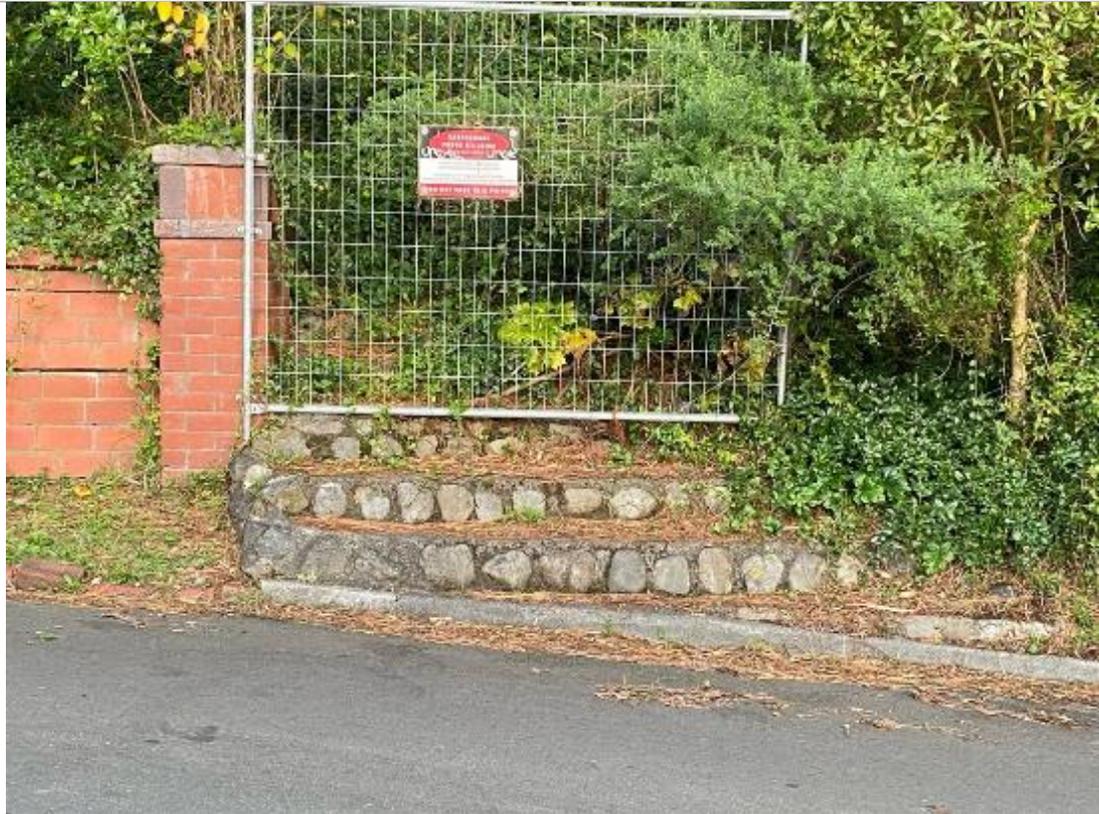
*Figure 15. 'Rock' steps to former site of hospital. Note no retaining wall to south (RHS). Brick kerb at north changes to concrete kerb.*

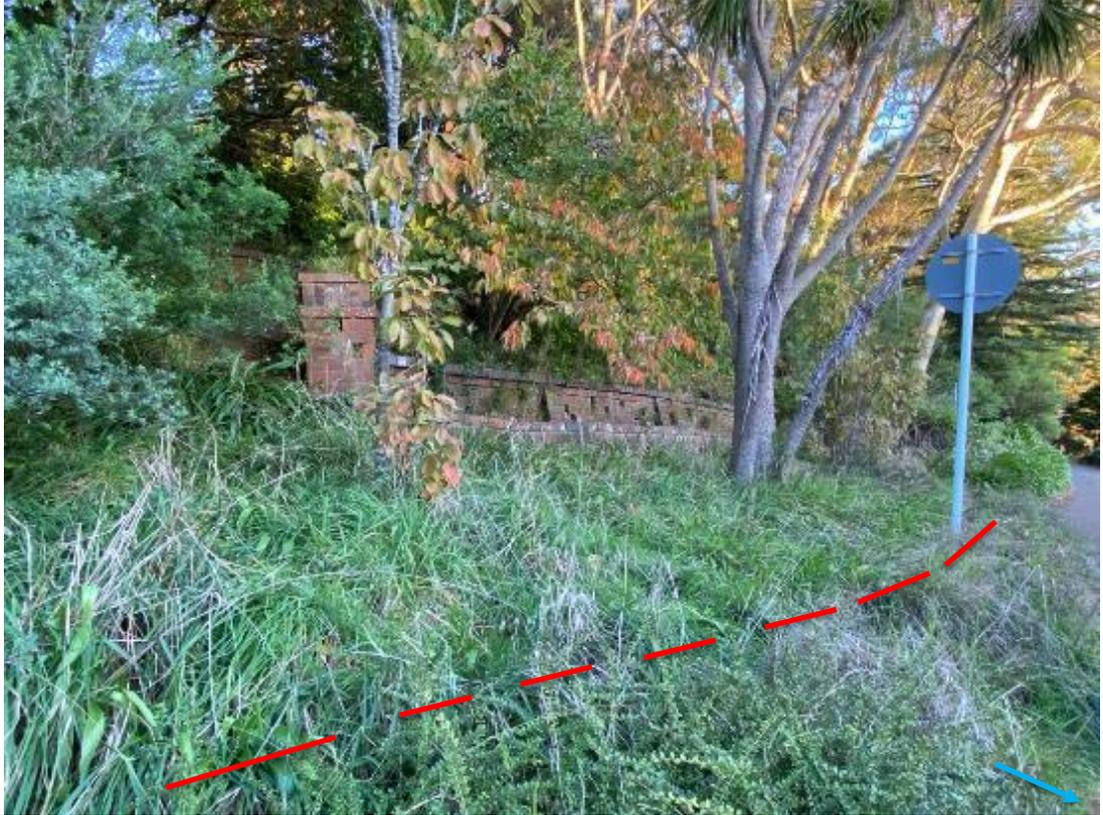
Figure 17. View of path from middle driveway. Pillar is at first zig-zag where path turns back to the south (to the right). Note that there is a low retaining wall (red) hidden under vegetation at bottom of picture, and a brick kerb below that (blue).

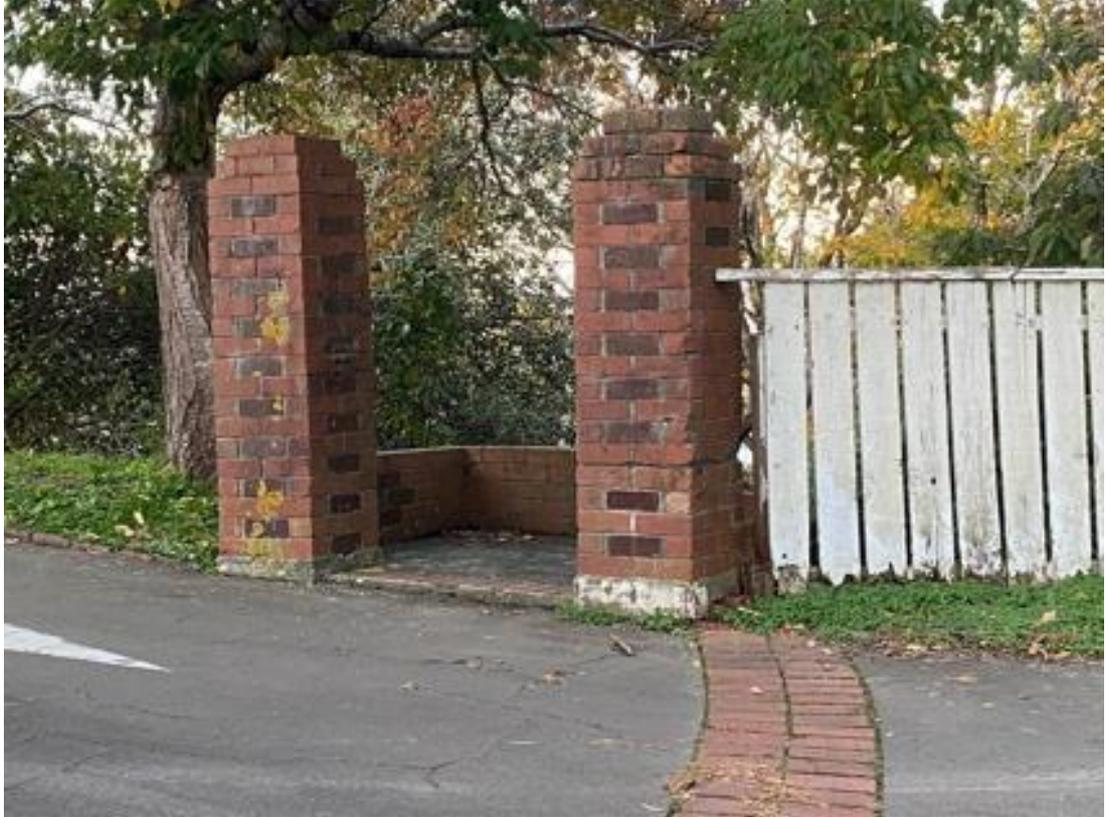
*Figure 28. This pair of columns mark the southern entry to the dell. Note top shaping that is different to that seen in retaining walls. Note brick 'threshold' in asphalt to mark the house grounds extent.*

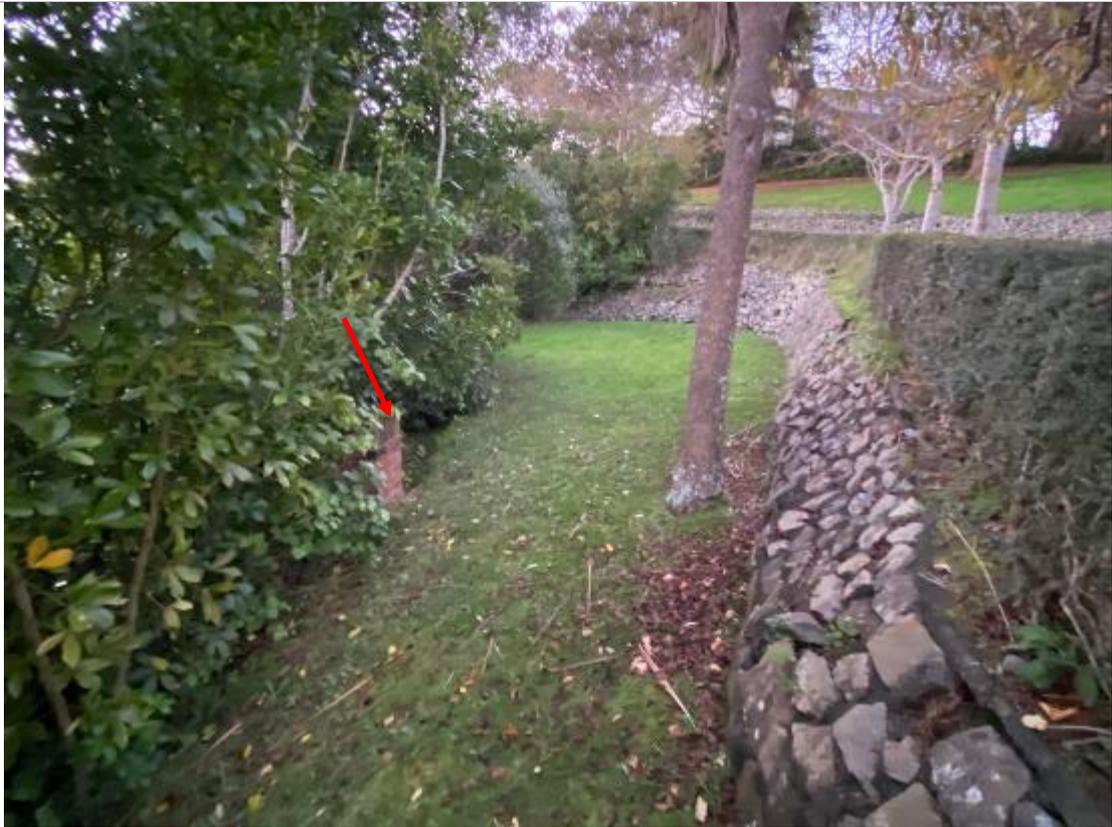
*Figure 33. Looking north along western lower lawn. Note stone retaining wall, and brick pier in undergrowth.*
