Shelly Bay Development

Preliminary Geotechnical Assessment Report

Client: The Wellington Company

19-Jan-2016

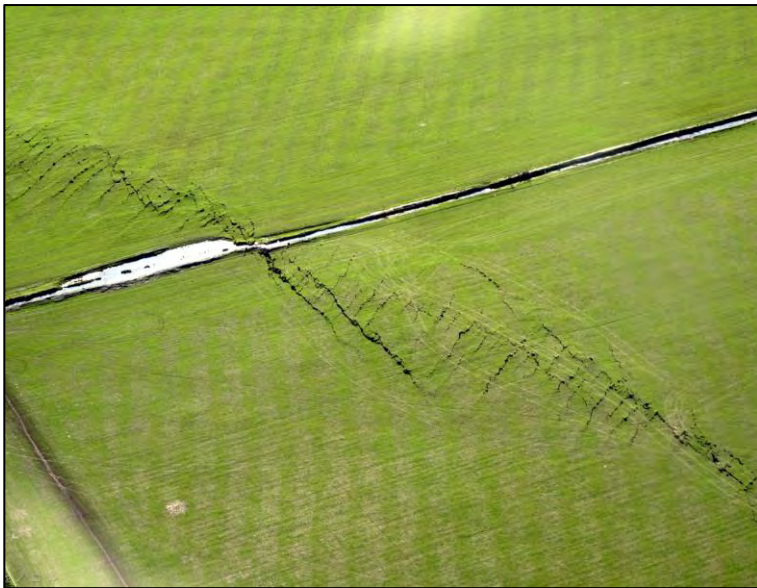
Figure 3 Surface Fault Rupture following 2010 Canterbury Earthquake (Ref. 6)

In sufficiently large or shallow earthquakes, the fault rupture may propagate up to the ground surface. In addition to being strongly shaken, any buildings situated on or near the fault rupture have the potential to suffer substantially more damage or collapse – particularly if the foundations are offset and the building straddles the fault trace. An example of Surface Fault Rupture observed after the 2010 Canterbury Earthquake is shown below in Figure 3.
