Active Fault Mapping and Fault Avoidance Zones for Wellington City

**GNS Science Consultancy Report 2020/57
May 2021**

Morgenstern R, Van Dissen RJ. 2021. Active fault mapping and fault avoidance zones for Wellington City. Lower Hutt (NZ): GNS Science. 94 p. Consultancy Report 2020/57.

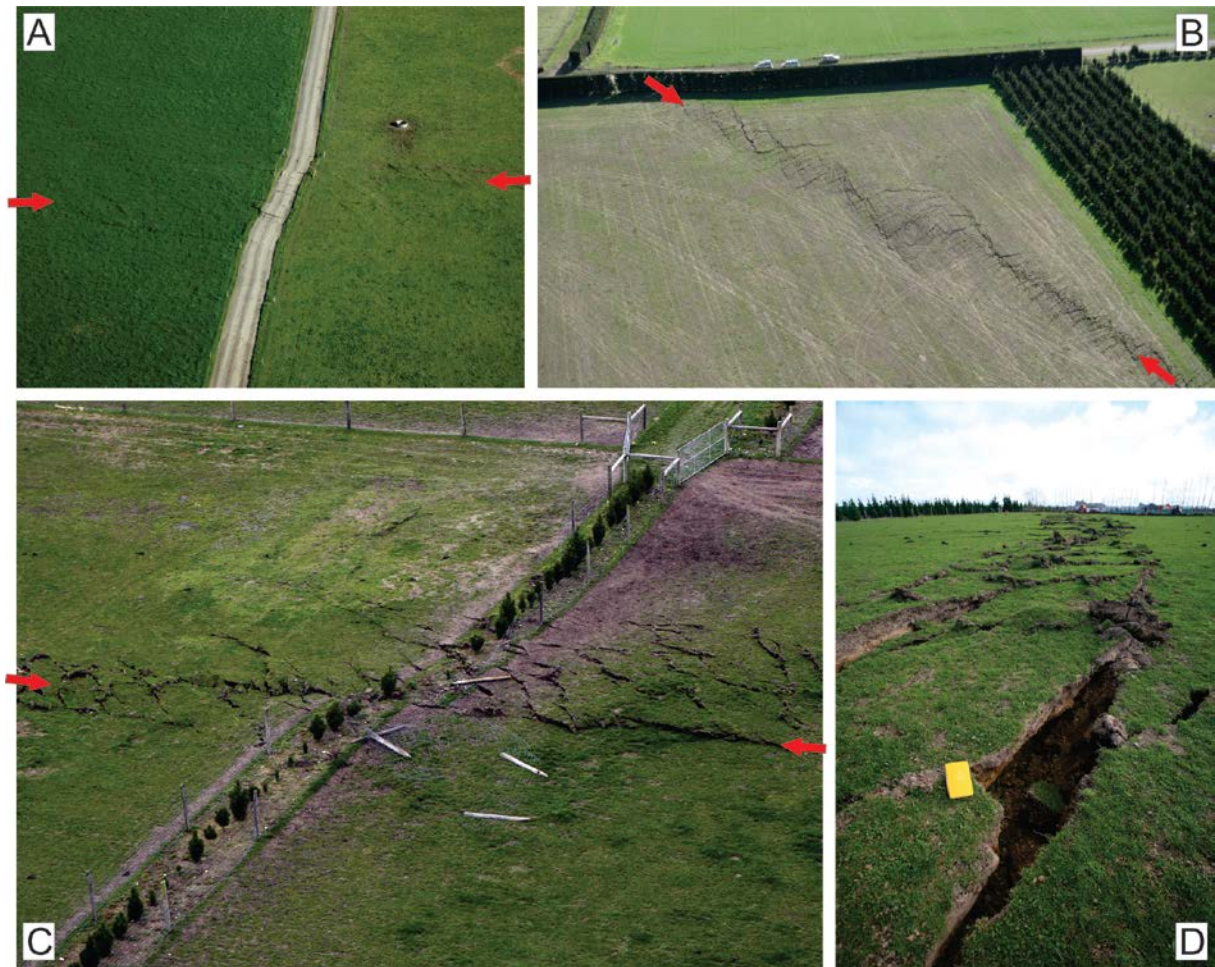
Figure A2.9 Examples of metre-scale dextral strike-slip ground-surface fault rupture along the Greendale Fault, 2010 Darfield earthquake.

The M_w 7.1 Darfield earthquake of 4 September 2010 had a shallow focus (~11 km deep) and an epicentre located within ~40 km west of Christchurch (Figure A2.7). It was a complex event, involving rupture of multiple fault planes with most of the earthquake's moment release resulting from slip on the previously unknown Greendale Fault (Beavan et al. 2010, Gledhill et al. 2010, Holden et al. 2011). Greendale Fault rupture propagated to the ground surface and extended east–west for ~30 km (Quigley et al. 2010, 2012). Surface rupture was mainly dextral strike-slip (Figures A2.7–A2.9).

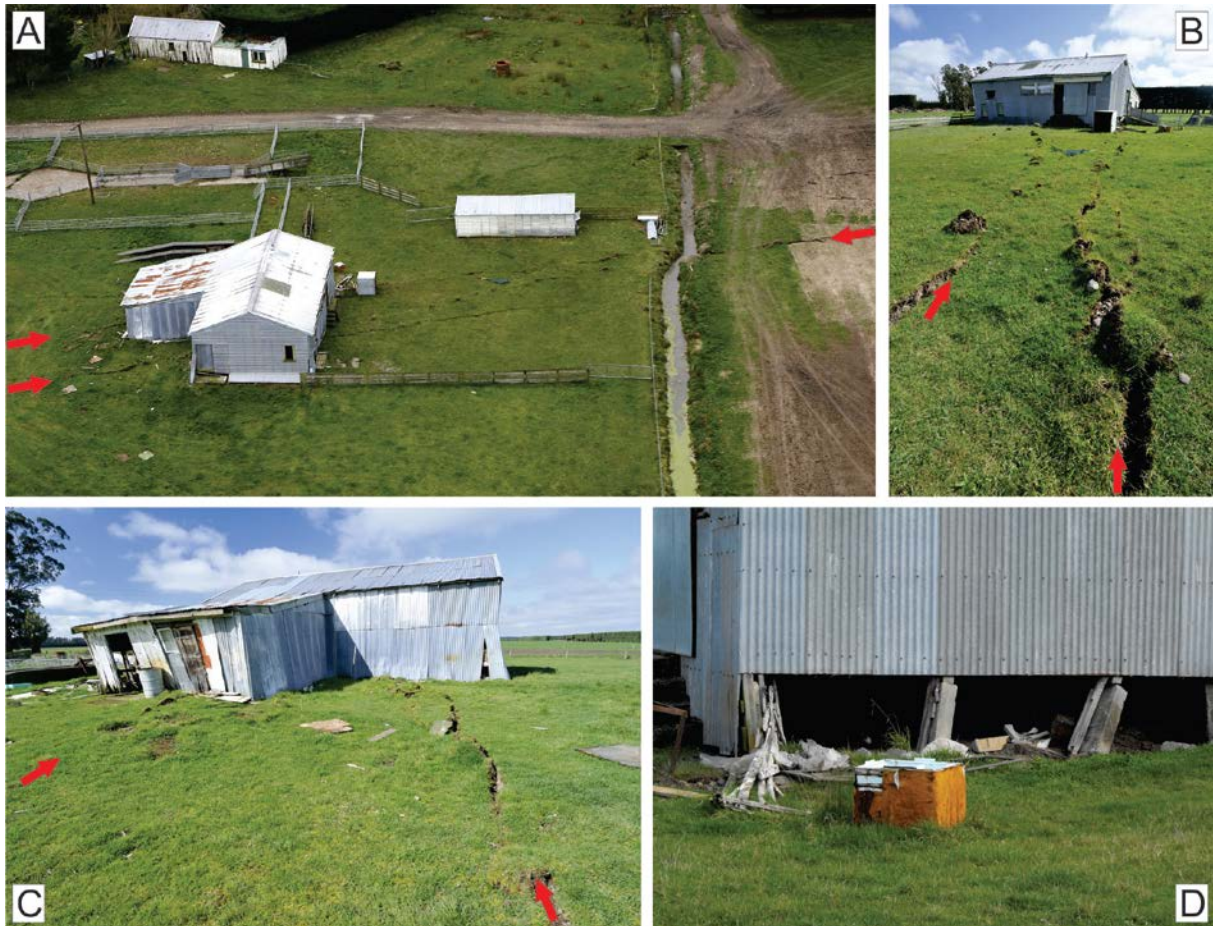
Figure A2.11 Kivers Road woolshed and Greendale Fault surface rupture; see Figures A2.7 and A2.8 for location. Red arrows denote location of discrete surface fault rupture. (A) Aerial view looking northeast – note dextral offset of irrigation channel in right-hand side of photograph. Photo by Richard Cosgrove. (B) View looking west. Photo by Dougal Townsend. (C) View looking east. Photo by Dougal Townsend. (D) View looking southwest showing detail of shallow-seated concrete piles. Photo by Russ Van Dissen.

The Kivers Road woolshed was a timber-framed structure located within a 25–50-m-wide ground-surface fault rupture deformation zone of the Greendale Fault. At this site, surface fault rupture deformation comprised both discrete shears and distributed deformation and accommodated ~2.7 m of net slip (predominantly strike-slip) (Figure A2.11). The woolshed was made up of two parts, a larger metal-clad structure with a timber floor founded on shallow-seated ~700-mm-high concrete piles (Figure A2.11D) and a smaller lean-to structure attached to the side (Figure A2.11A, C). The lean-to was a pole building (part metal-clad and part wood-clad) with an unreinforced concrete floor. The response of the two different construction styles to surface fault rupture was noticeably different. The support poles of the lean-to were set into the ground; dextral fault rupture under the lean-to led to lateral displacement of the support poles on either side of the rupture and significant distortion of the walls and roof (Figure A2.11C). In contrast, surface rupture deformation under the larger piled structure was, in large measure, isolated from the superstructure by rotation of the shallow-seated piles. The timber flooring and framing and metal cladding proved a resilient structural system that limited internal distortion.

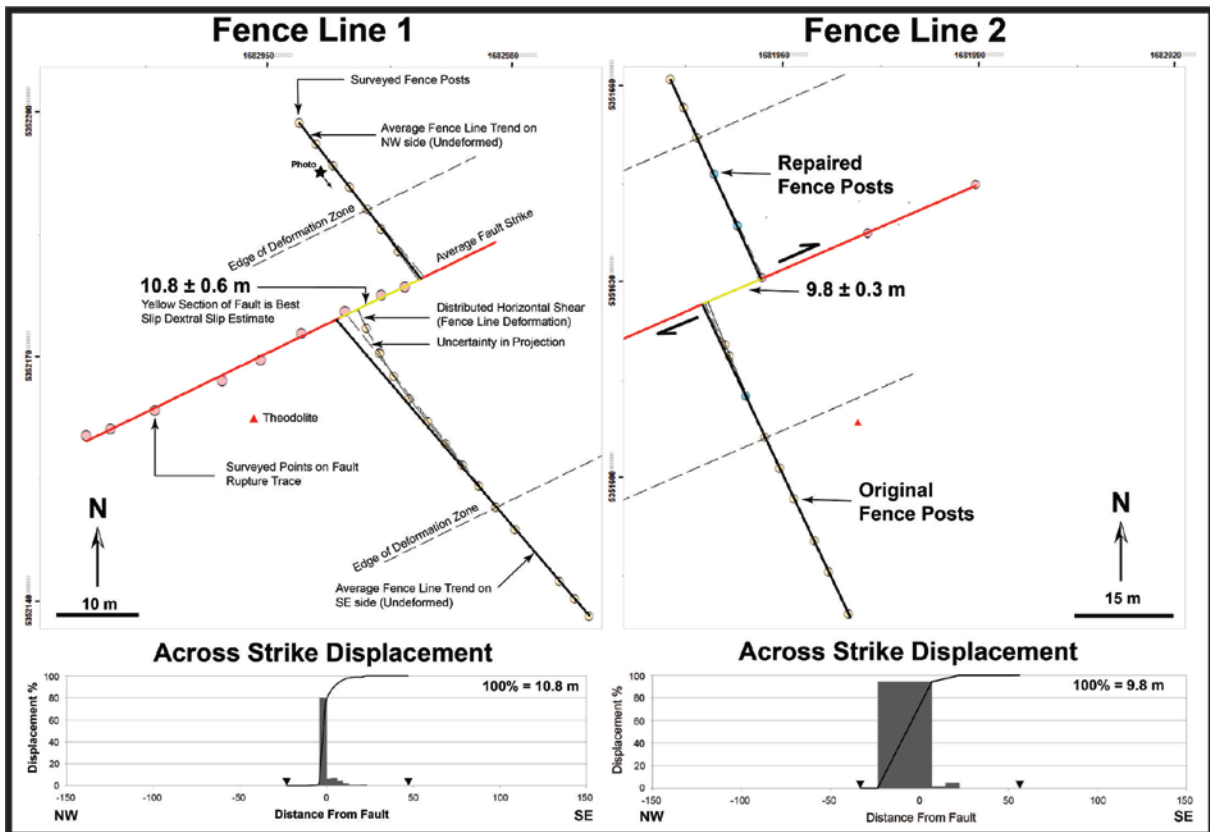
Figure A2.17 Examples of fence line displacements along the Kekerengu Fault near Bluff Cottage that document both the amount of right-lateral displacement and how that displacement is distributed as a function of distance perpendicular to fault strike (see Kearse et al. [2018] for more detail). See Figure A2.15 for locations. Coordinates are New Zealand Transverse Mercator 2000.

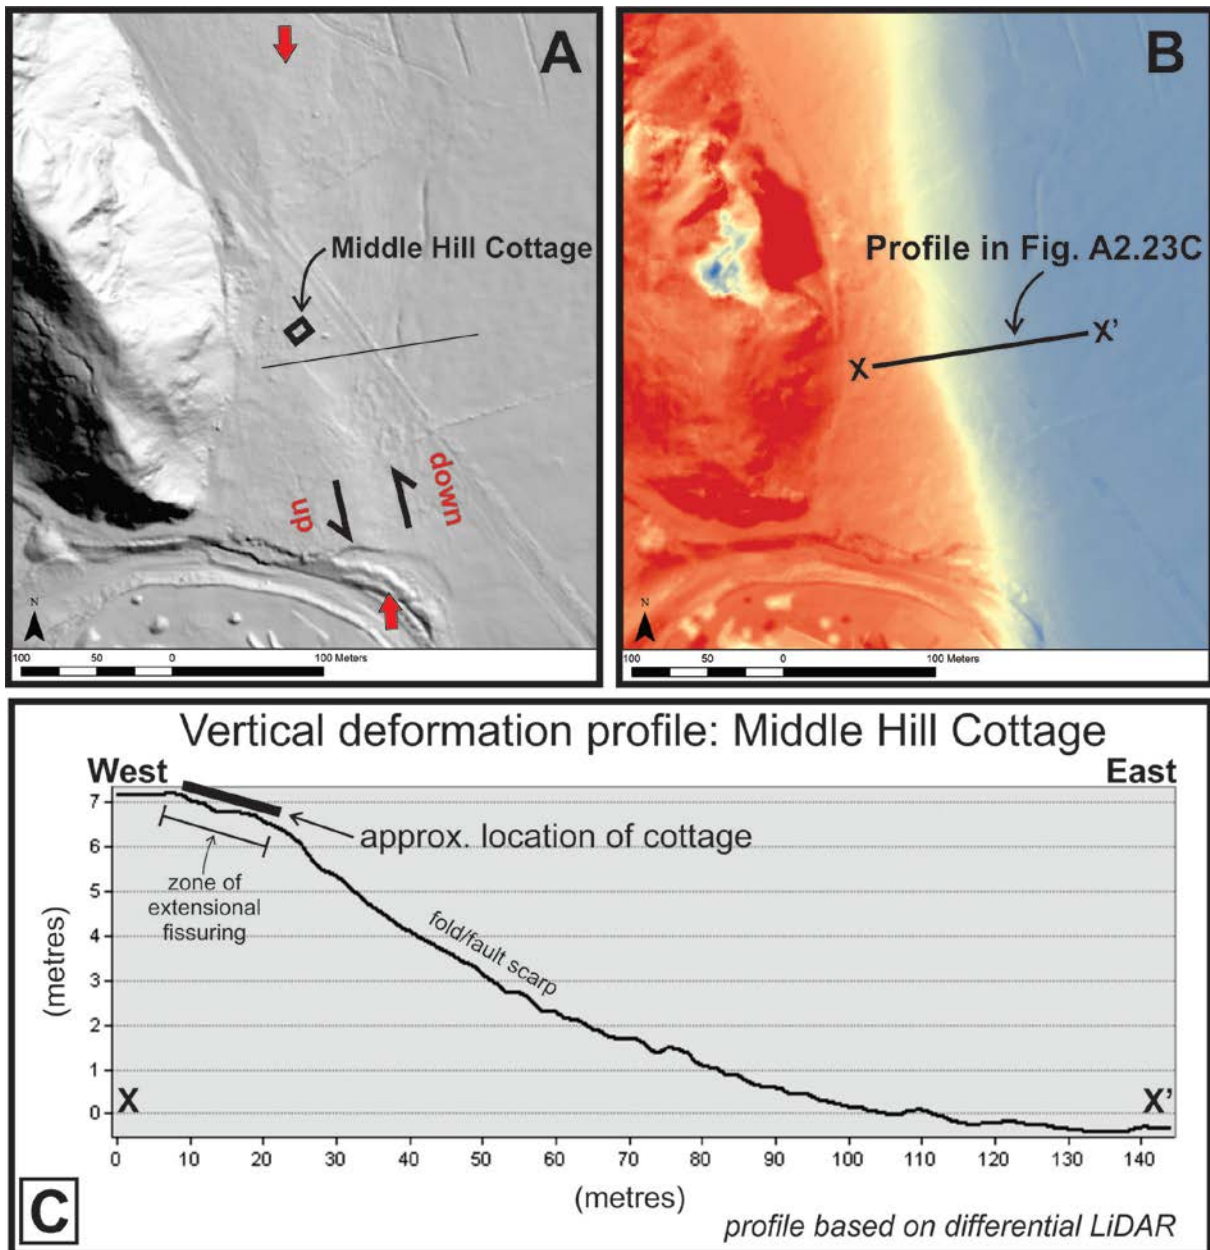
Figure A2.23 Middle Hill Cottage and Papatea Fault surface rupture. (A) 2016 post-earthquake LiDAR hill shade DEM with the black square denoting cottage's location and red arrows showing the location the surface fault rupture scarp. (B) Differential LiDAR DEM with blue colours denoting little vertical change and red colours denoting significant positive vertical change (see C for more detail regarding scale). (C) Vertical deformation profile derived from the differential LiDAR DEM. Vertical exaggeration = 6.1.

Middle Hill cottage was a timber-framed single-storey residential structure with a corrugated metal roof, timber weatherboard cladding and timber pile foundation (Figures A2.14, A2.22 and A2.23). It had a roughly rectangular floor plan with an approximate area of 75 m².
