Beca Geotech Memo

**To:** Jo Lester **Error! Unknown document property name.** **Date:** 28 September 2020  
**From:** Sarah Barrett and Jasmine La **Our Ref:** 3324206  
**Copy:**  
**Subject:** WIAL Master Grading Retaining Wall - Geotechnical Desktop Study (Revised)

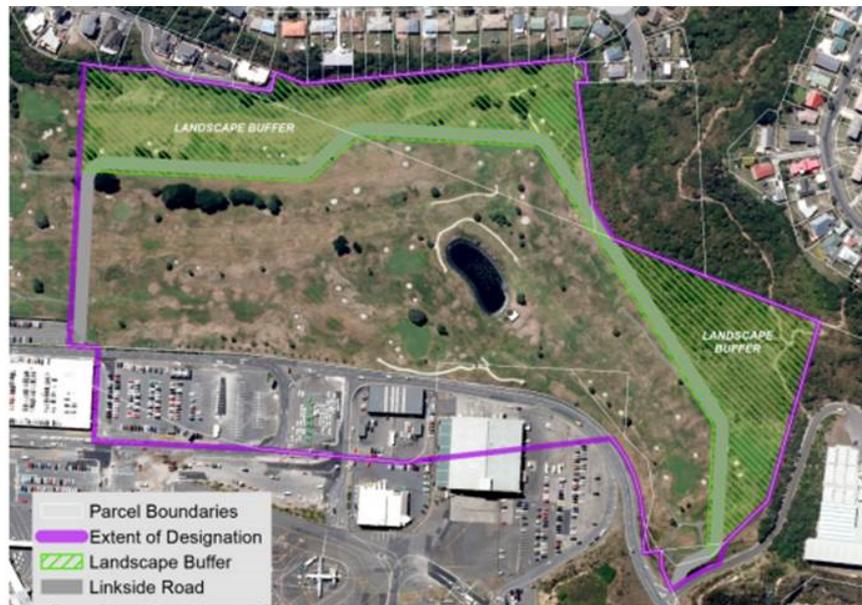
Figure 1: Outline the designation including indicative road alignment allowing for the realignment of Stewart Duff Drive.

Beca has developed a 3D Master Grading Model outlining the geometric design of the proposed layout of the proposed apron expansion. The model enables consideration of geometric requirements for finished surface geometries and outlines the anticipated earthworks depths and volumes including impacts on existing trunk services. The proposed eastern expansion requires a cut-volume of approximately 480,000m<sup>3</sup> to reach the finished surface level with an additional cut to of 110,000m<sup>3</sup> required to reach pavement foundation level. Concept drawings show the expansion extending to the toe of the hillslopes to the south-east of the existing airfield resulting in a 30-metre high cut-slope retained by a concrete retaining wall. The area of the designation, including indicative road alignment allowing for the realignment of Stewart Duff Drive is shown in Figure 1.

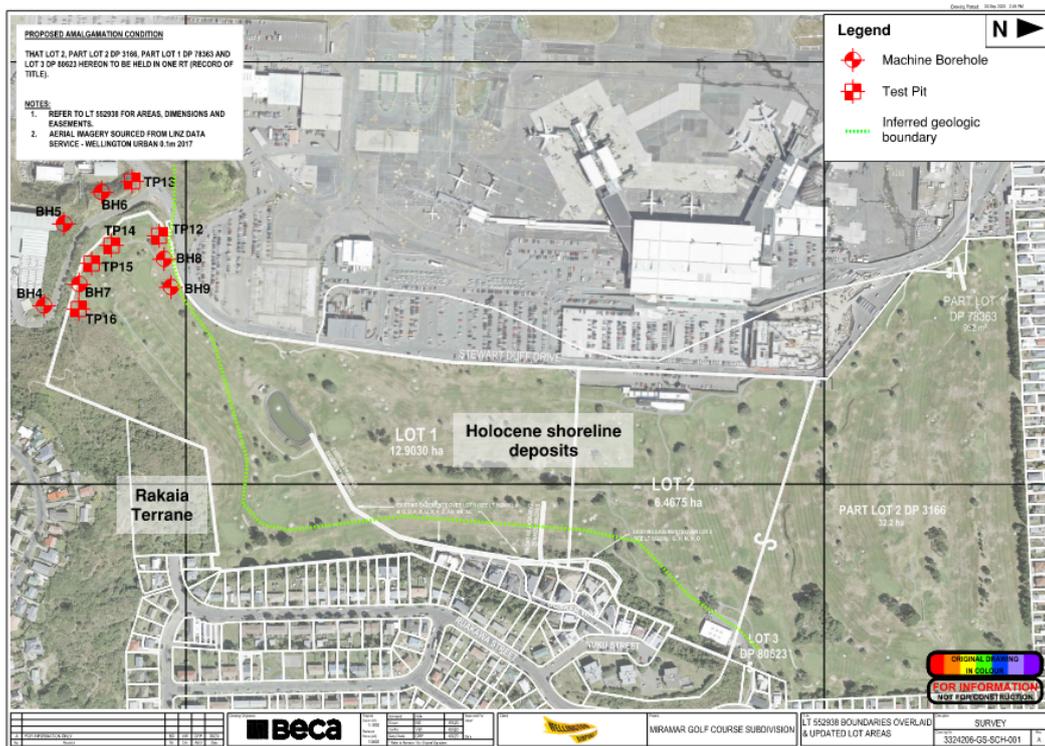
Figure 2: Alignment of proposed retaining wall shown in relation to mapped geologic units and previous geotechnical investigations.

Beca has been commissioned by Wellington International Airport Ltd (WIAL) to conduct a desk-top study examining potential options for retaining the cut-slope. We understand from the concept drawings that the cut-slope could potentially be up to 30m high, and overall 500m long and consist of three segments: a 80m west-east aligned segment below the Moa Point access road crossing a ~20° northeast facing slope, a 260m southwest-northeast aligned segment along the toe of a northwest facing slope of about 20° to 30°, and a 160m south-north aligned segment. The proposed wall is within the western boundary of Lot 1 and 2, as indicated in Figure 2).

- Testing adjacent to the southern boundary of Lot 1 (BH7, TP15, and TP16; shown in Figure 2) revealed up to 4 m of fill consisting of sand with minor gravel, cobbles, and boulders, overlying up to 5 m of colluvium consisting of dense silty gravel, cobbles and boulders. The deposits are underlain by completely to moderately weathered greywacke at approximately 10 m depth.
- Testing in the golf course land (BH 8-9) indicates the area is underlain by up to 8 m of sand with organics and fine to medium gravel, and colluvium of sandy gravel to gravelly sand. BH08 encountered weathered greywacke at approximately 8m depth; BH09 terminated at 15m depth and did not encounter greywacke.
- Investigations at the south-east corner of Lot 1 (BH6 in Figure 1) revealed 3.0 m of sand underlain by 1.0 m of colluvium and completely to moderately weathered greywacke.

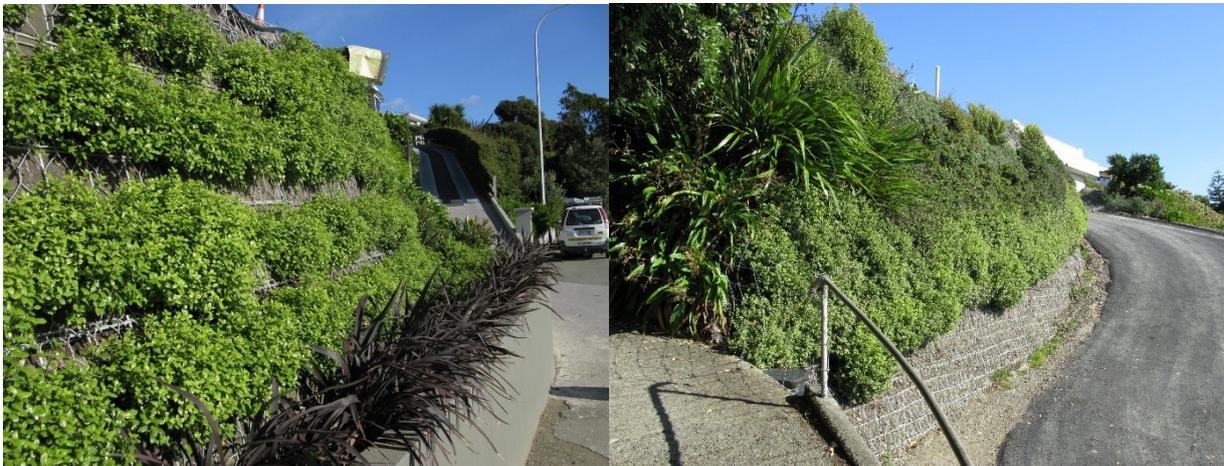
Figure 3: Photographs of “green” MSE walls

Figure 3 includes photographs of an example of a “green” type MSE wall.
