**LANDSCAPE REPORT**  
**55 - 85 CURTIS STREET, KARORI**  
September 2012

PREPARED FOR:  
**WELLINGTON CITY COUNCIL**

**DRAKEFORD WILLIAMS LTD**  
**LANDSCAPE ARCHITECTS**  
REFERENCE 12008W

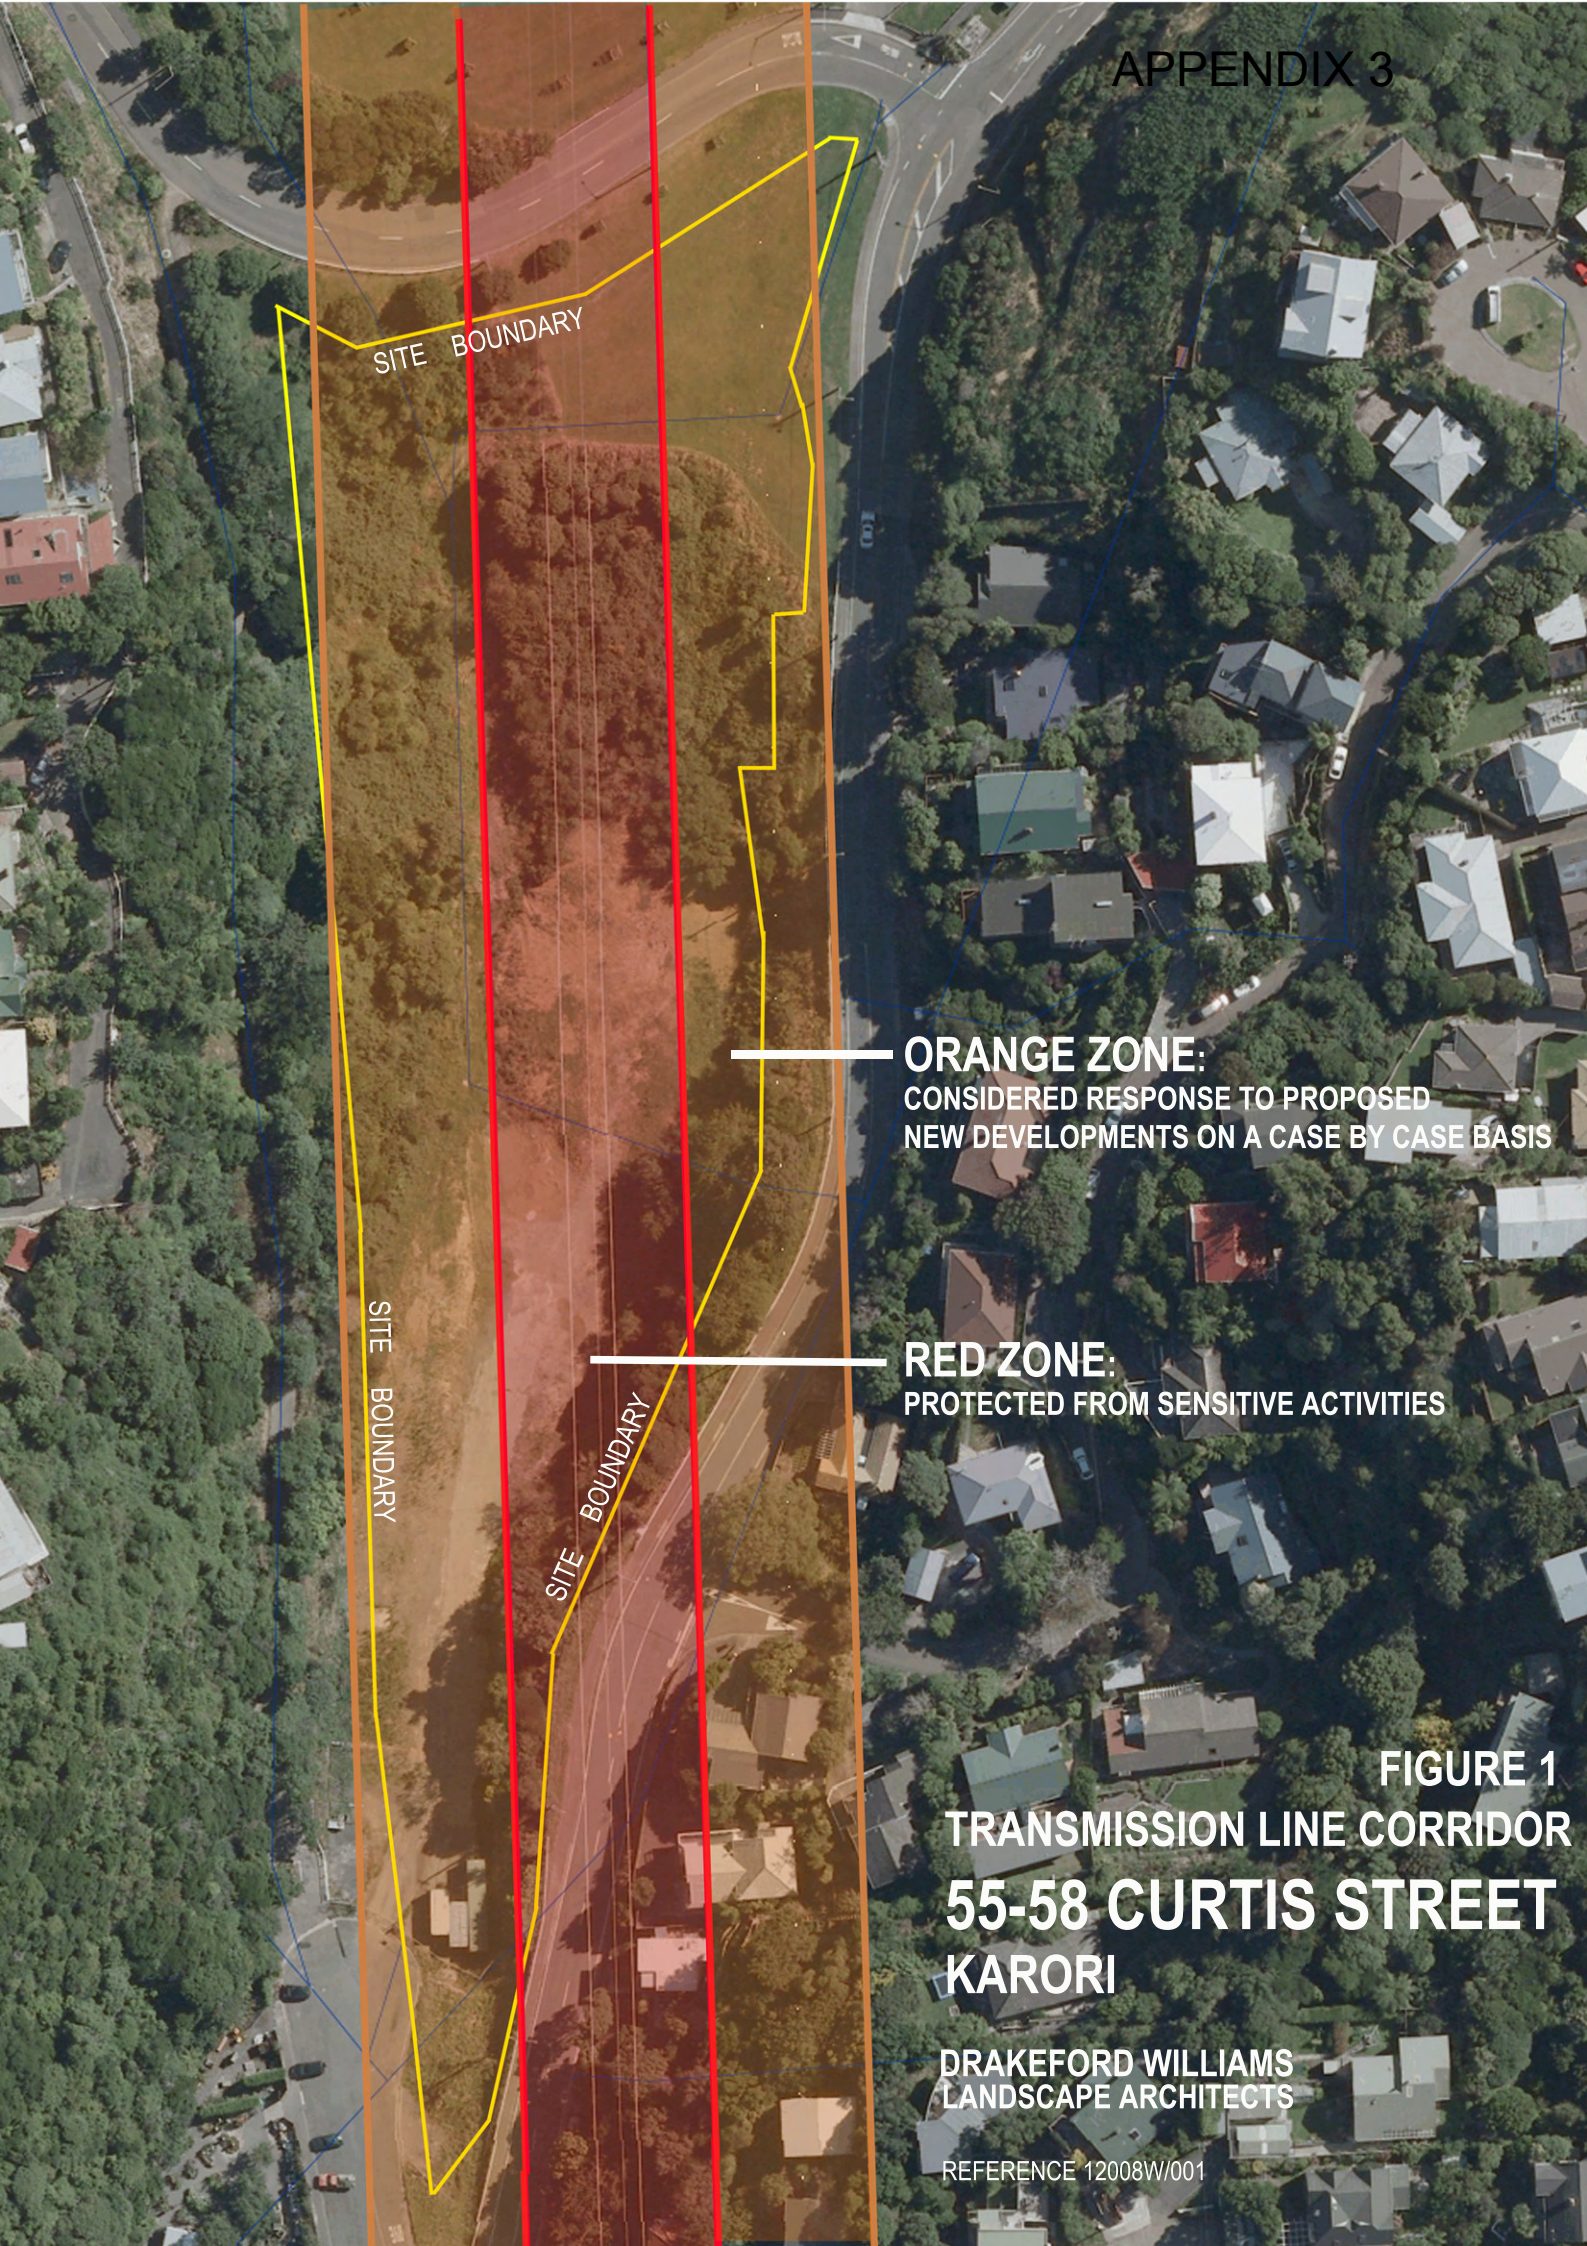
**FIGURE 1**  
**TRANSMISSION LINE CORRIDOR**  
**55-58 CURTIS STREET**  
**KARORI**

**ORANGE ZONE:**  
CONSIDERED RESPONSE TO PROPOSED  
NEW DEVELOPMENTS ON A CASE BY CASE BASIS

**RED ZONE:**  
PROTECTED FROM SENSITIVE ACTIVITIES

With transmission lines, the appropriate zoning for the site is less obvious. National guidelines dictate that the site is unsuited to sensitive activities such as residential development, schools and hospitals, although NPSET allow that a range of land uses can still occur. Transpower remains neutral in principle, although has indicated a preference for built development to avoid a defined *red zone* directly underneath the lines. *Refer Figure 1.*

- Adherence to NPSET guidelines would concentrate built development in the *orange zone* away from the floor of the site and onto the western or eastern boundaries. *Refer Figure 1.*
