Slope Stability Review

Kiwi Point Quarry

Ngauranga Gorge

Wellington

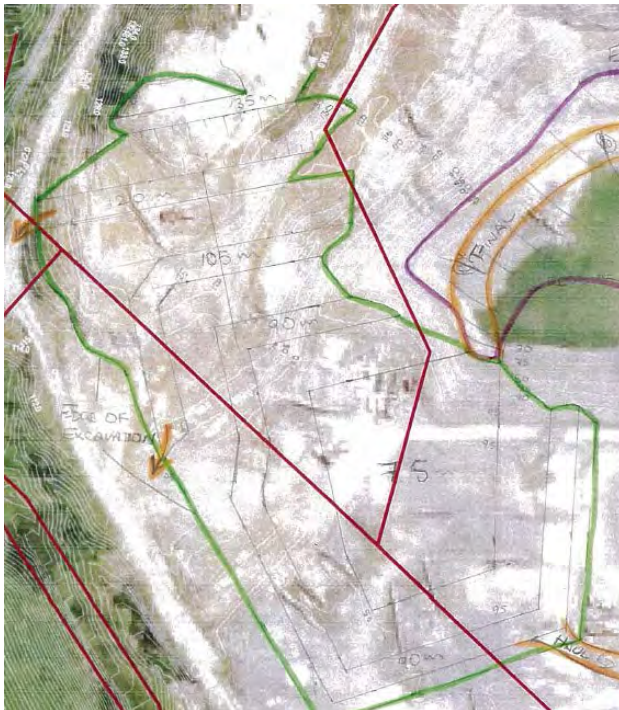
Figure 2: Sketch Plan of Proposed West Wall Batters

It is proposed to extend the West Wall further to the north. The current proposal is to form 15 m high cut batters with a south facing aspect (see proposed sketch plan presented as Figure 2). Defect mapping was undertaken on the West Wall in 2012. During our recent quarry visit on 25 August 2014, additional kinematic data was collected. All the data collected for the West Wall has been analysed using Rocscience Dips. The results of the analysis are discussed in the following section. The Dips outputs are presented in Appendix D.

A slip has occurred recently at the location of the West Wall, which is believed to be activated on a planar discontinuity as a result of steep cut batters and loading of overburden at the slope crest.

The main control on slope instability on the West Wall currently is planar sliding on Joint Set 2, which will occur if batter slopes are cut at an angle of 45° or more with an east facing slope aspect. There is also some risk of toppling failure on bedding planes if the cut slopes are steeper than 30°.

With the proposed south facing slope aspect, wedge failures are likely to occur at cut batters steeper than 45°. As with an east facing slope, there is a risk of toppling failure on bedding planes if the cut slopes are steeper than 30°.
