# CONDITION SURVEY REPORT WELLINGTON CITY COUNCIL

August 2023

THIS REPORT HAS BEEN COMMISSIONED BY WELLINGTON CITY COUNCIL (WCC). THE OBJECTIVE OF THE REPORT IS TO RECORD THE CONDITION OF THE PROPERTY INCLUDING DRAINS AND SERVICES, ASSESSES THE GLAZED CLADDING SYSTEM INSTALLED ON THE GREENHOUSE/CAFÉ, AND IDENTIFY REMEDIAL OPTIONS ALL IN ACCORDANCE WITH THE WCC SCOPE OF WORKS.

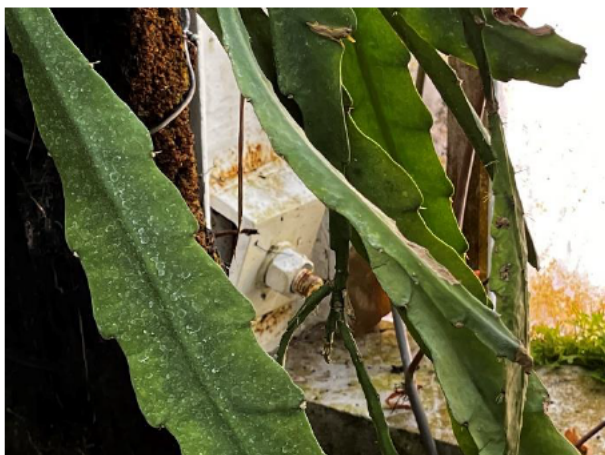
1.3 Example of surface corrosion

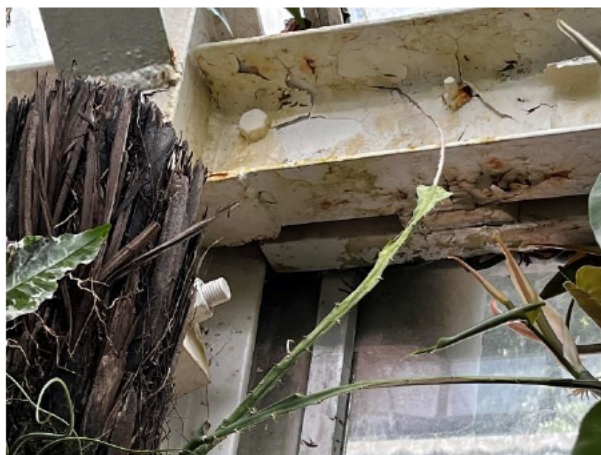
1.4 Corroded beam and damaged painted finish

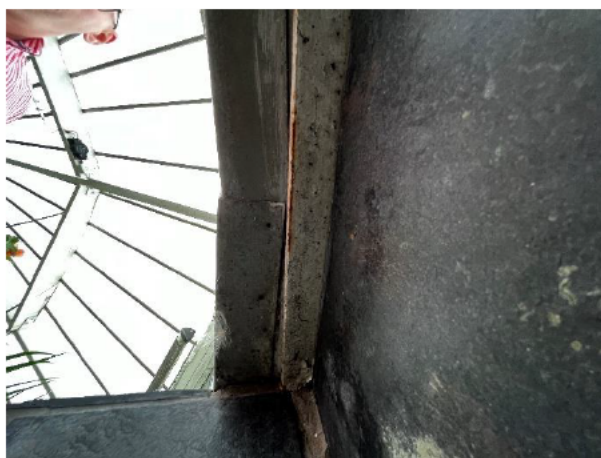
1.10 Isolated surface corrosion on a perimeter beam

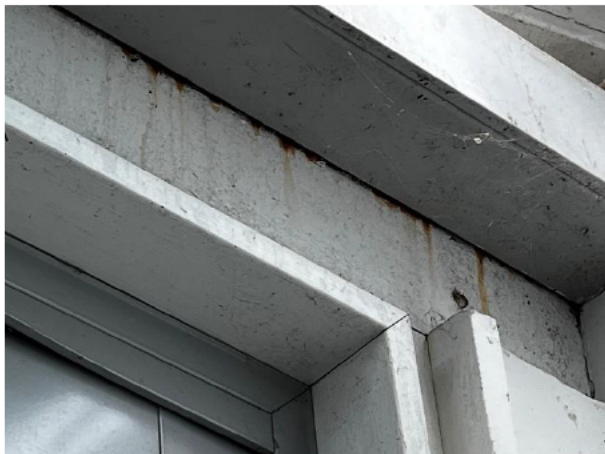
1.11 Corrosion in the lintol above the doors to the central annex back of house

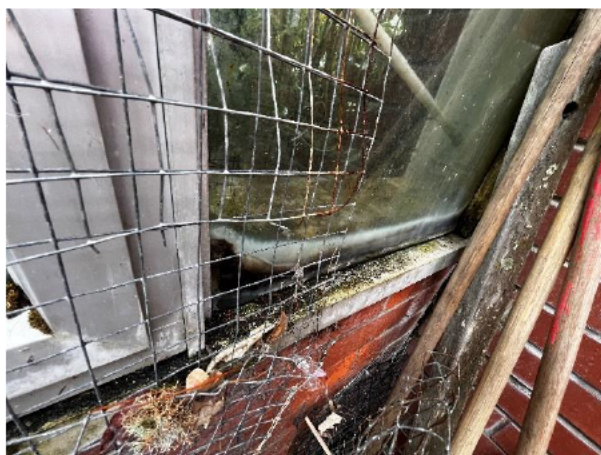
1.14 Surface of the bricks are spalling

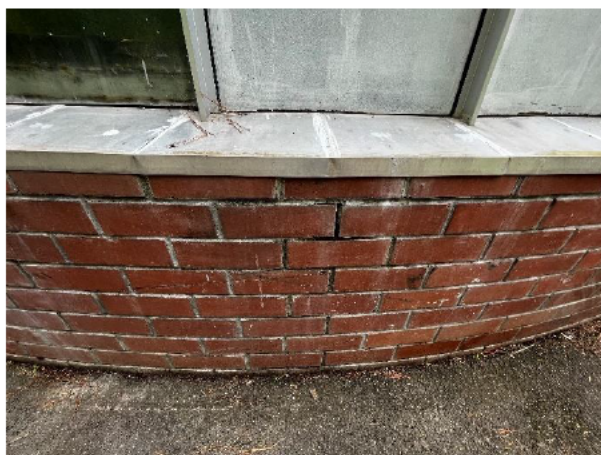
1.16 Cracking in the mortar joints located on the west elevation

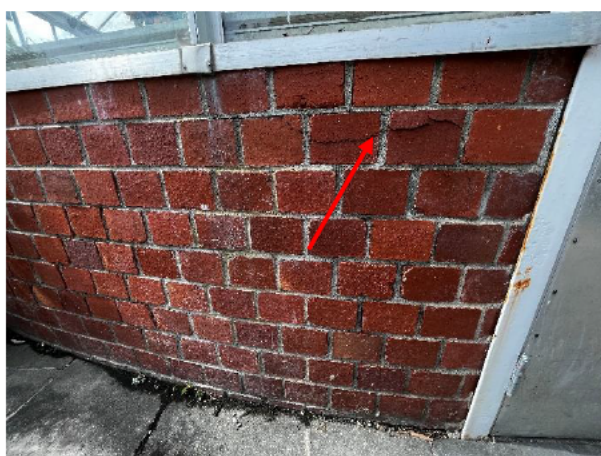
1.18 Damaged bricks located on the west elevation next to the door on the central annex

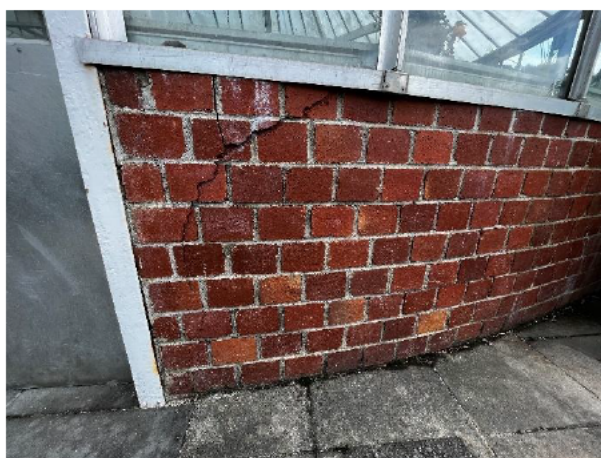
1.22 Close up view of the cracked veneer

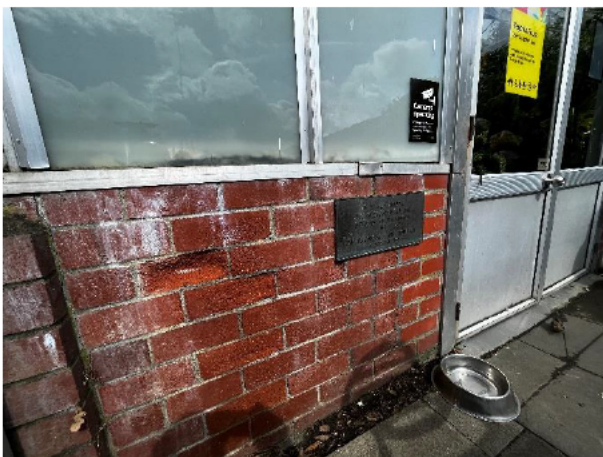
1.25 Spalled and degraded bricks to the door panel of the east annex note that the plaque states that the tea house was constructed circa 1981 and the joinery is therefore at end of life.

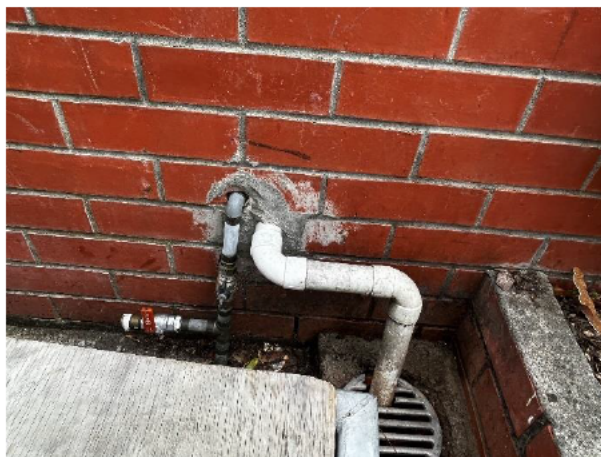
1.26 Example of unsealed penetrations through the veneer

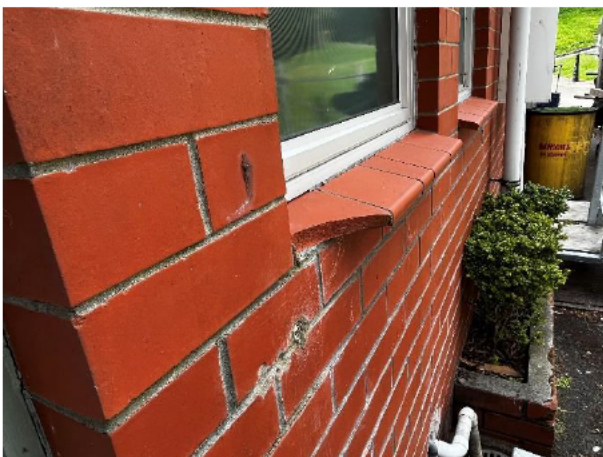
1.27 Damaged sill and unsealed penetration

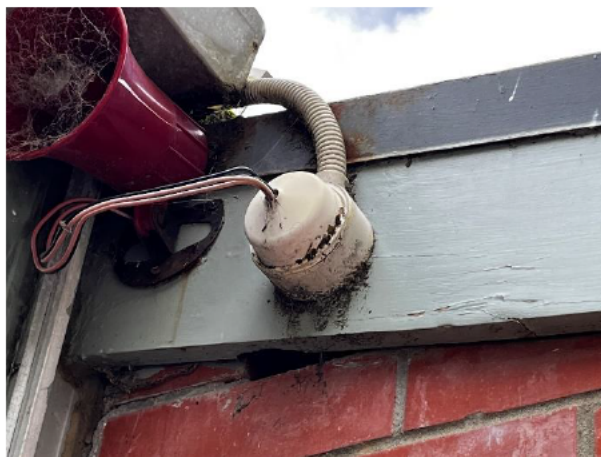
1.28 Gap between the barge and wall veneer creating a vermin access point

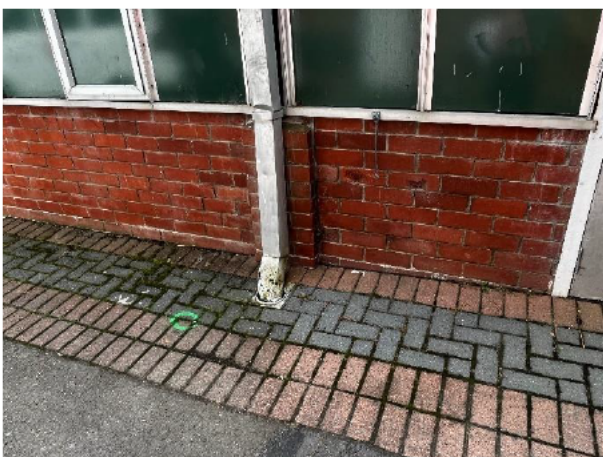
1.29 Spalled bricks in the rear wall veneer

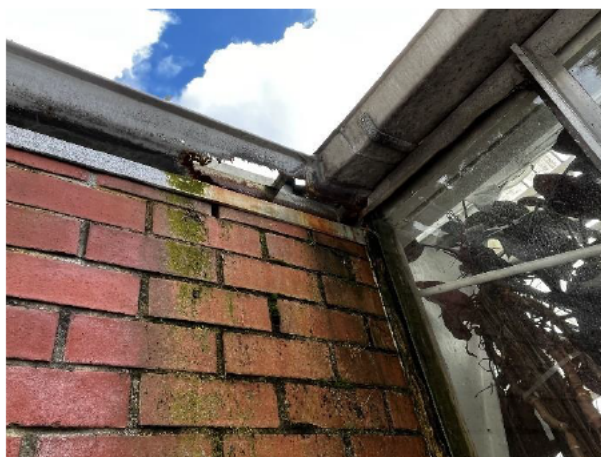
1.30 Gap between the link wall and glass house creating a water access route into the wall frame.

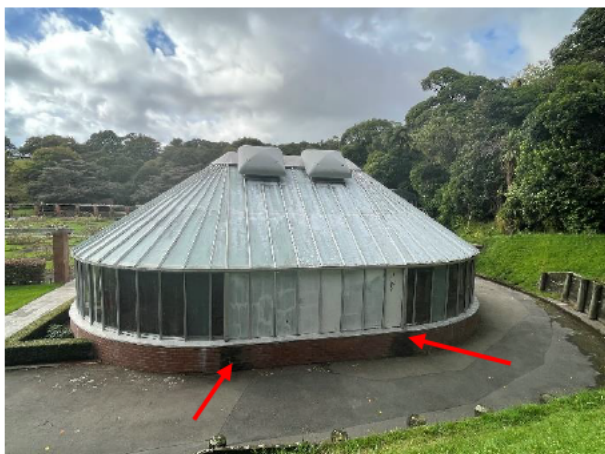
1.31 West annex. Arrows indicate where the gutter downpipes drain onto the perimeter wall

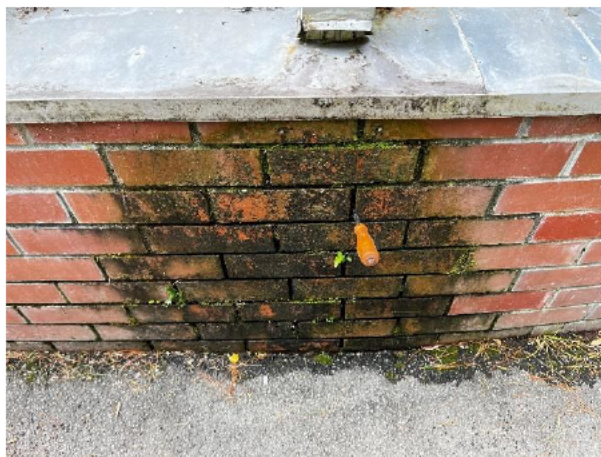
1.32 Mortar joints have degraded where the downpipes terminate.

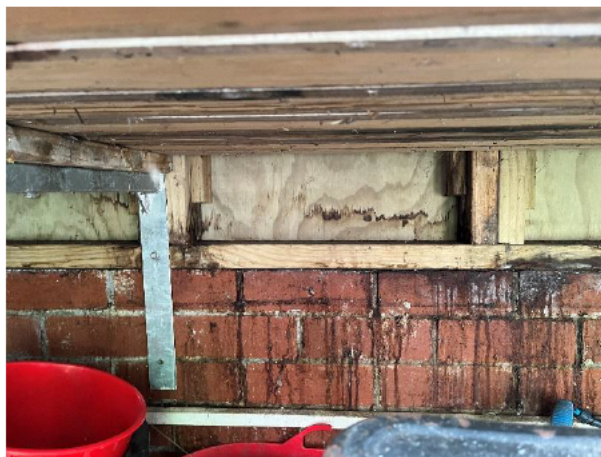
1.34 Moisture damaged timber frame and plywood substrate below the potting shed bench

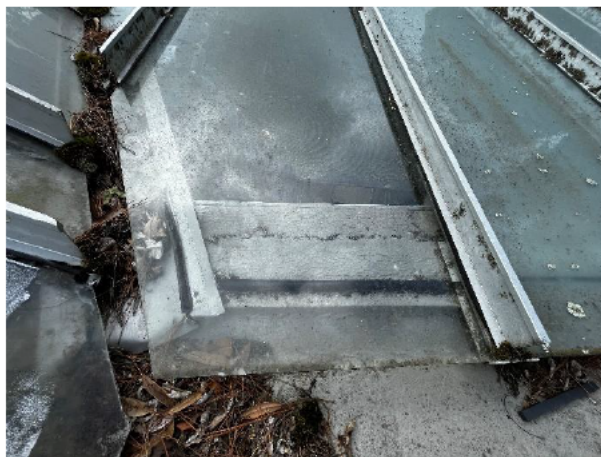
1.36 Corner junction is leaking into the roof frame below

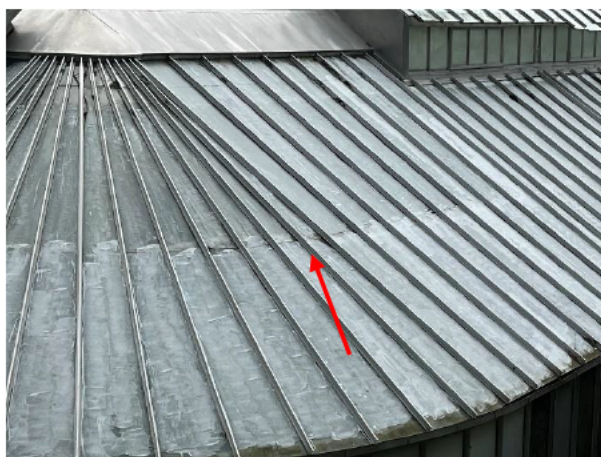
1.38 Glass panels butt together and are temporarily sealed with silicone. This is a high maintenance detail

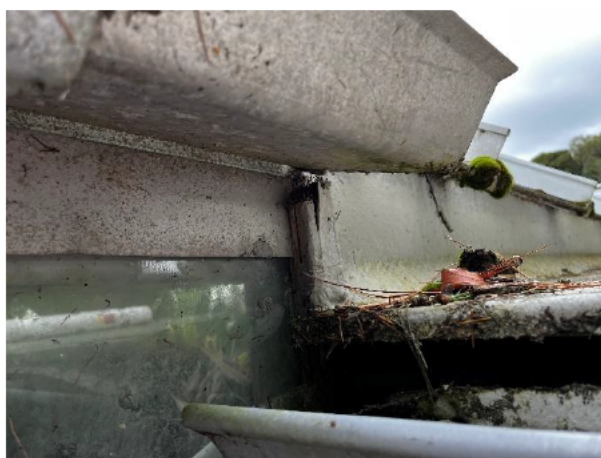
1.40 The link extension is incorrectly built into the glass house creating moisture ingress routes and damage

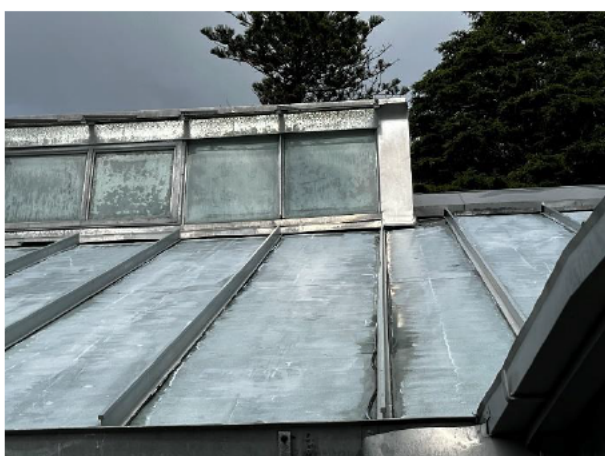
1.41 Apron flashings to the lantern have lifted

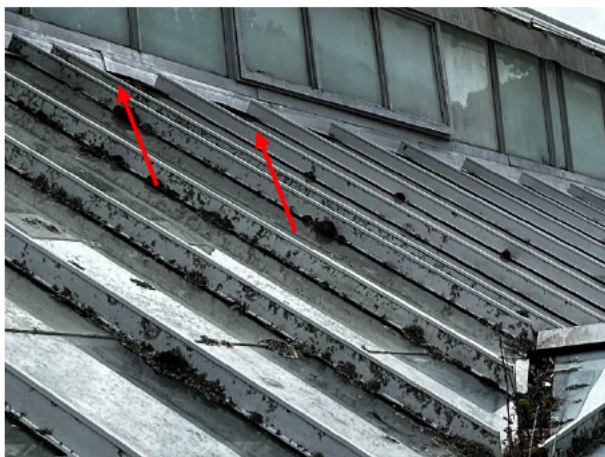
1.43 Flashings have lifted

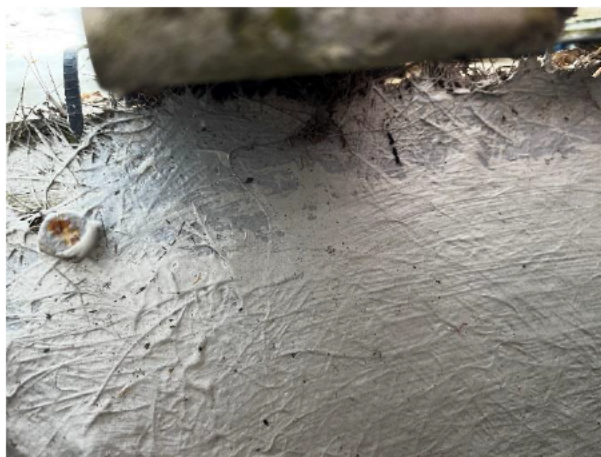
1.44 Unsealed bottom edges of the glazing panels

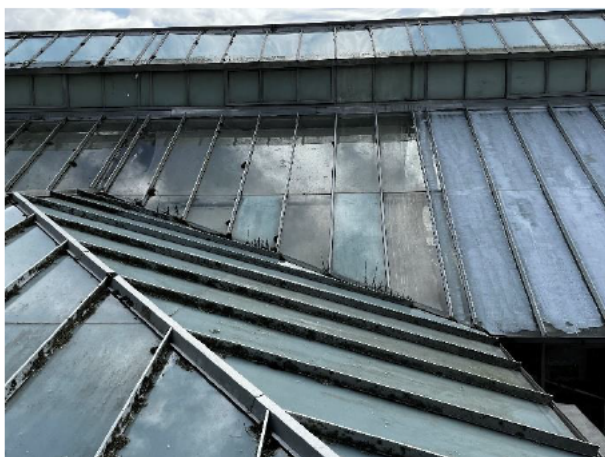
1.45 Vegetation growth in the valleys preventing drainage

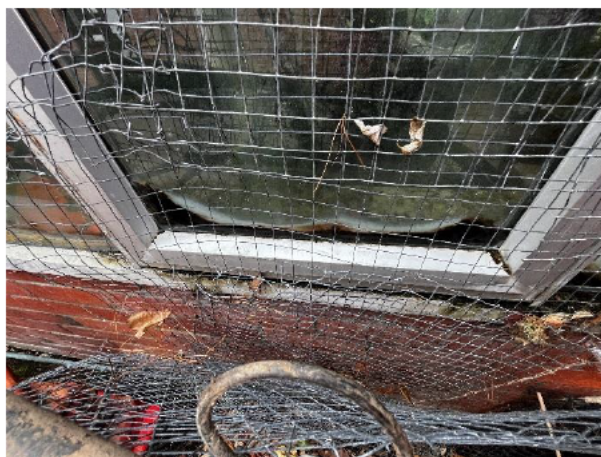
1.46 Open mitre joints and corrosion

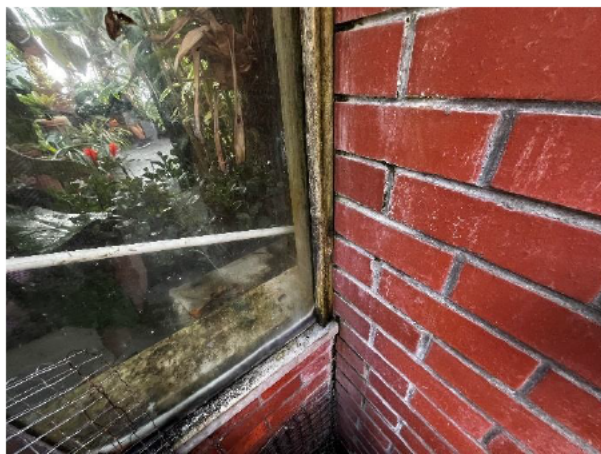
1.48 This junction no longer performs a weathertight seal

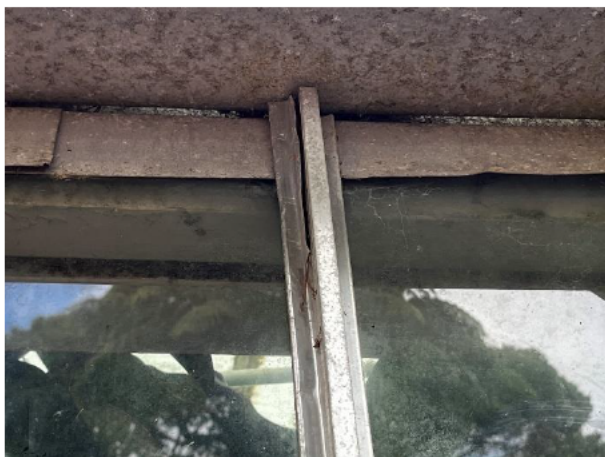
1.49 Aluminium, glazing bead is split and dislodged

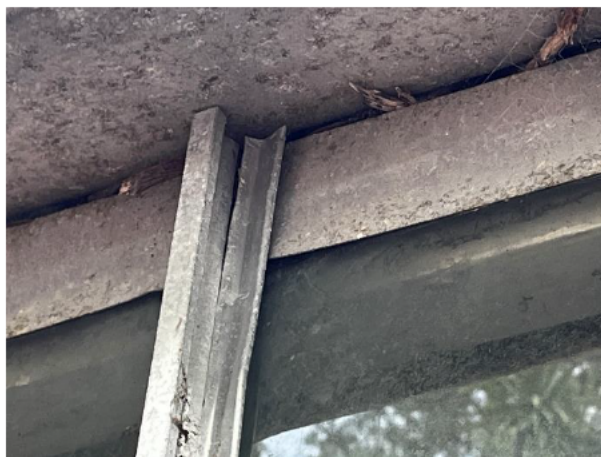
1.50 Aluminium, glazing bead is split and dislodged

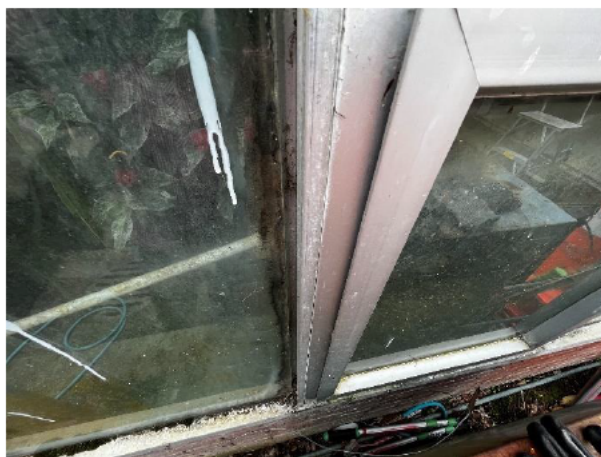
1.52 Missing glazing bead

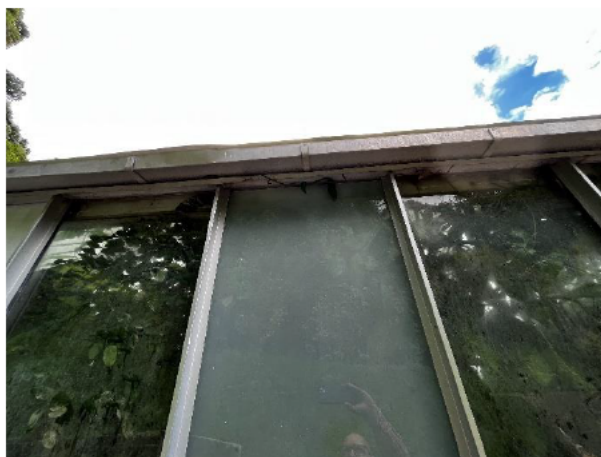
1.54 Plants growing through between the glass and frame

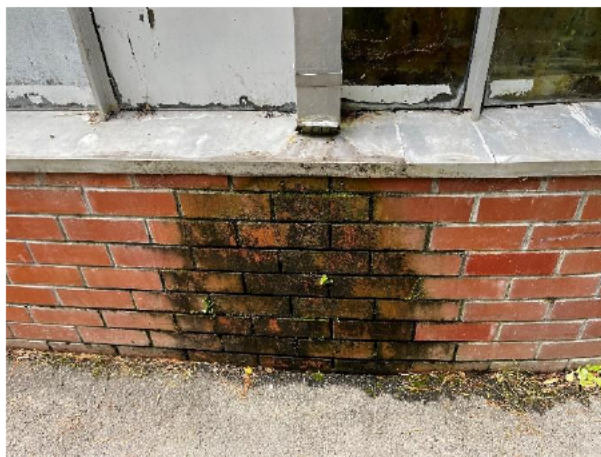
1.56 Downpipe cut short assume because the bottom section damaged by vehicles. Result is damage to the wall.

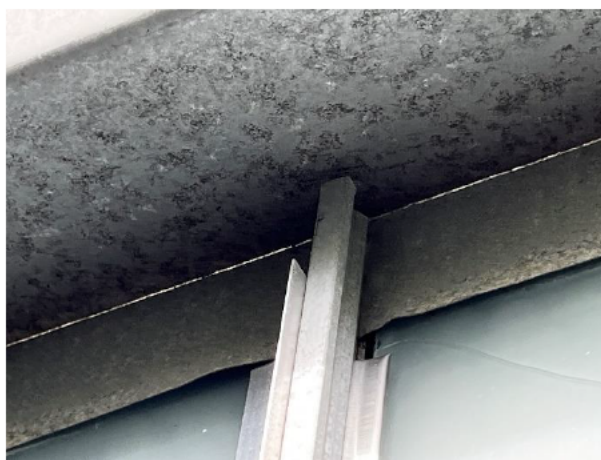
1.58 Glazing bead cut short

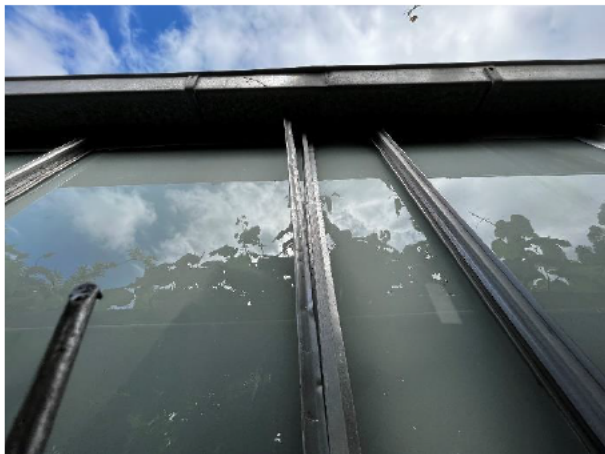
1.59 Glazing bead damaged and detached

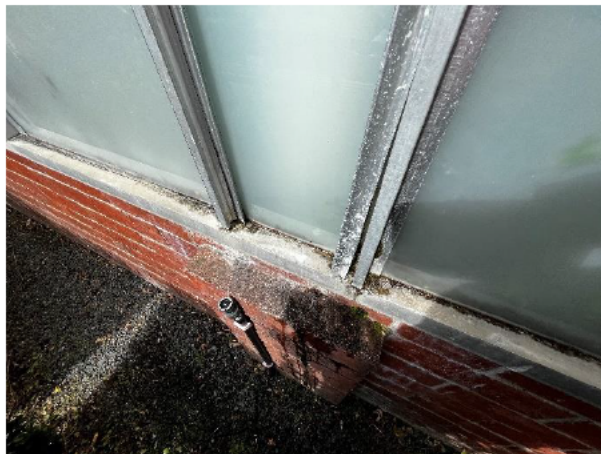
1.60 Loose glazing Bead

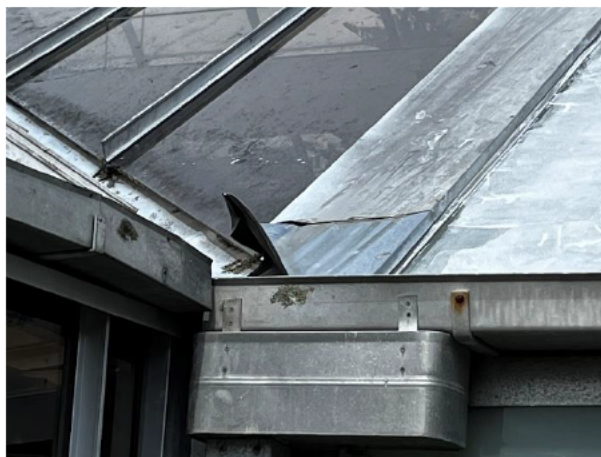
1.62 Flashing has deflected and lifted on the bottom corner junction with the cafe

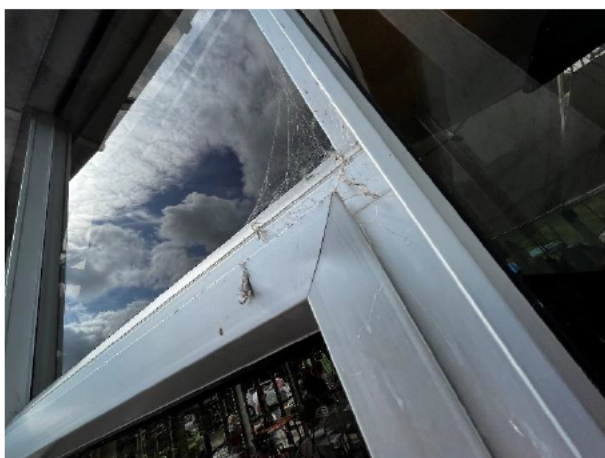
1.63 Open mitre joint

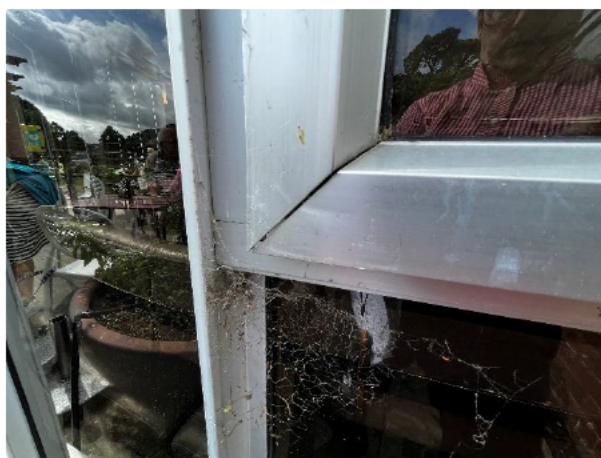
1.64 Open mitre joint

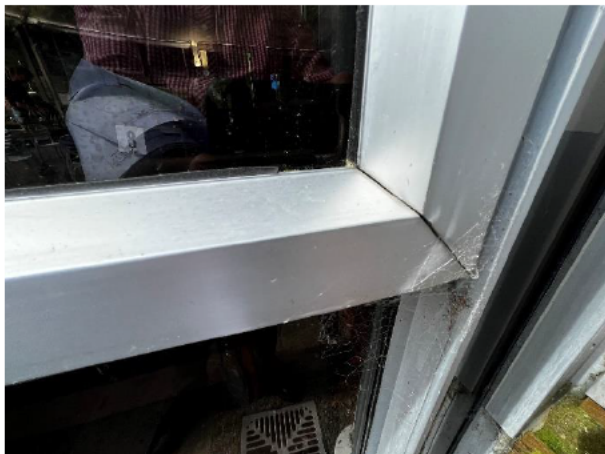
1.65 Open mitre joint

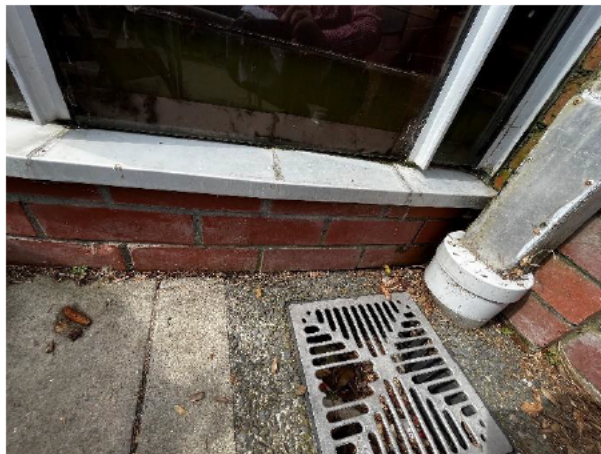
1.66 Poorly sealed junction between the wall and glazing system creating a moisture ingress route

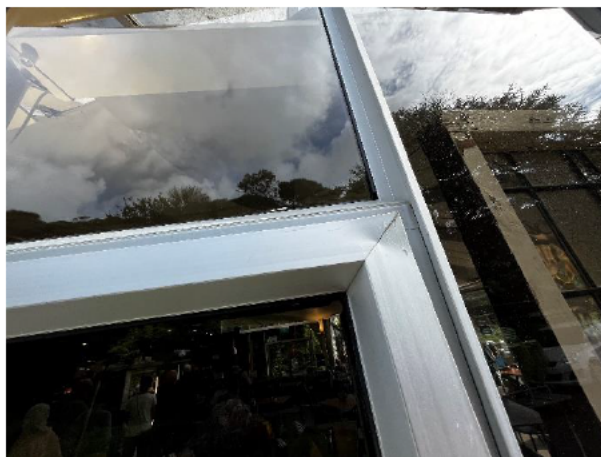
1.68 Open and damaged mitre joint both sides

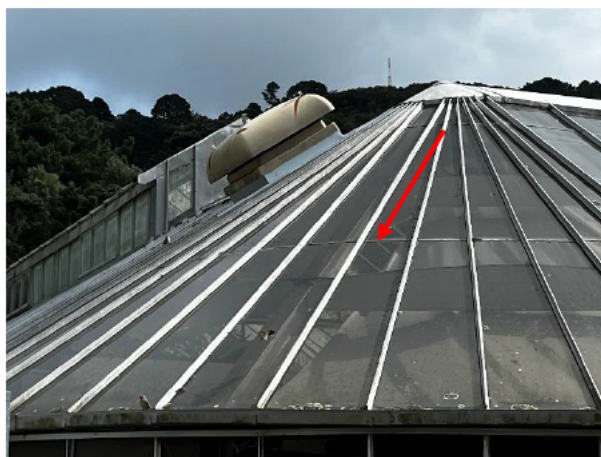
1.70 Glazing joint sealant has failed resulting in damage to the kitchen ceiling

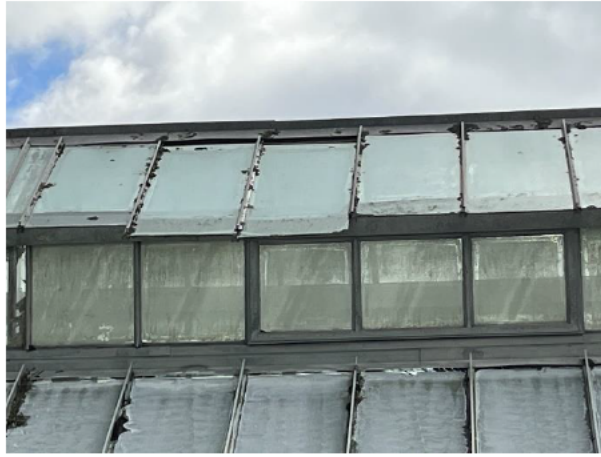
1.72 Slipped panes on the lantern

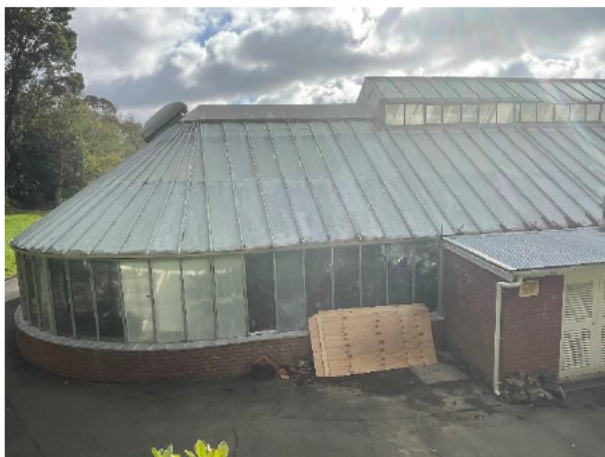
1.73 The glazing panels are whitewashed which requires regular high cost maintenance

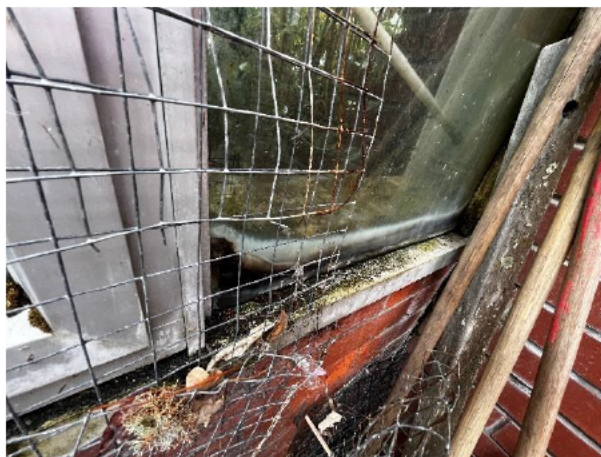
1.74 Bottom edges of the laminated glass panel are delaminating

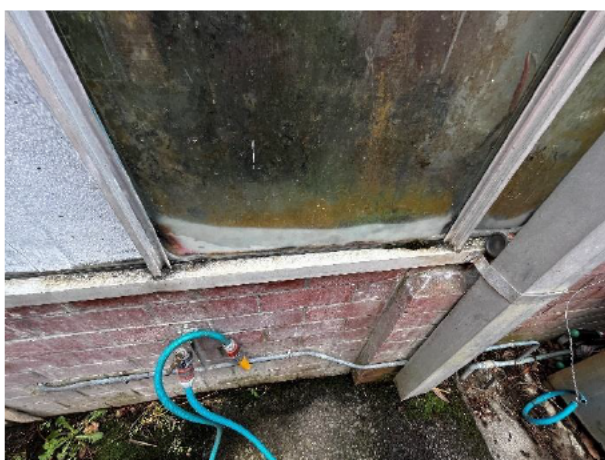
1.75 Delaminating pane

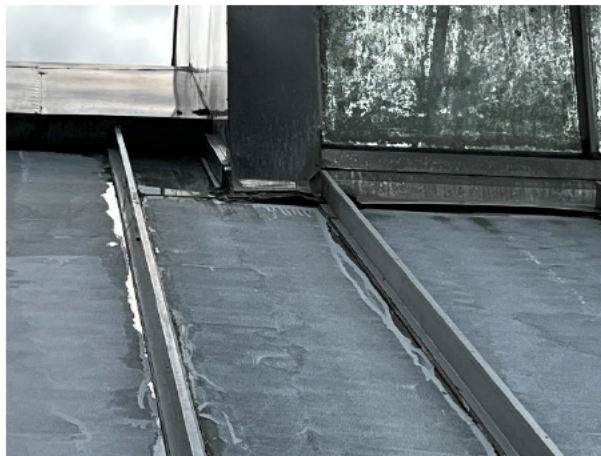
1.76 Open flashing and glazing joint between the roof and lantern

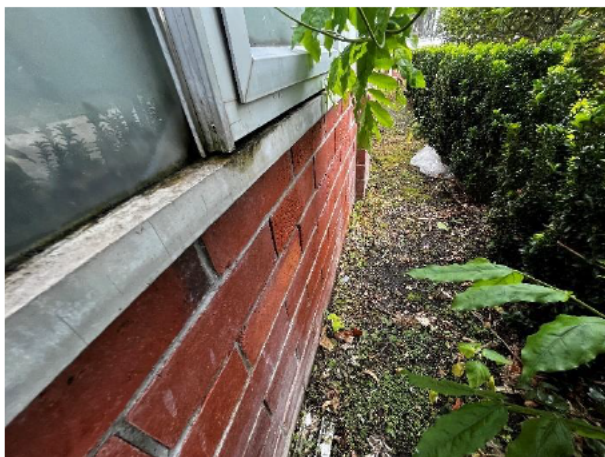
1.77 Delamination of the glazing panes

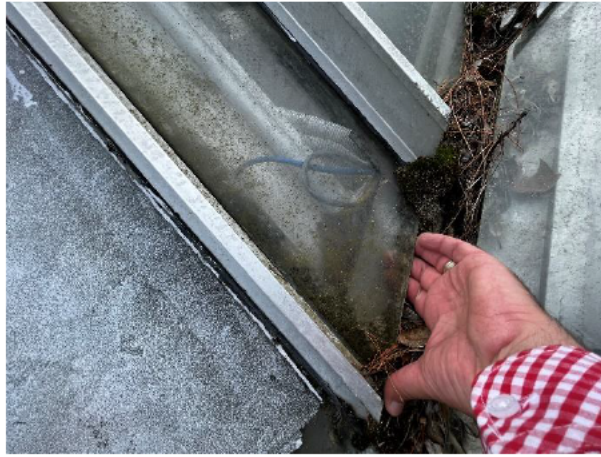
1.78 Gasket missing to base of glazing pane

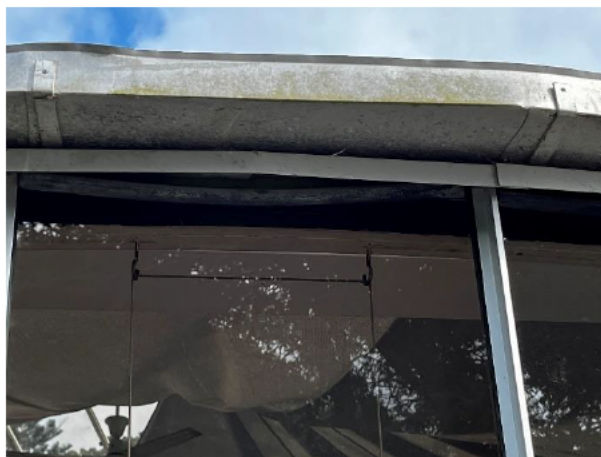
1.80 Gaskets have worked loose

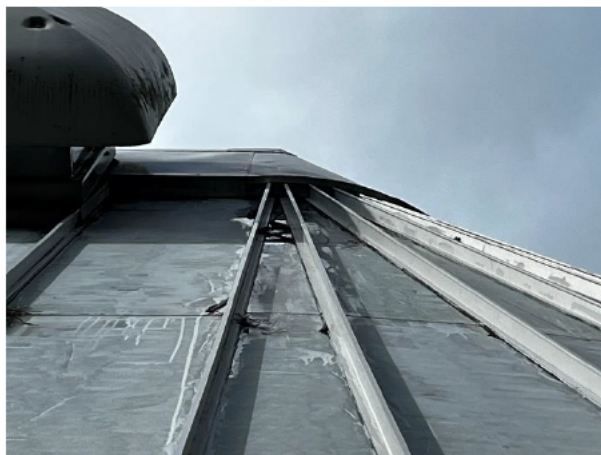
1.82 Gaskets detached

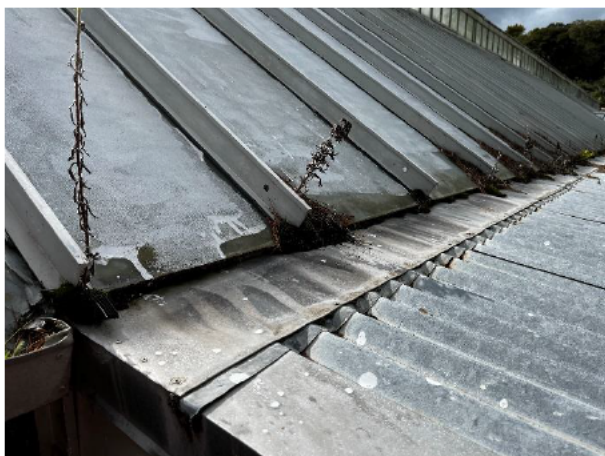
1.83 Slipped gaskets and vegetation growth through deferred maintenance

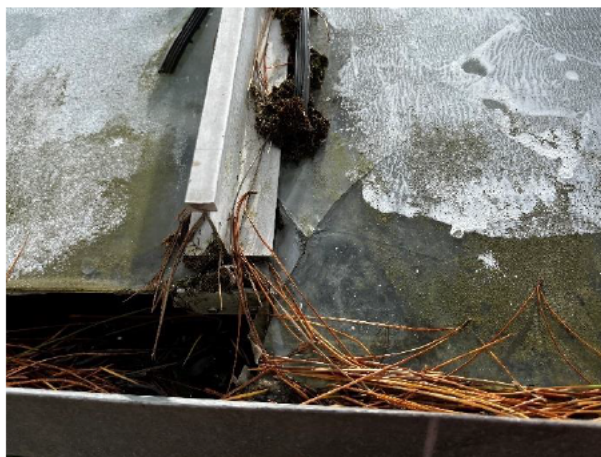
1.84 Slipped and dislodged pane and gaskets

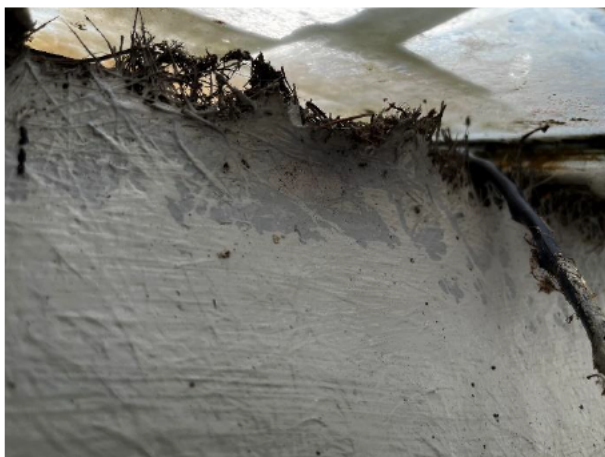
1.85 Gaskets have fallen out and condensation from the glasshouse roof is running into the wall frame

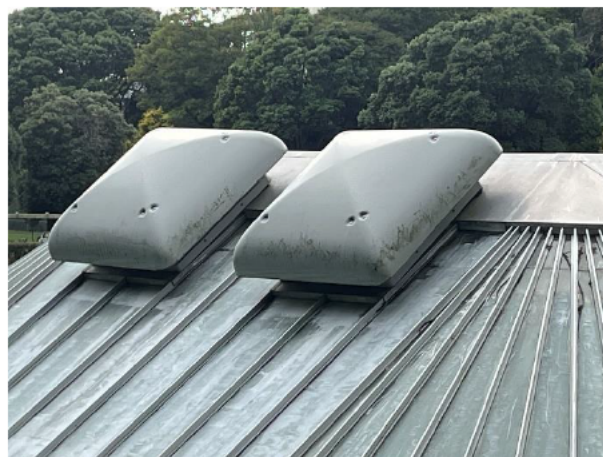
1.86 Glazing gaskets have worked loose

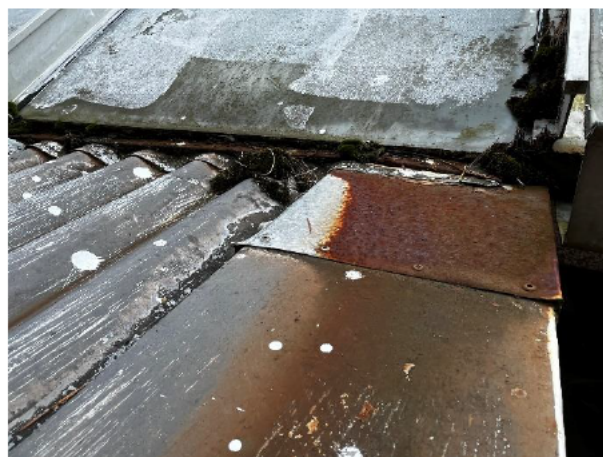
1.88 Corroded barge caps and apron flashings

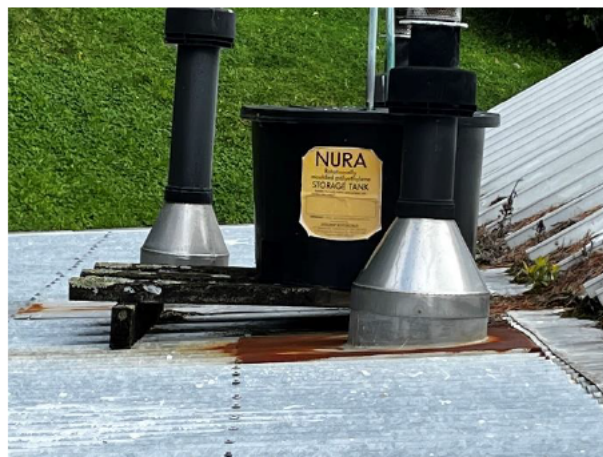
1.90 Corroded back flashings

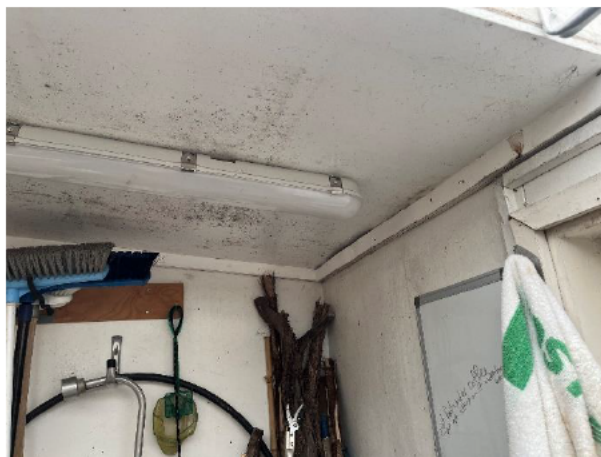
1.92 Mould on the potting shed ceiling and moisture damaged cornice

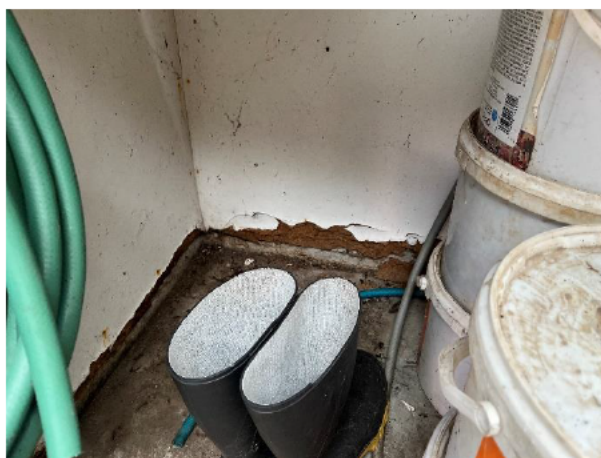
1.94 Moisture damage to the bottom edge of the wall linings

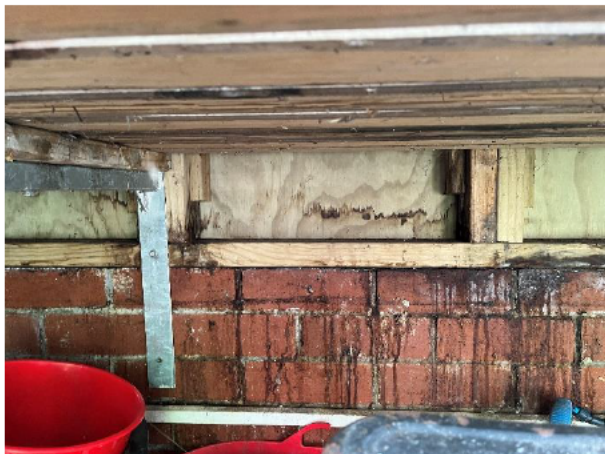
1.95 Moisture damaged wall framing and substrate in the potting shed

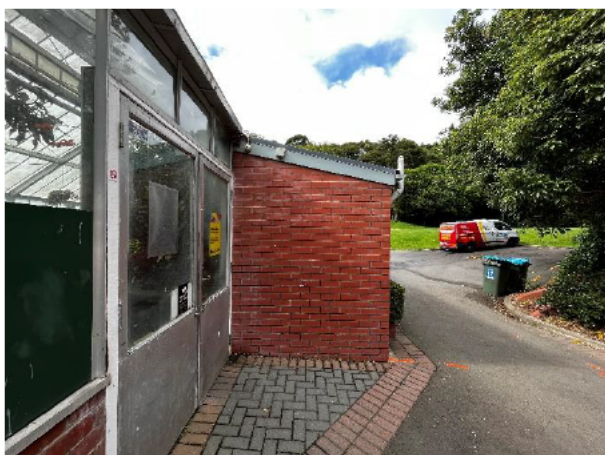
1.96 These double door joinery units are at end of life and recommended for replacement. The steel perimeter frames are corroded and either require repair or replacement

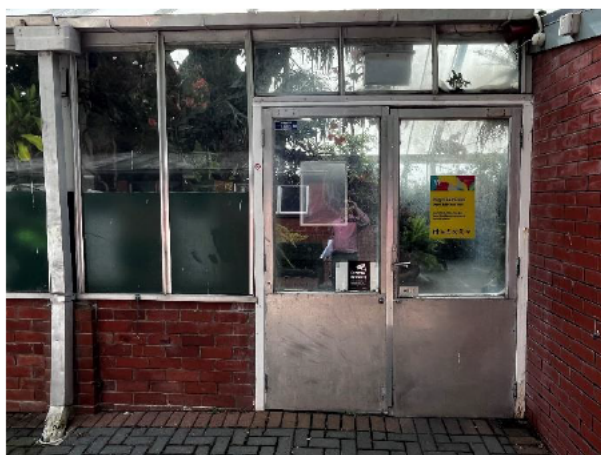
1.97 Doors are out of alignment and corrosion in the frame

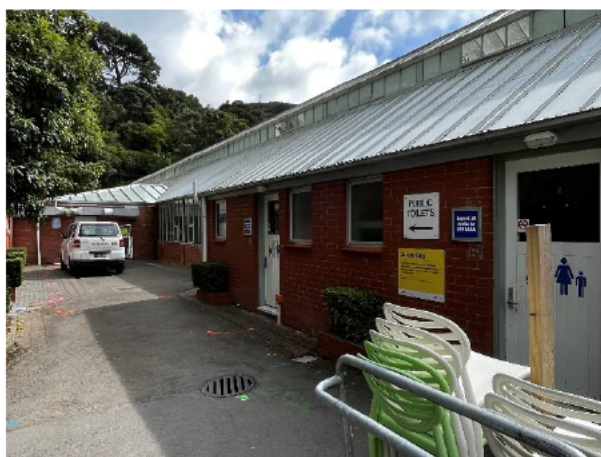
1.101 Door joinery to the toilets is in moderate condition but the aluminium joinery units are in poor condition.,

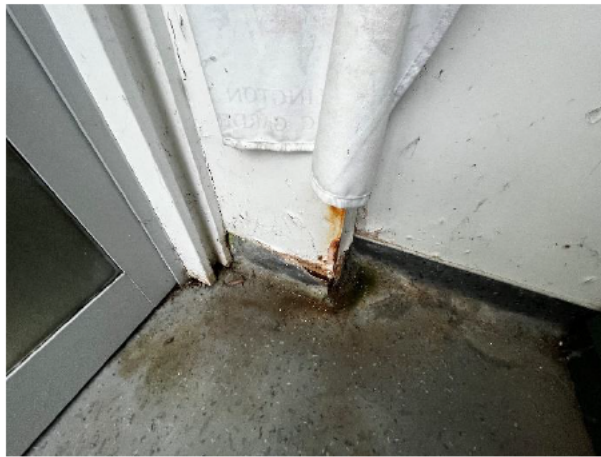
1.106 Moisture related dmaage

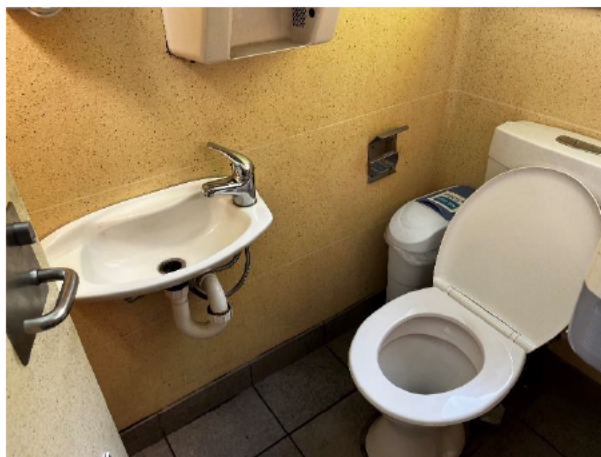
1.108 The sanitary ware is operable. The linings are dated and worn

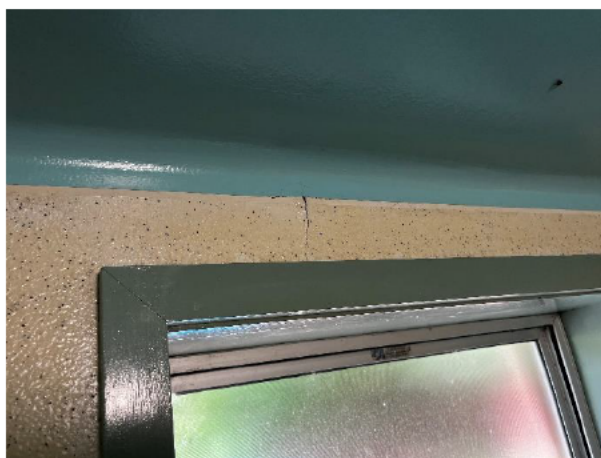
1.110 Cracked wall board joint with moisture damage

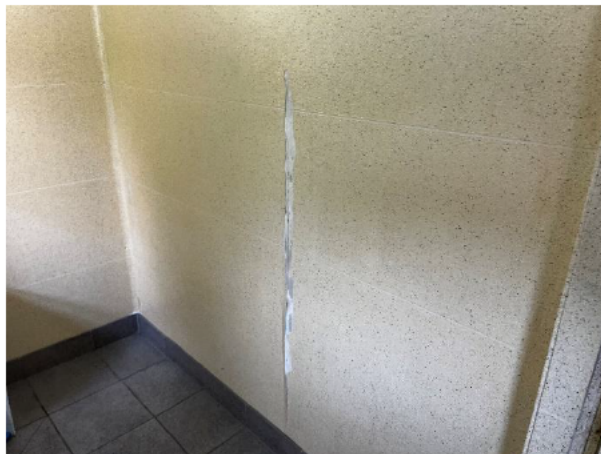
1.112 Wall damage

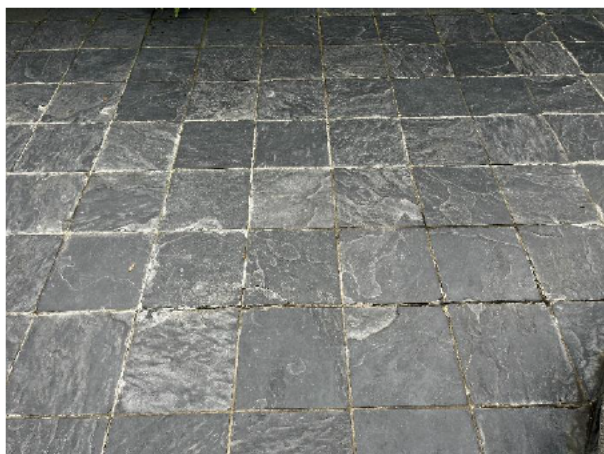
1.113 Delaminating floor tiles

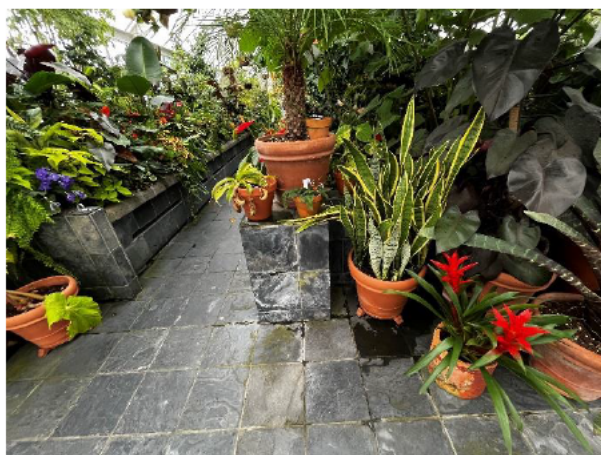
1.114 Floor and planter box tiles are lifting in isolated area, are chipped throughout but remain serviceable though are becoming dated and unsightly

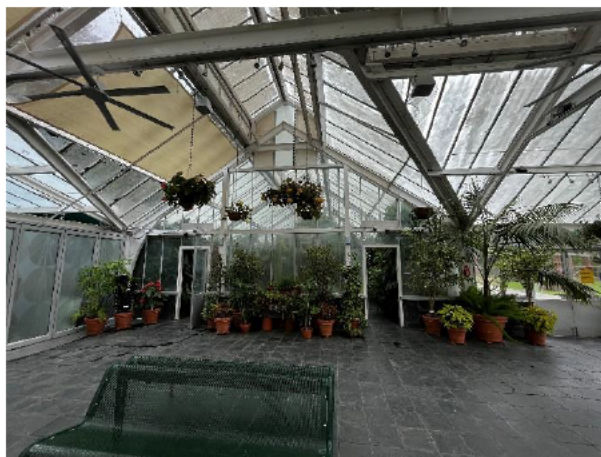
1.120 Electrical fixtures and fittings range in condition between moderate and good

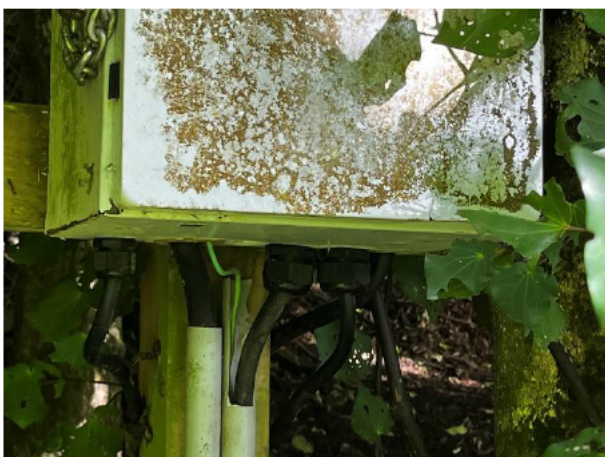
1.123 Electrical supply is present along the tree line, stage and to a lamppost and the underground position does not appear to have been confirmed.

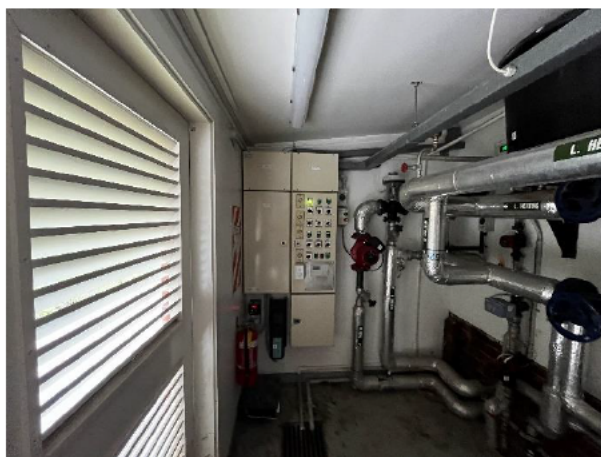
1.124 Electrical switch gear we understand is circa 1988-1991. The heating and hot water supply pipework appears to be in moderate condition within the boiler room. WT understand the main electrical supply cable was replaced in 2021

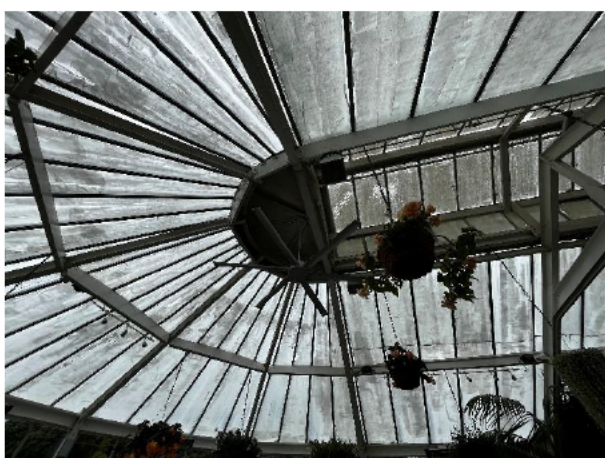
1.127 Strip spots appear to be in moderate condition

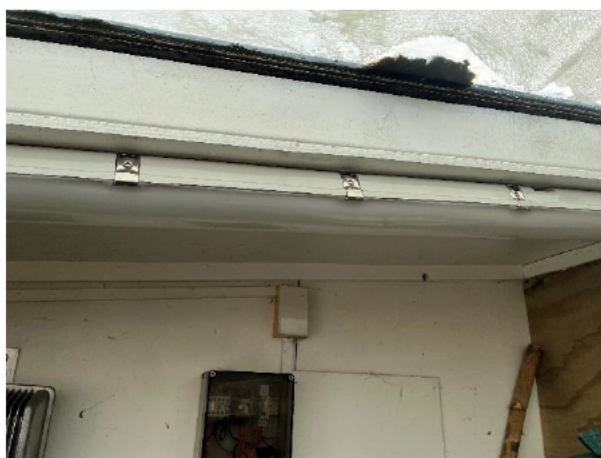
1.128 Lighting and electrics are in moderate condition

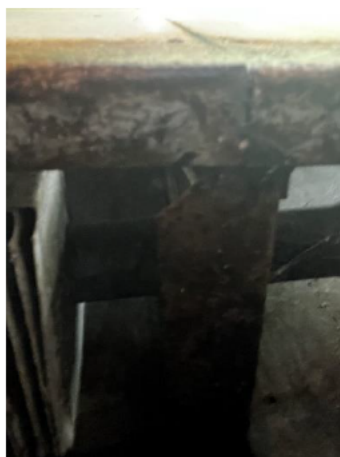
1.134 Framework is corroding around the radiator covers

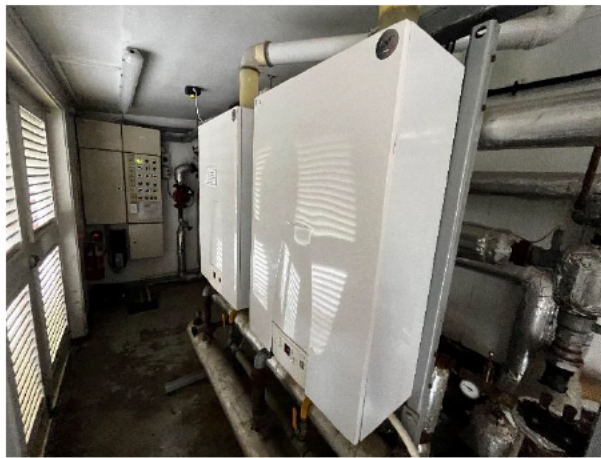
1.140 Condensing boilers are 10-12 years old and remain in an operable condition but are nearing end of economic life.

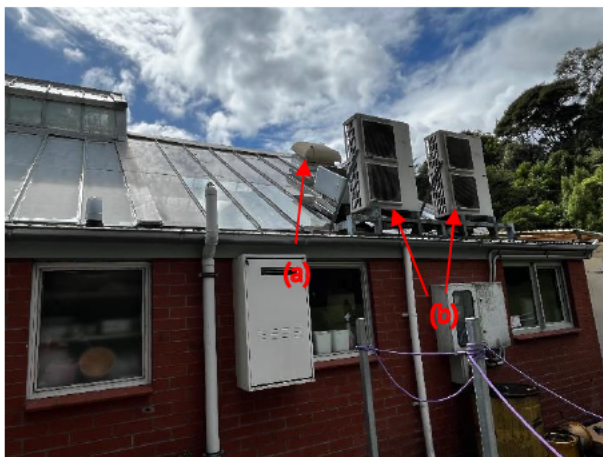
1.141 The (a) extract fans and (b) air conditioning pumps are at the end of economic life.

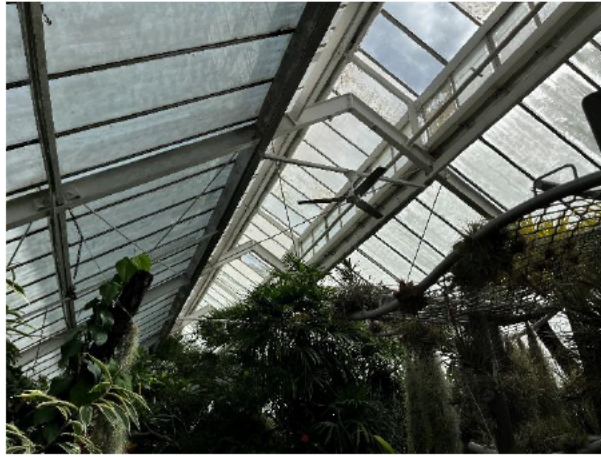
1.142 Air circulation fans are at the end of their design life

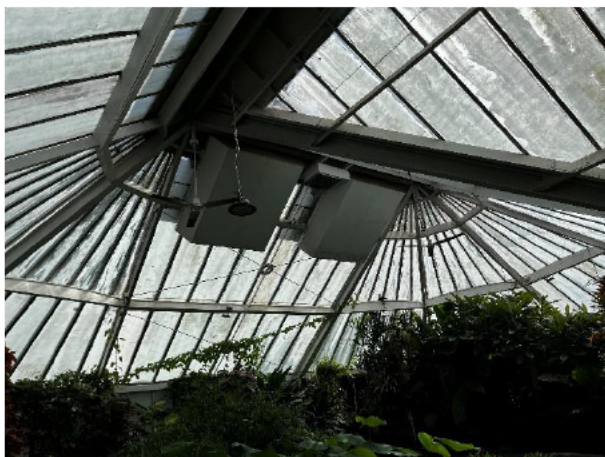
1.143 Air extraction units are at end of life

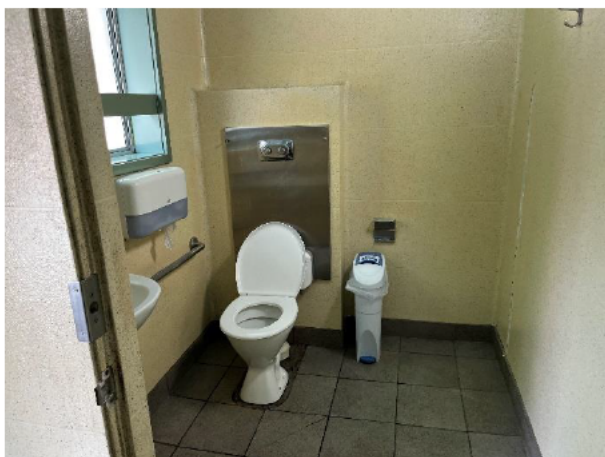
1.145 Sanitary remains operable but has reached end of economic life
