# CONDITION SURVEY REPORT WELLINGTON CITY COUNCIL

August 2023

THIS REPORT HAS BEEN COMMISSIONED BY WELLINGTON CITY COUNCIL (WCC). THE OBJECTIVE OF THE REPORT IS TO RECORD THE CONDITION OF THE PROPERTY INCLUDING DRAINS AND SERVICES, ASSESSES THE GLAZED CLADDING SYSTEM INSTALLED ON THE GREENHOUSE/CAFÉ, AND IDENTIFY REMEDIAL OPTIONS ALL IN ACCORDANCE WITH THE WCC SCOPE OF WORKS.

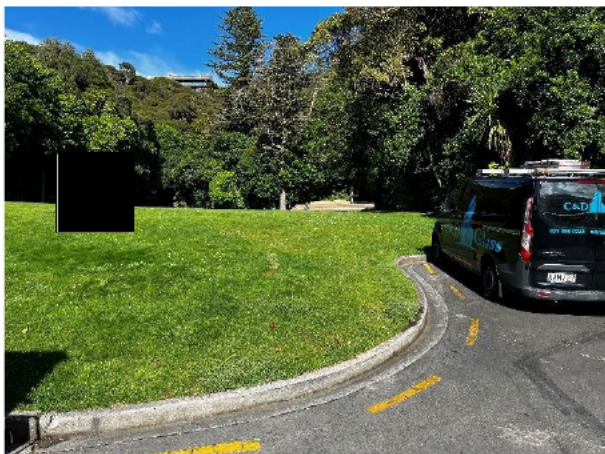
1.148 Water supplies are present along the tree line and the underground location has not been confirmed

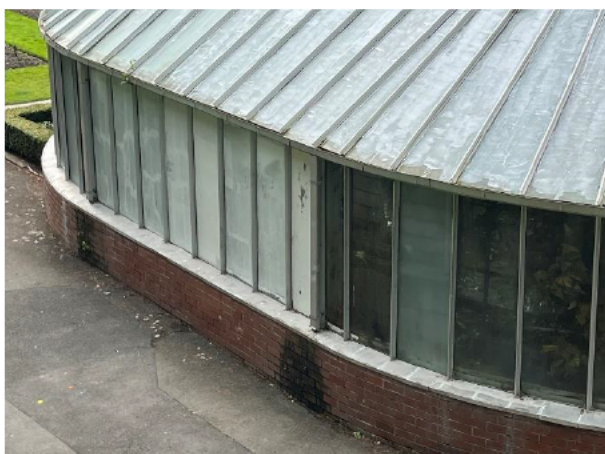
1.149 Gutter joints have failed

4.2.4	Gutters	All	Generally, the gutters remain in a moderate condition with	Replace all gutters	2.23-2.25	4

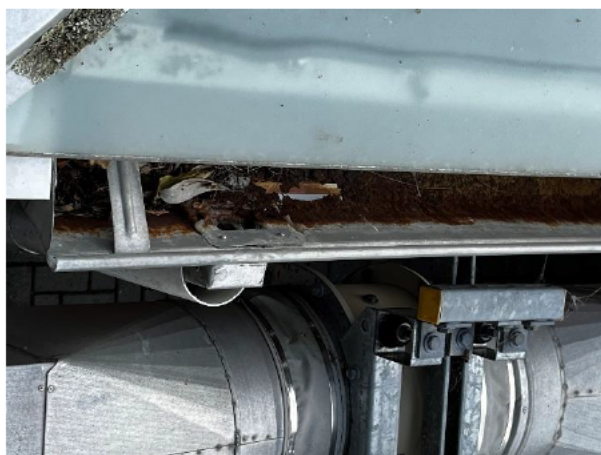
1.150 Gutters corroded through

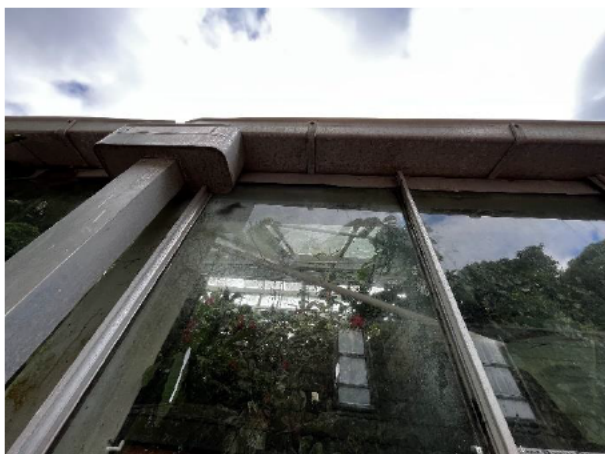
1.151 Gutter fixings are corroded

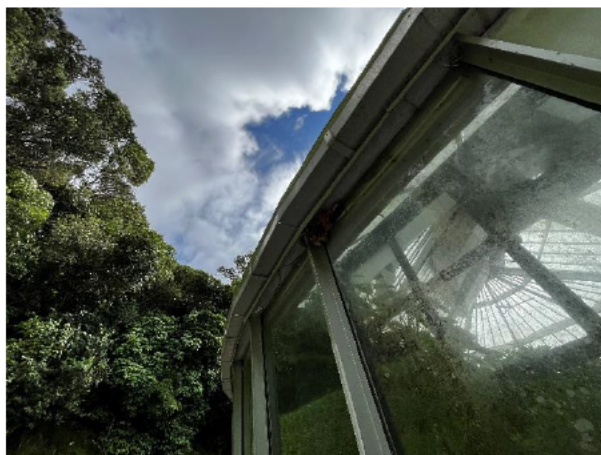
1.152 Open gutter joints

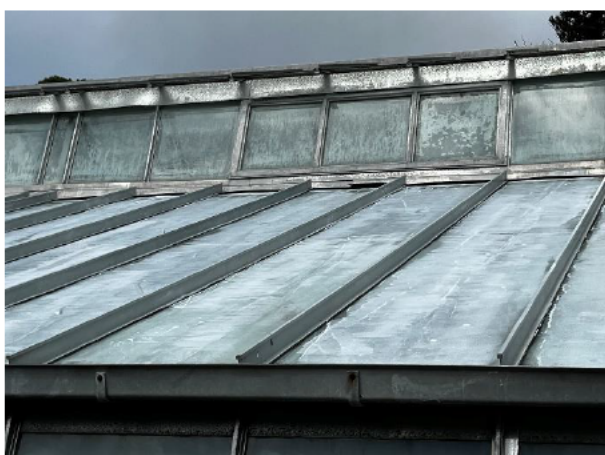
1.153 Gutter brackets are corroded

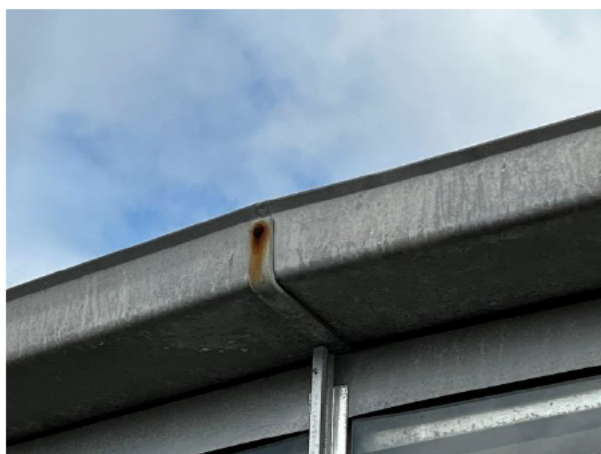
1.154 Corroded gutter brackets

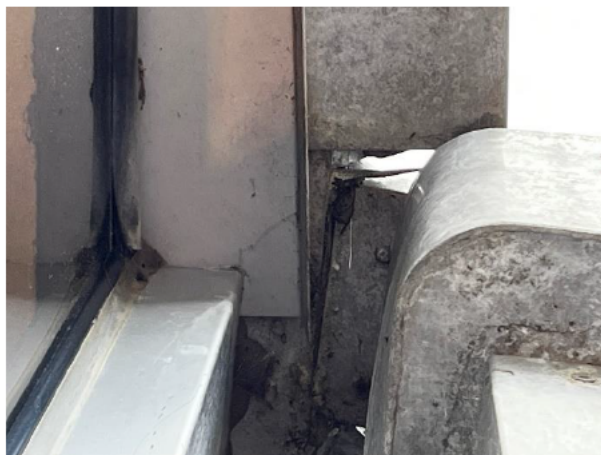
1.158 Gap between the gutter and rain head

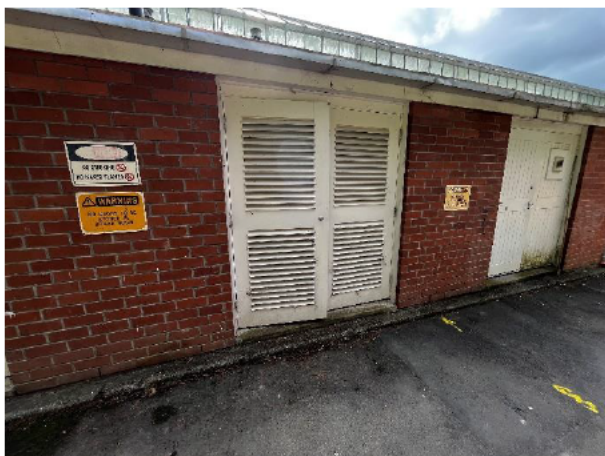
1.159 Impact damaged gutters

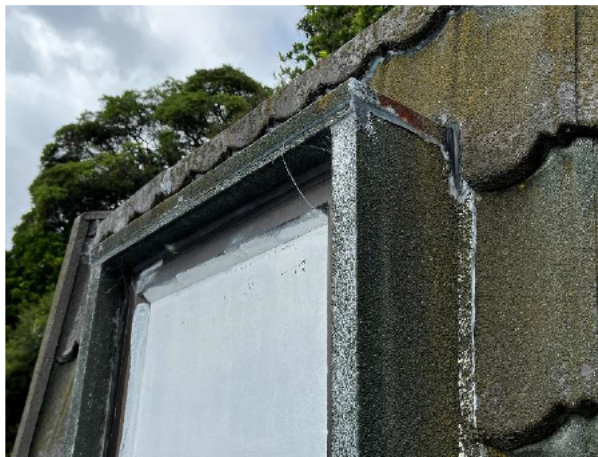
ITEM	ELEMENT	ELEVATION	INSPECTION COMMENTS	ACTION REQUIRED	PHOTO REF	CONDITION RATING
<b>Roofs</b>						
4.2.1	Mansard roof to the staff room	North and south	The timber framed mansard roof is clad with Decramastic tin tiles. This product appears to be an asbestos containing material. The painted timber barge boards are decaying at junctions and on the ends with peeling paint along the lengths. The roof cladding system has reached the end of its economic design life. Internal moisture damage was observed to ceilings, trims and wall linings. There have been numerous unsuccessful attempts at repair with sealant.	Replace the roof cladding system and create a new pitched roof over with large eaves. Straighten the walls and reclad with a new cavity-based system. Allow 20% frame replacement and 2 coats of Protim frame saver.	2.1-2.5	4

2.4 There are numerous failed sealant repairs to prevent moisture ingress into the building.

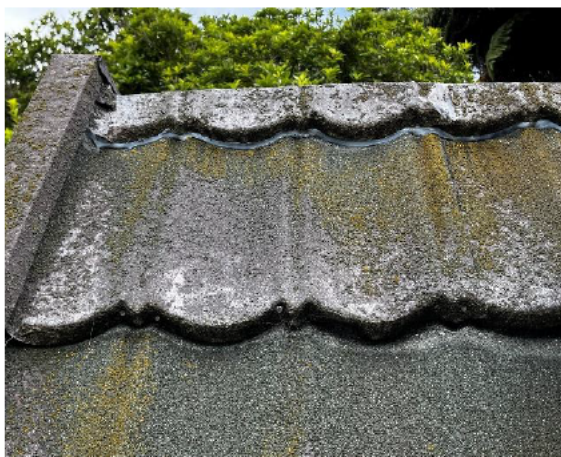
2.5 Sealant repairs at the hip junction

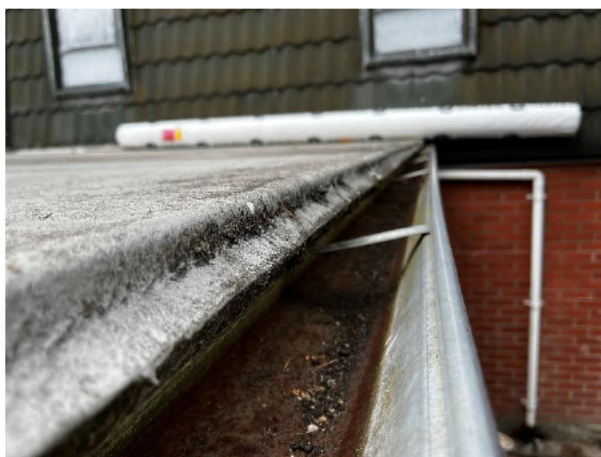
4.2.2	Workshop flat roof membrane	Link between Block A & B	The membrane has been coated with a liquid plastic type repair. The roof to roof and roof to wall junctions have been poorly applied/designed resulting in moisture ingress and damage to the roof substrate, drips, roof and wall framing and linings. Gaps are present between the roof membrane upstands and the wall at the toilet block gutter.	Replace the roof membrane and substrate. Install new flashings and create an eaves.	2.6-2.17	4

2.8 Gutters are corroded

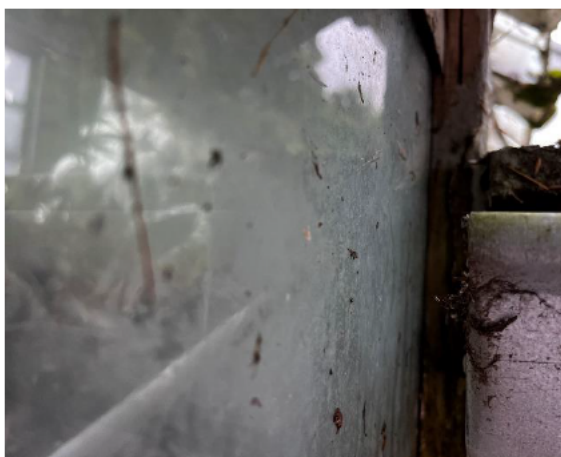
2.9 Unsealed junction between the glasshouse and workshop fascia's

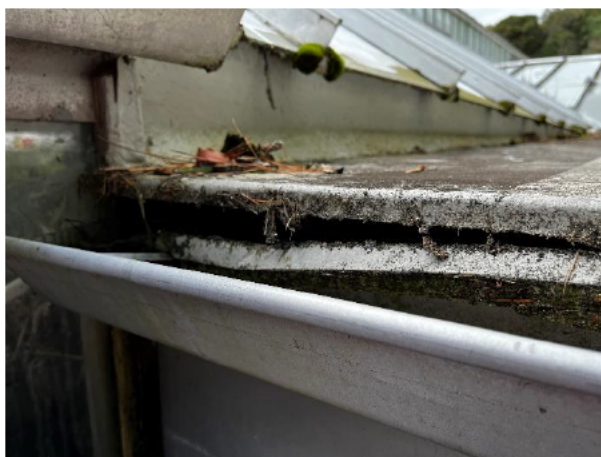
2.10 The drip edge has detached from the roof overhang

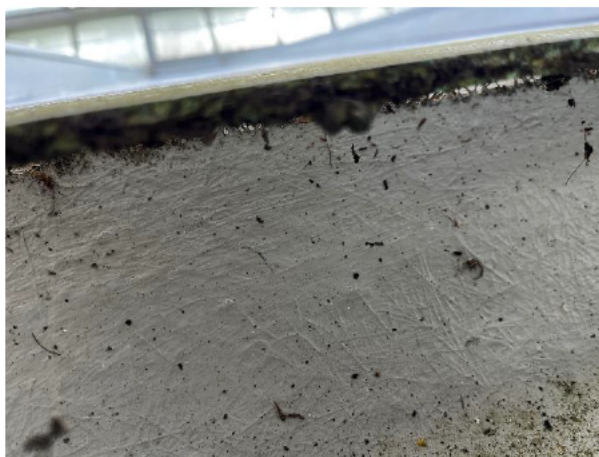
2.12 The membrane terminates level with the top edge of the roof upstand creating a moisture ingress route into the roof and wall framing

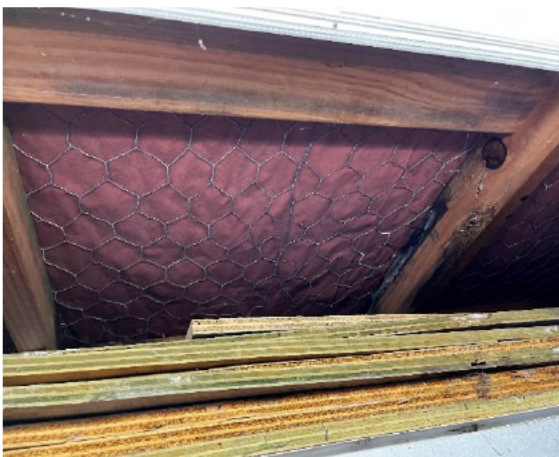
2.13 Decayed roof framing

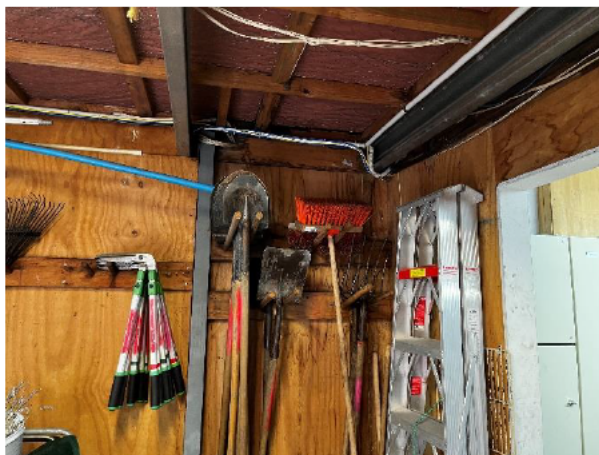
2.14 Moisture stained roof framing and wall lining

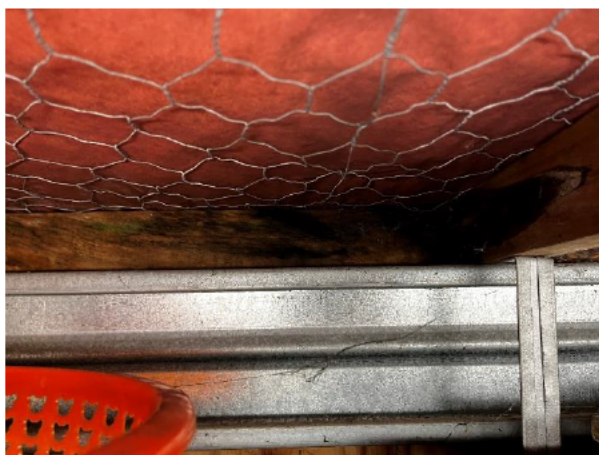
2.16 Decayed roof framing

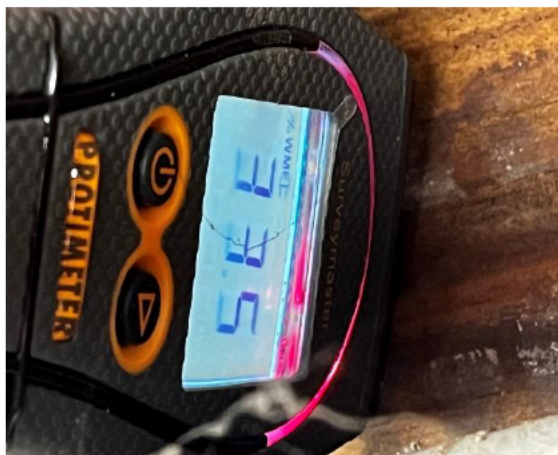
2.17 Elevated moisture readings

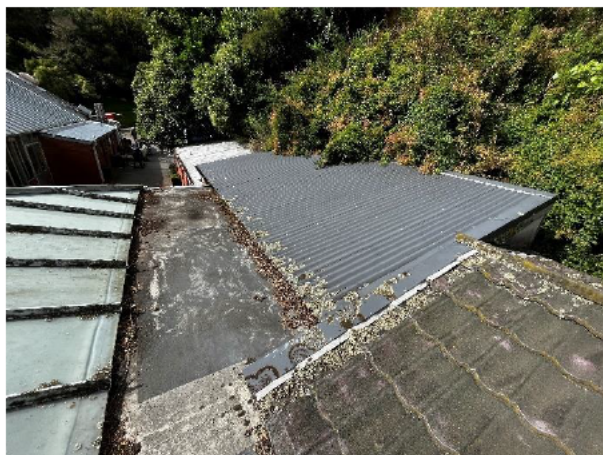
4.2.3	Toilet block roof cladding	Toilet block	A section of the infill link has recently been reclad with powder coated corrugated iron. The paper underlay has degraded along the eaves which can cause moisture to drain into the internal of the roof. The corrugated roof cladding over the toilet block has reached the end of its economic life.	Replace the roof cladding and 1 Velux skylight	2.18-2.22	4

2.18 Roof cladding reward of the central annex has recently been replaced. The flat roof membrane is perished and requires replacement

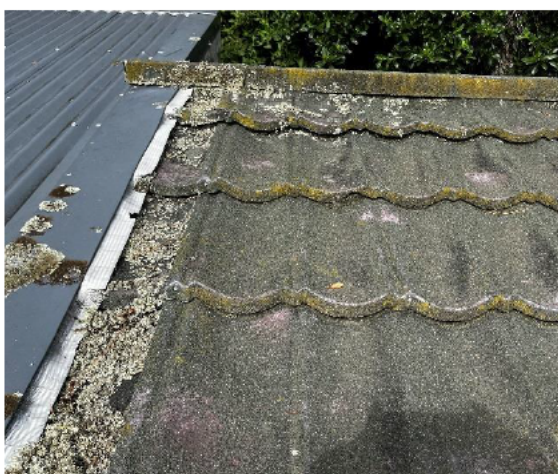
2.19 The roof junction flashing is poorly installed

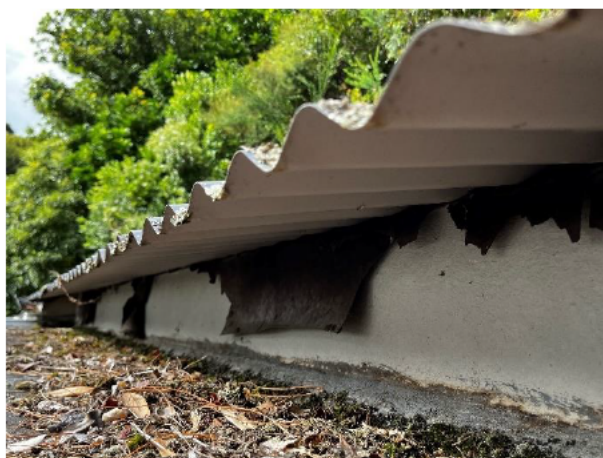
2.20 The roof underlay has perished along the eaves

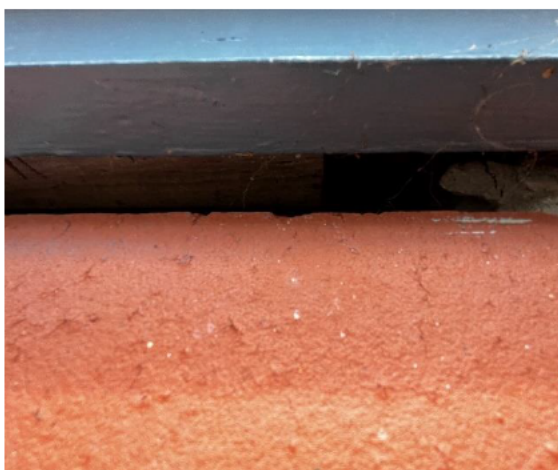
2.21 Gap between the wall and fascia providing a vermin access route into the roof space

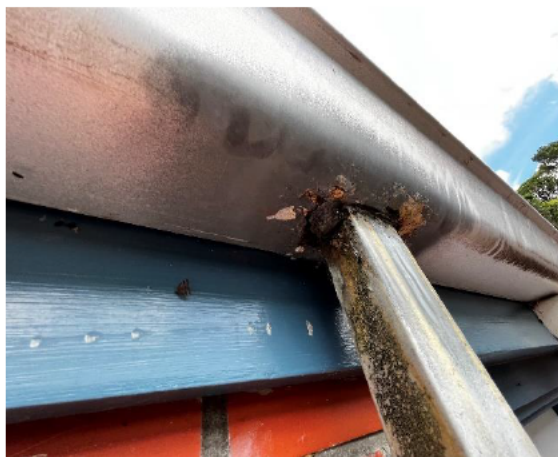
some sections having been replaced.  
The gutter installed on the south elevation of the toilet block and east elevation of the workshop have corroded through. The gutters have generally attained the end of their design life.

2.23 Gutter outlet is corroded through

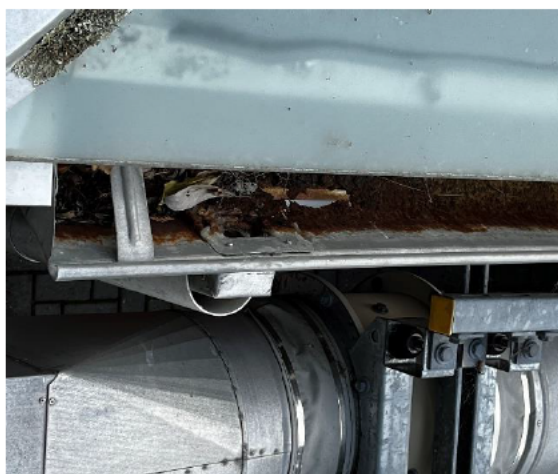
2.25 The gutters have perished

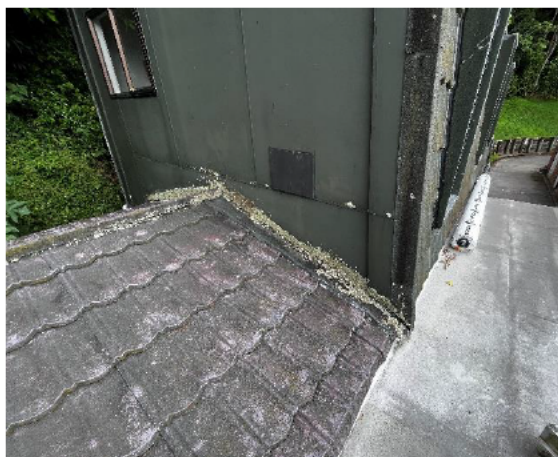
4.2.5	First floor staff room gable walls	East and west	Direct fixed fibre cement wall cladding system has numerous defects which are recognised to contribute to weathertightness failure. Fastening nails are working loose, joint strips are broken, there are limited gaps between the cladding sheets and adjoining roofs, limited joinery flashings and cracked or damaged panels. Elevated moisture levels were recorded in the first-floor walls. Internal moisture damage was observed to ceilings, trims and wall linings.	Reclad the building and allow 10% frame replacement and 2 coats of Protim frame saver to the timber frame.	2.26-2.31	4

2.26 Direct fixed external wall cladding system is defective and damaged

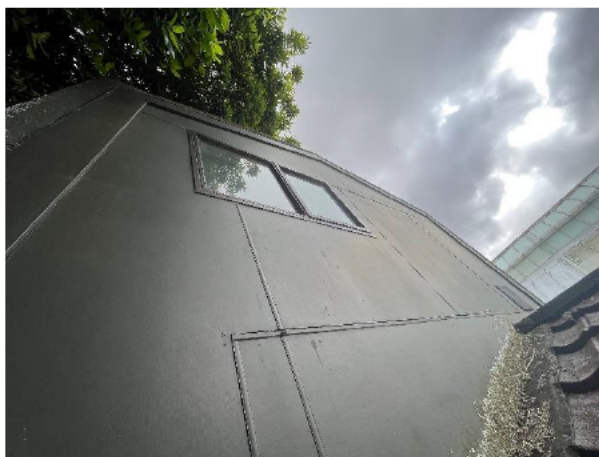
2.27 Popped nail fixings, cracked boards, and damaged jointing strips

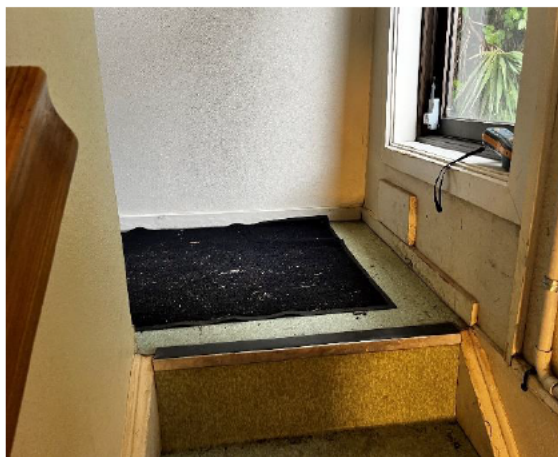
2.28 Moisture swollen trims at the upper door

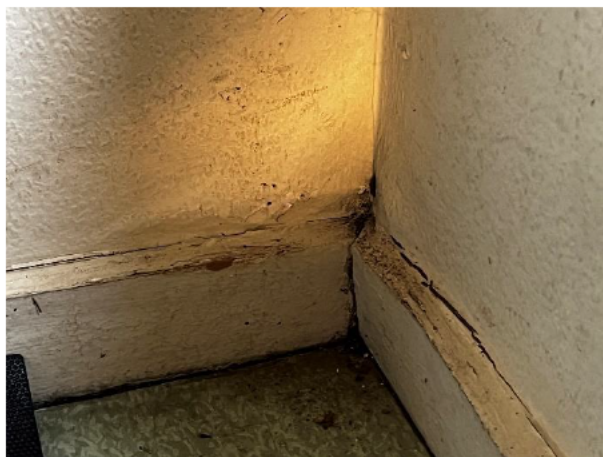
2.29 Moisture swollen trims below the upper door

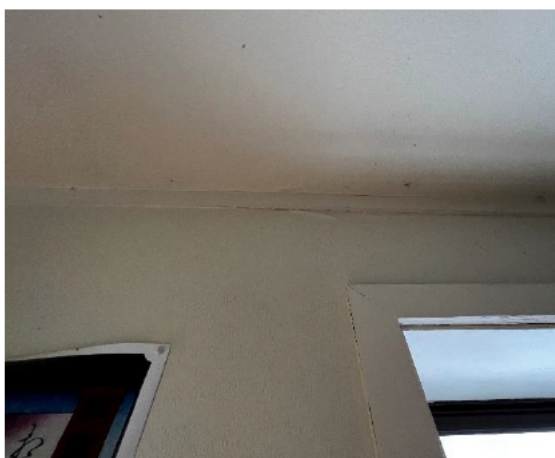
2.30 The wall to ceiling junction is moisture damaged and staff informed that water penetrates when the wind blows from a norther direction

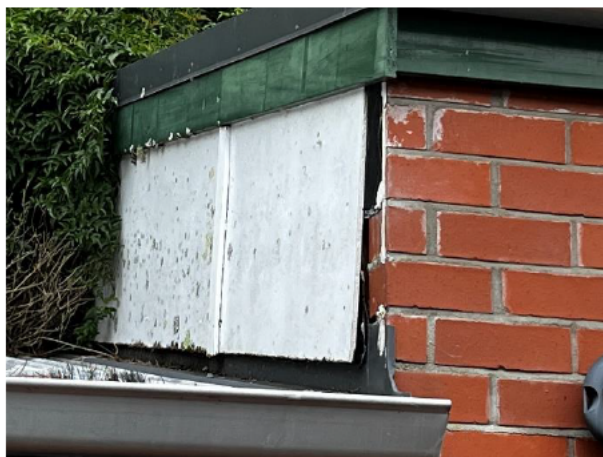
2.33 Direct fixed wall cladding has detached and created a water ingress route into the roof and walls

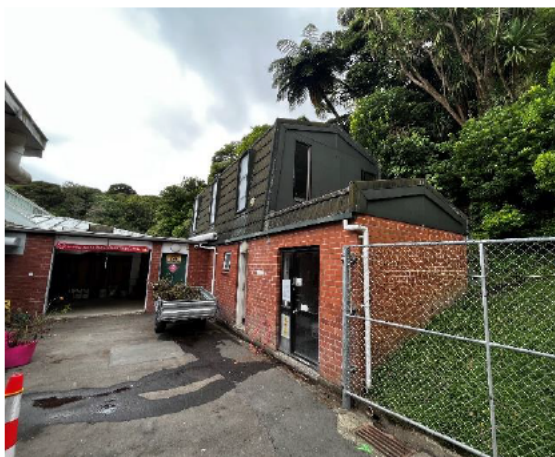
2.34 The building is set into the hillside and the gable and rear wall does not appear to have been adequately waterproofed, if at all

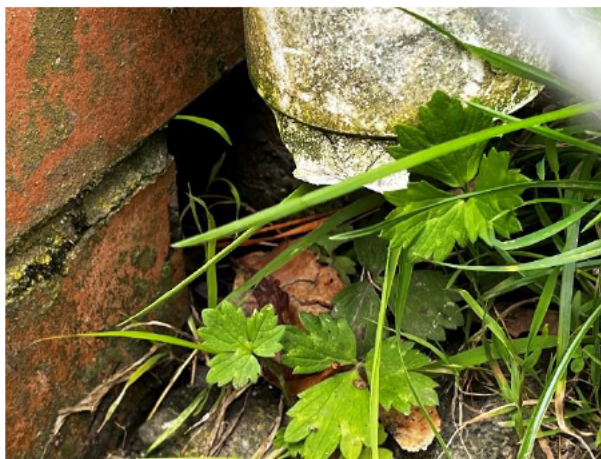
2.35 Hole in the brick veneer where the downpipe terminates

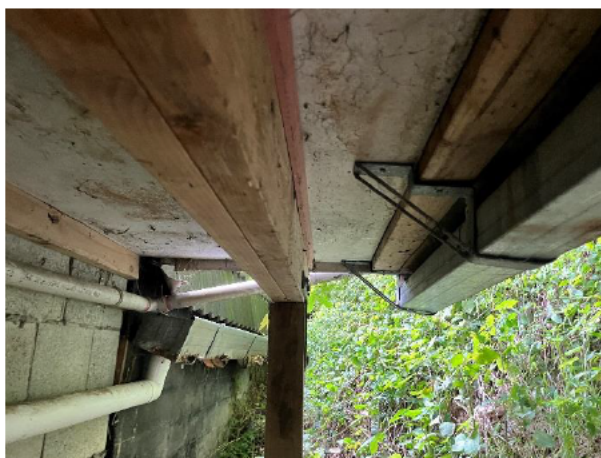
2.37 Rear wall junctions appear to have been poorly detailed

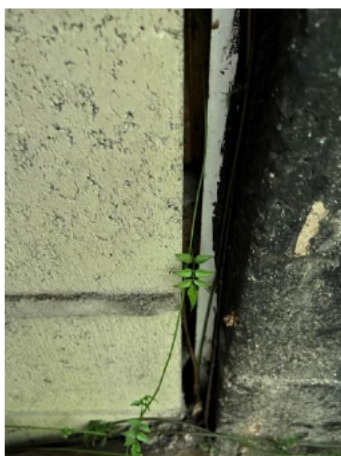
2.38 The junction is packed with timber and expanding foam

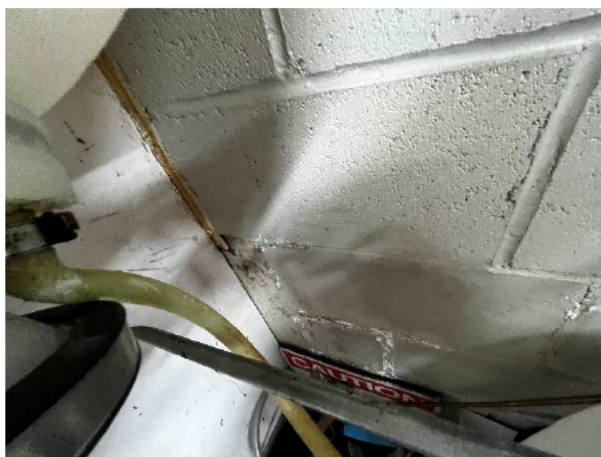
2.39 The corner wall junction has been infilled with expanding foam to create a weatherproof seal. Efflorescence and moisture staining was observed

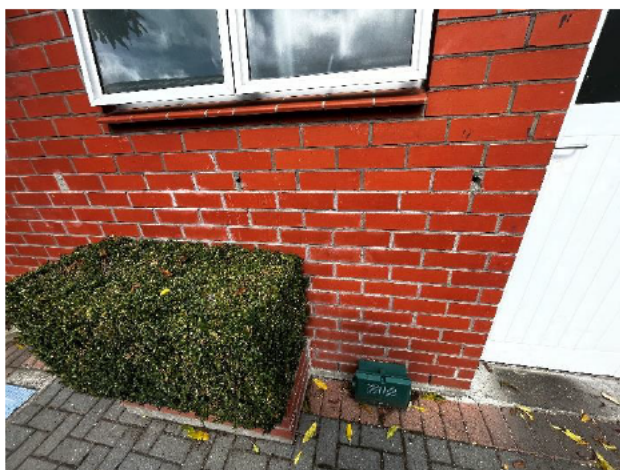
2.41 Unsealed obsolete penetration holes through the wall

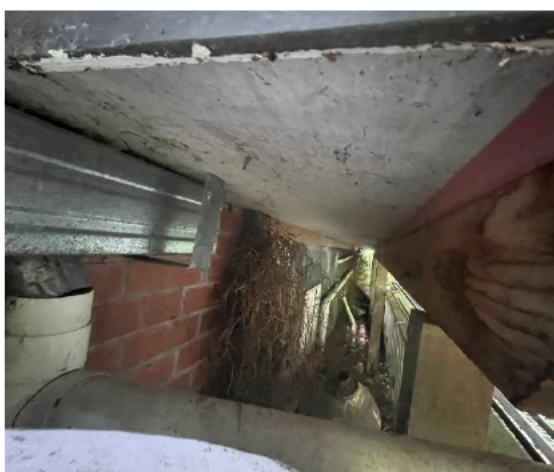
2.44 Rear retaining brick and concrete wall junctions are poorly waterproofed resulting in moisture ingress

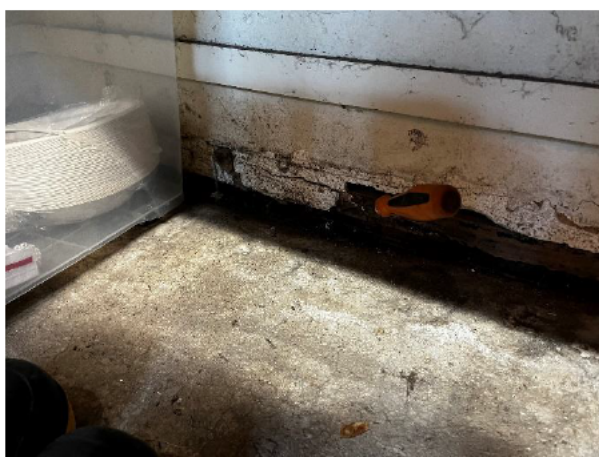
2.45 The damage is present around the perimeter of the room

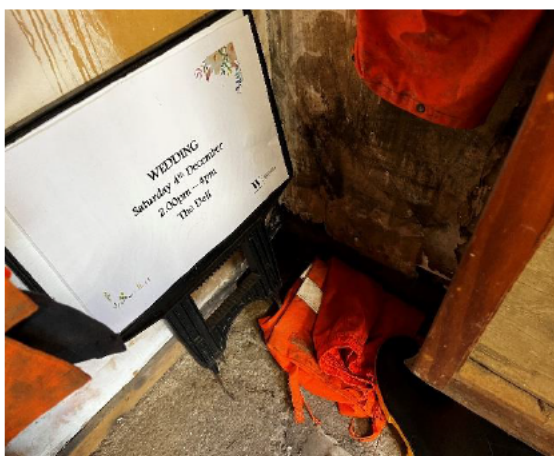
2.46 The timber wall frame below ground level is substantially decayed and disintegrated along the bottom plate and bottom of the studs

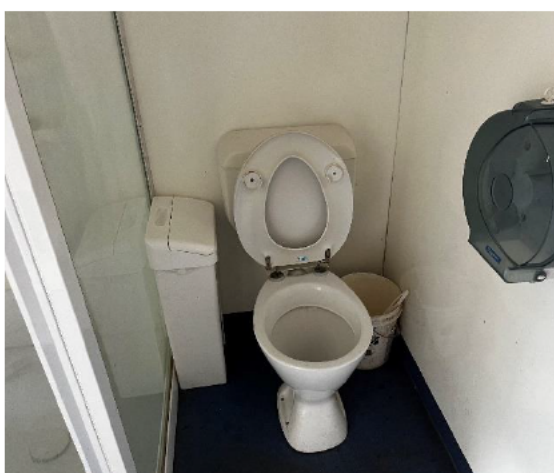
2.48 Facilities are generally in a moderate condition and the electrical and mechanical services are in good condition.

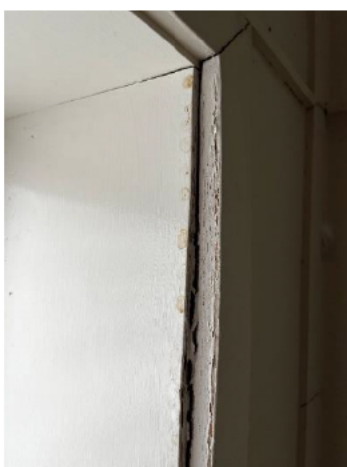
2.54 Rear office moisture damaged window trims and frame

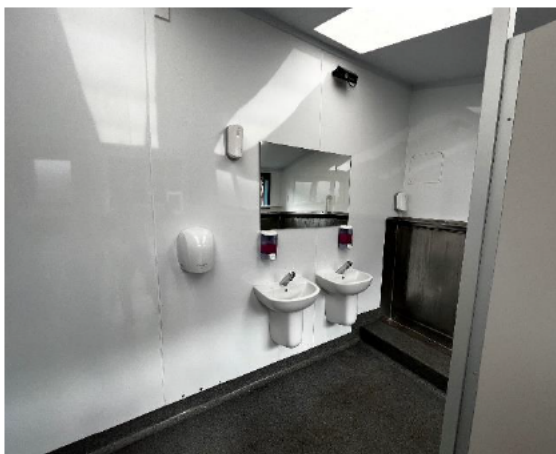
2.58 Refurbishment is in good condition. However, WT understand that the urinals are original but remain in a serviceable condition

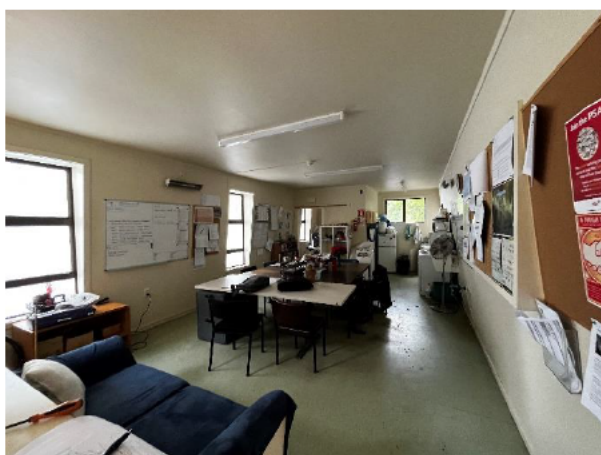
2.61 Staff room with kitchenette. Note that the floor dips in the corner next to the sink

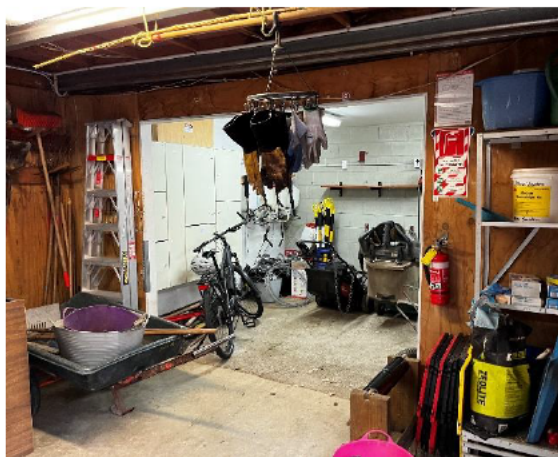
2.64 New electrical incomings mains supply and distribution boards are in very good condition; Fire extinguisher

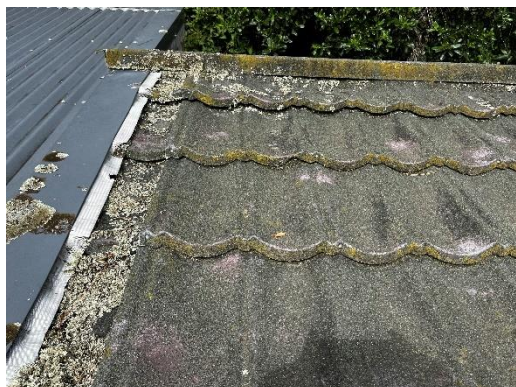
3.1 The coating of Decramastic tiles is known to contain asbestos

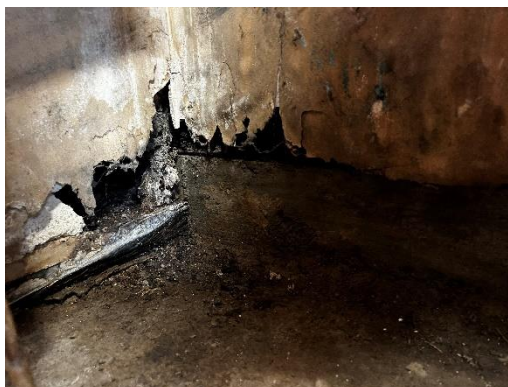
3.2 Decay and mould growth can be carcinogenic

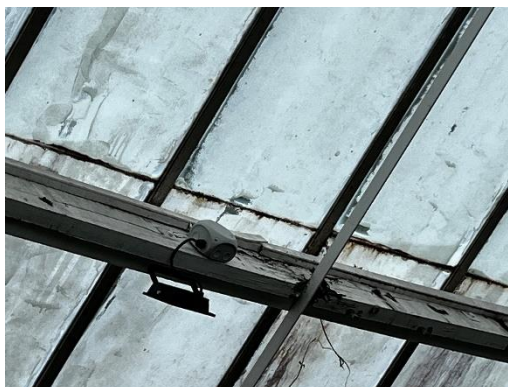
3.4 Deflected purlins to be strengthened

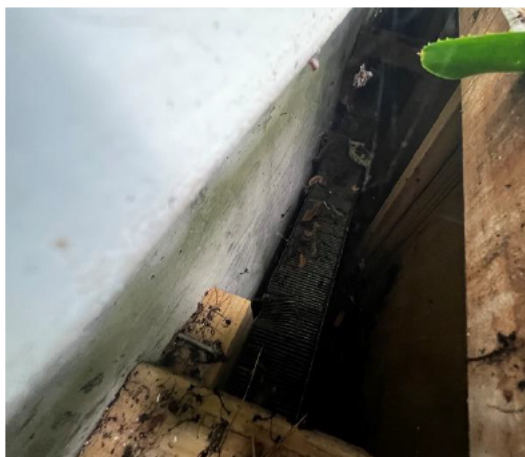
3.7 Timber framing below the sills is moisture stained

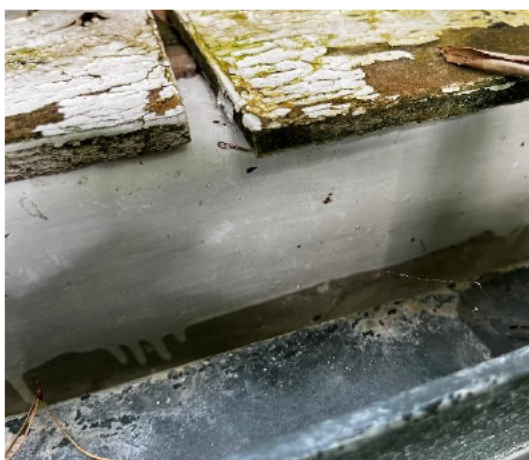
3.8 Mock timber wall is water damaged

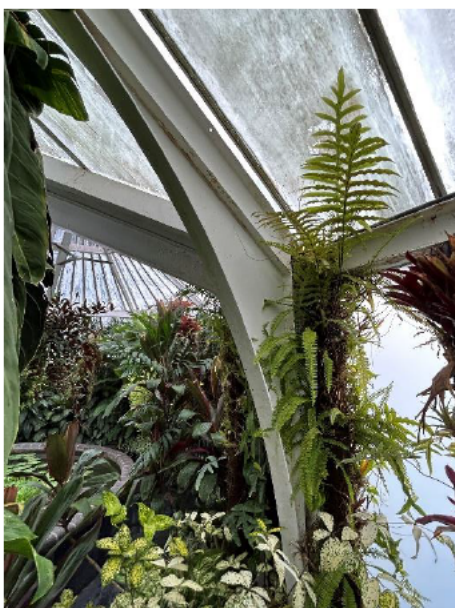
**Photo 4**

Strengthening has been carried out on the portal legs as detailed

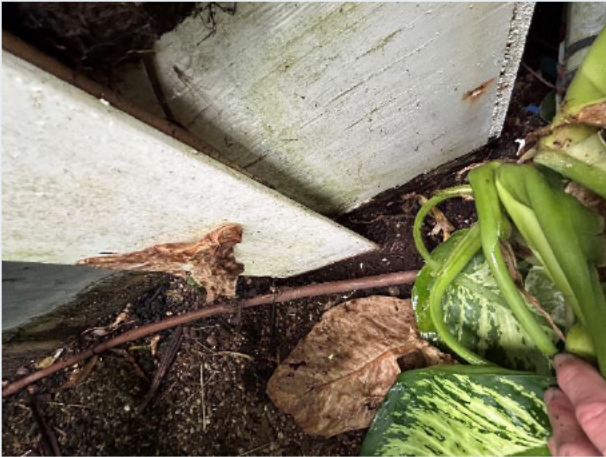
**Photo 5**

Soil built up around portal leg

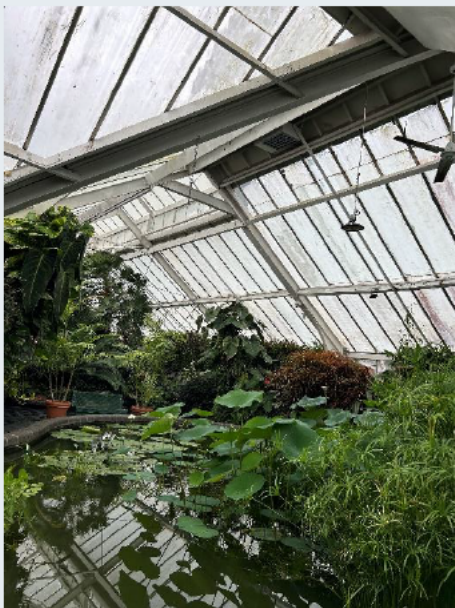
**Photo 7**

Top area of strengthened portal frame with the roof bracing in the next bay

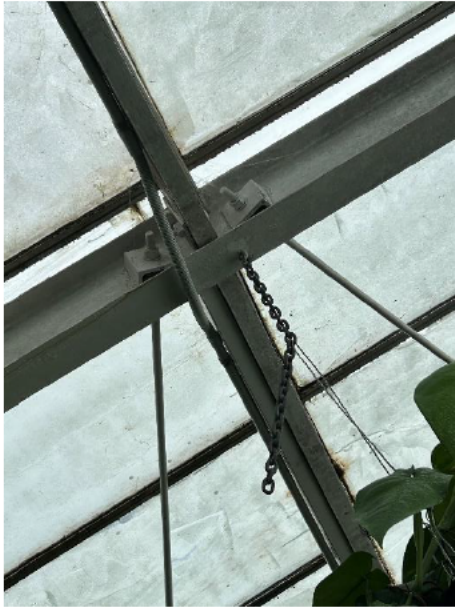
**Photo 8**

Rod roof bracing detail

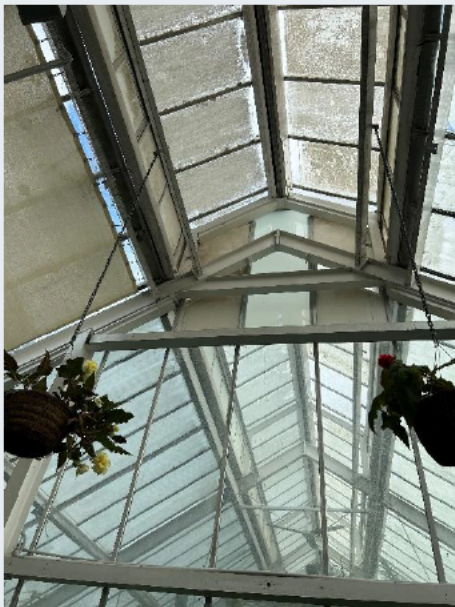
**Photo 9**

High level members at portal strengthening

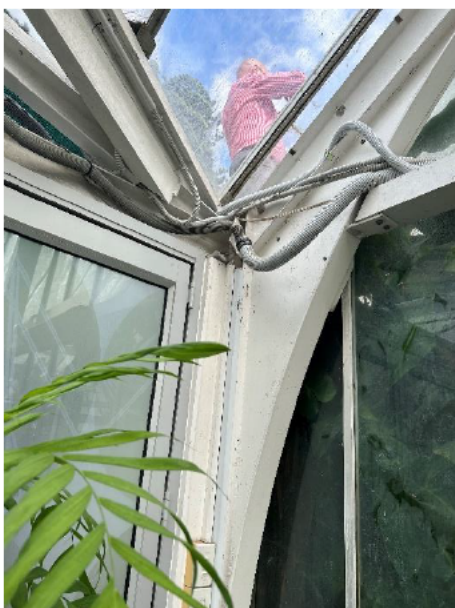
**Photo 10**

Portal knee at the centre area of the building no sign of rusting

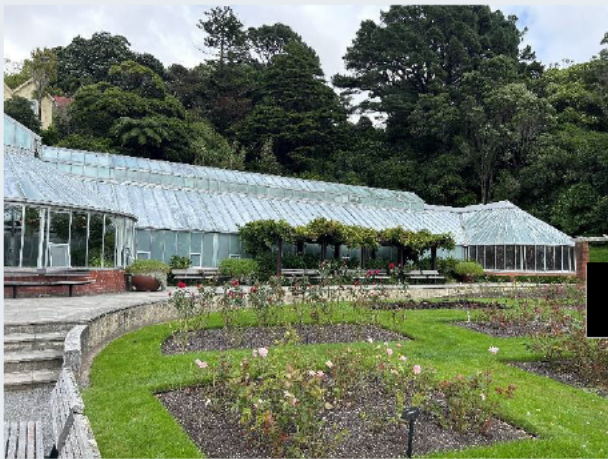
**Photo 21**

Part front elevation

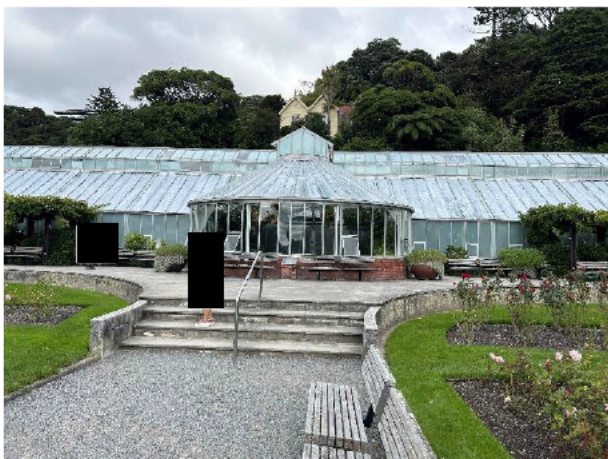
**Photo 22**

Centre of front elevation

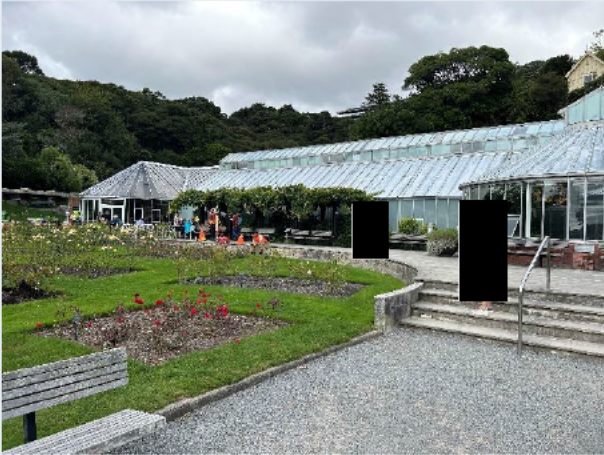
**Photo 23**

Part front elevation

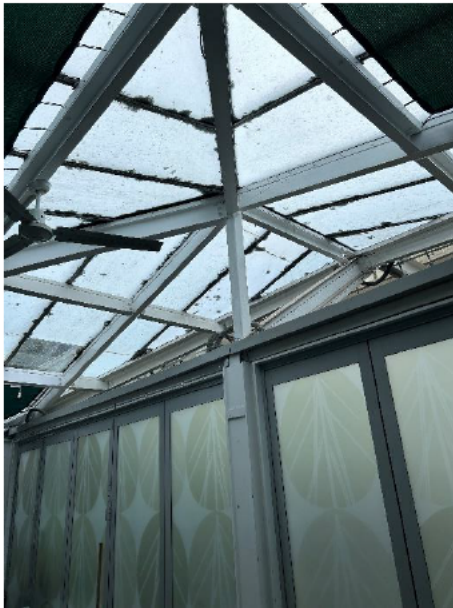
**Photo 24**

Rear area steel structure no signs of rusting

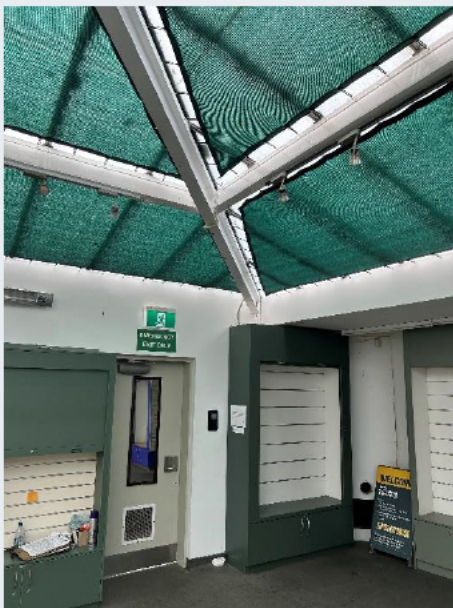
**Photo 25**

Rear area steel structure no signs of rusting

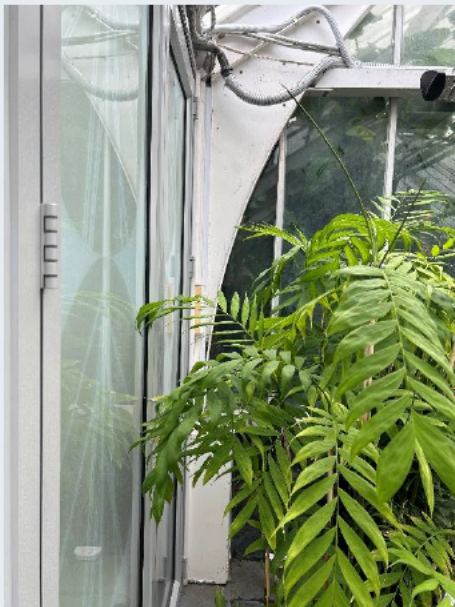
**Photo 27**

Stiffener plates at the portal knee as detailed

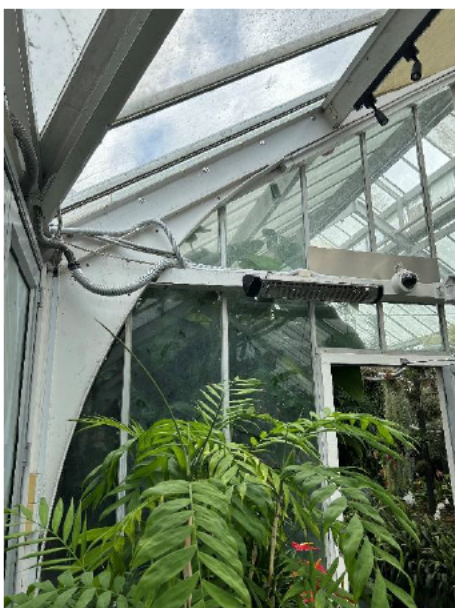
**Photo 28**

Stiffener plates at the portal knee and hip member to the centre atrium

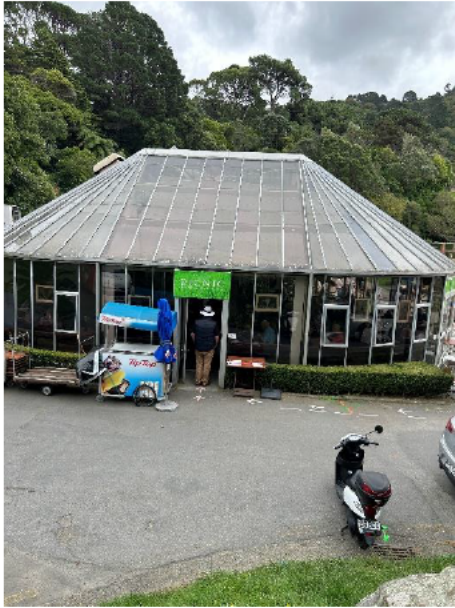
**Photo 32**

Outside view at Grid 1 portal. Roof bracing can be seen through the roofing. The roof bracing can't be seen from the inside of the room due to ceiling coverings
